Investigation of the Effect of the May 2008 Earthquake on Bridges in China

Original presentation in China by Dr. Banfu Yan of
Hunan University, Changsha, China

Investigation of Earthquake-damaged Bridges in Guangyuan, Mianyang, and Deyang, Sichuan Province

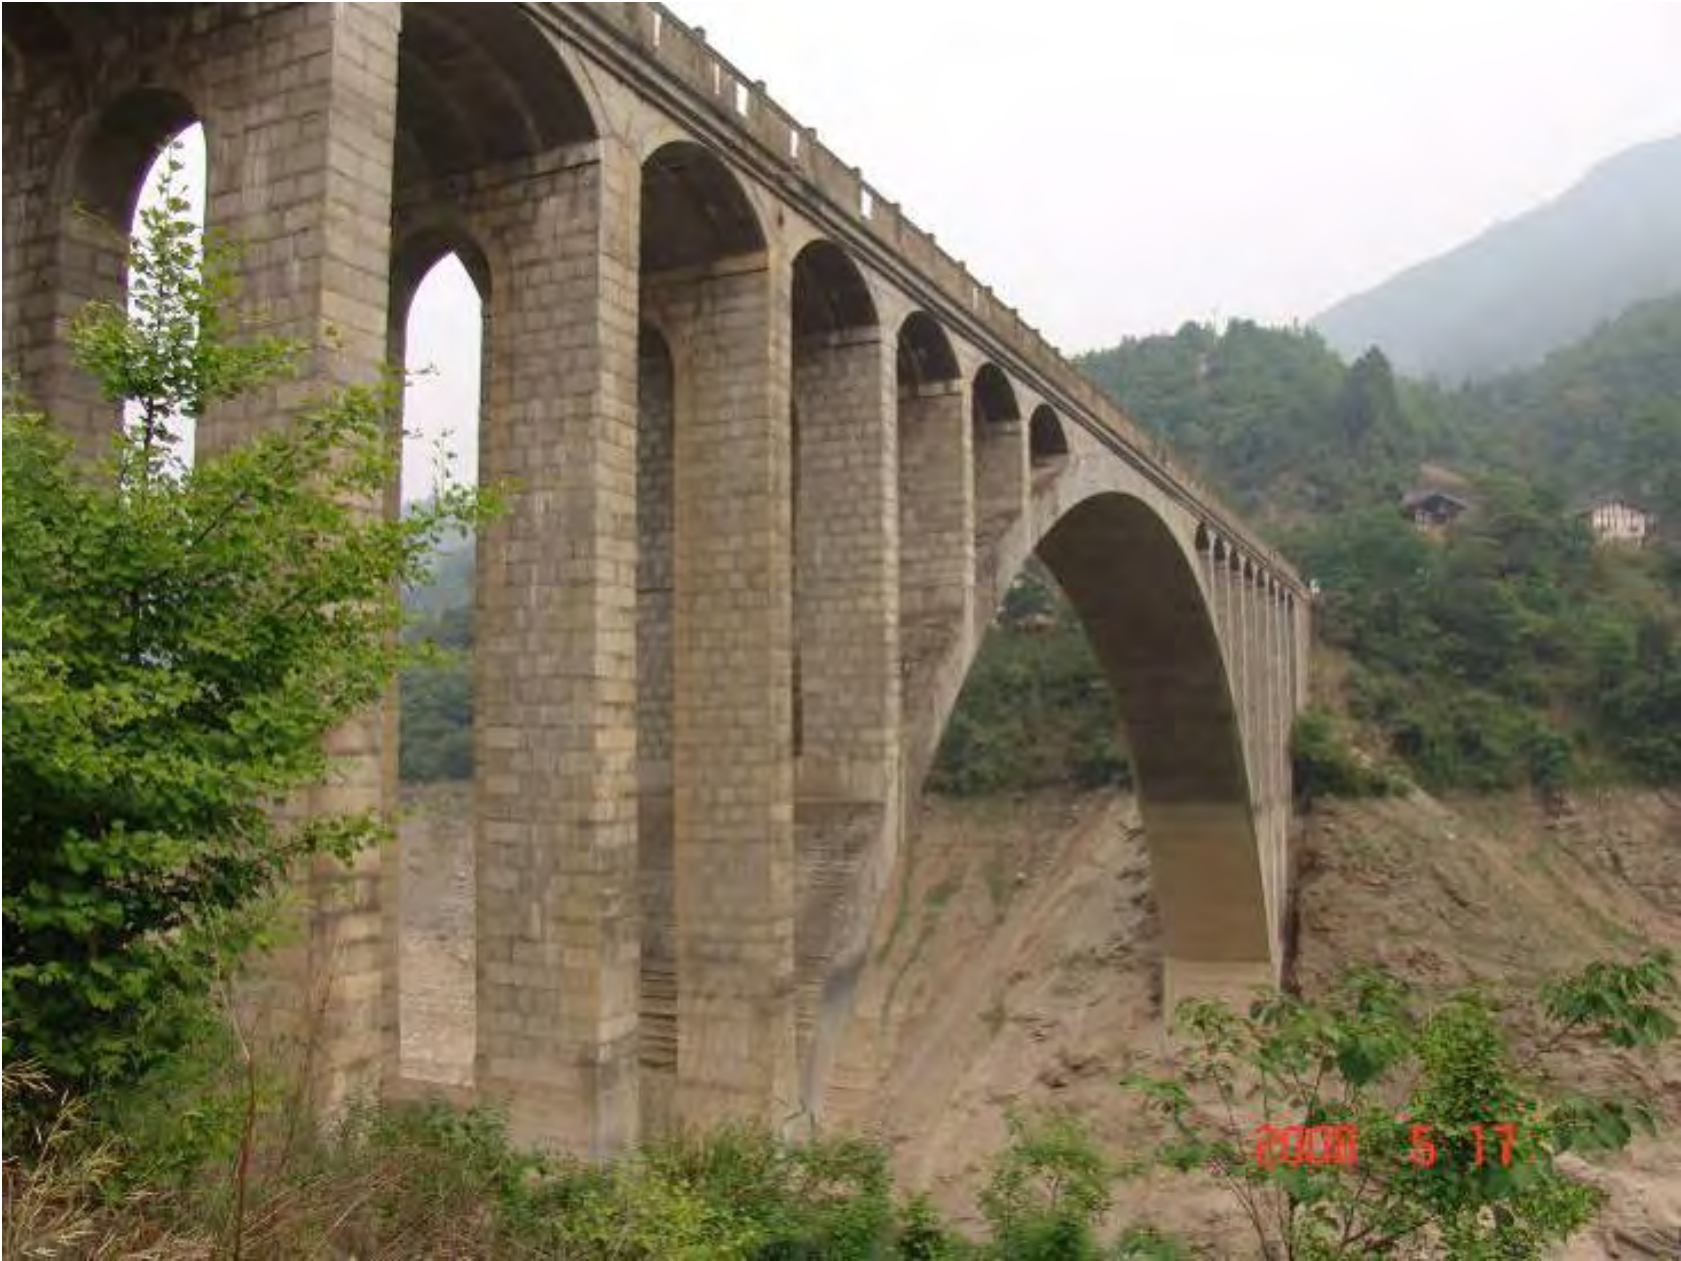
Damage to the abutment walls

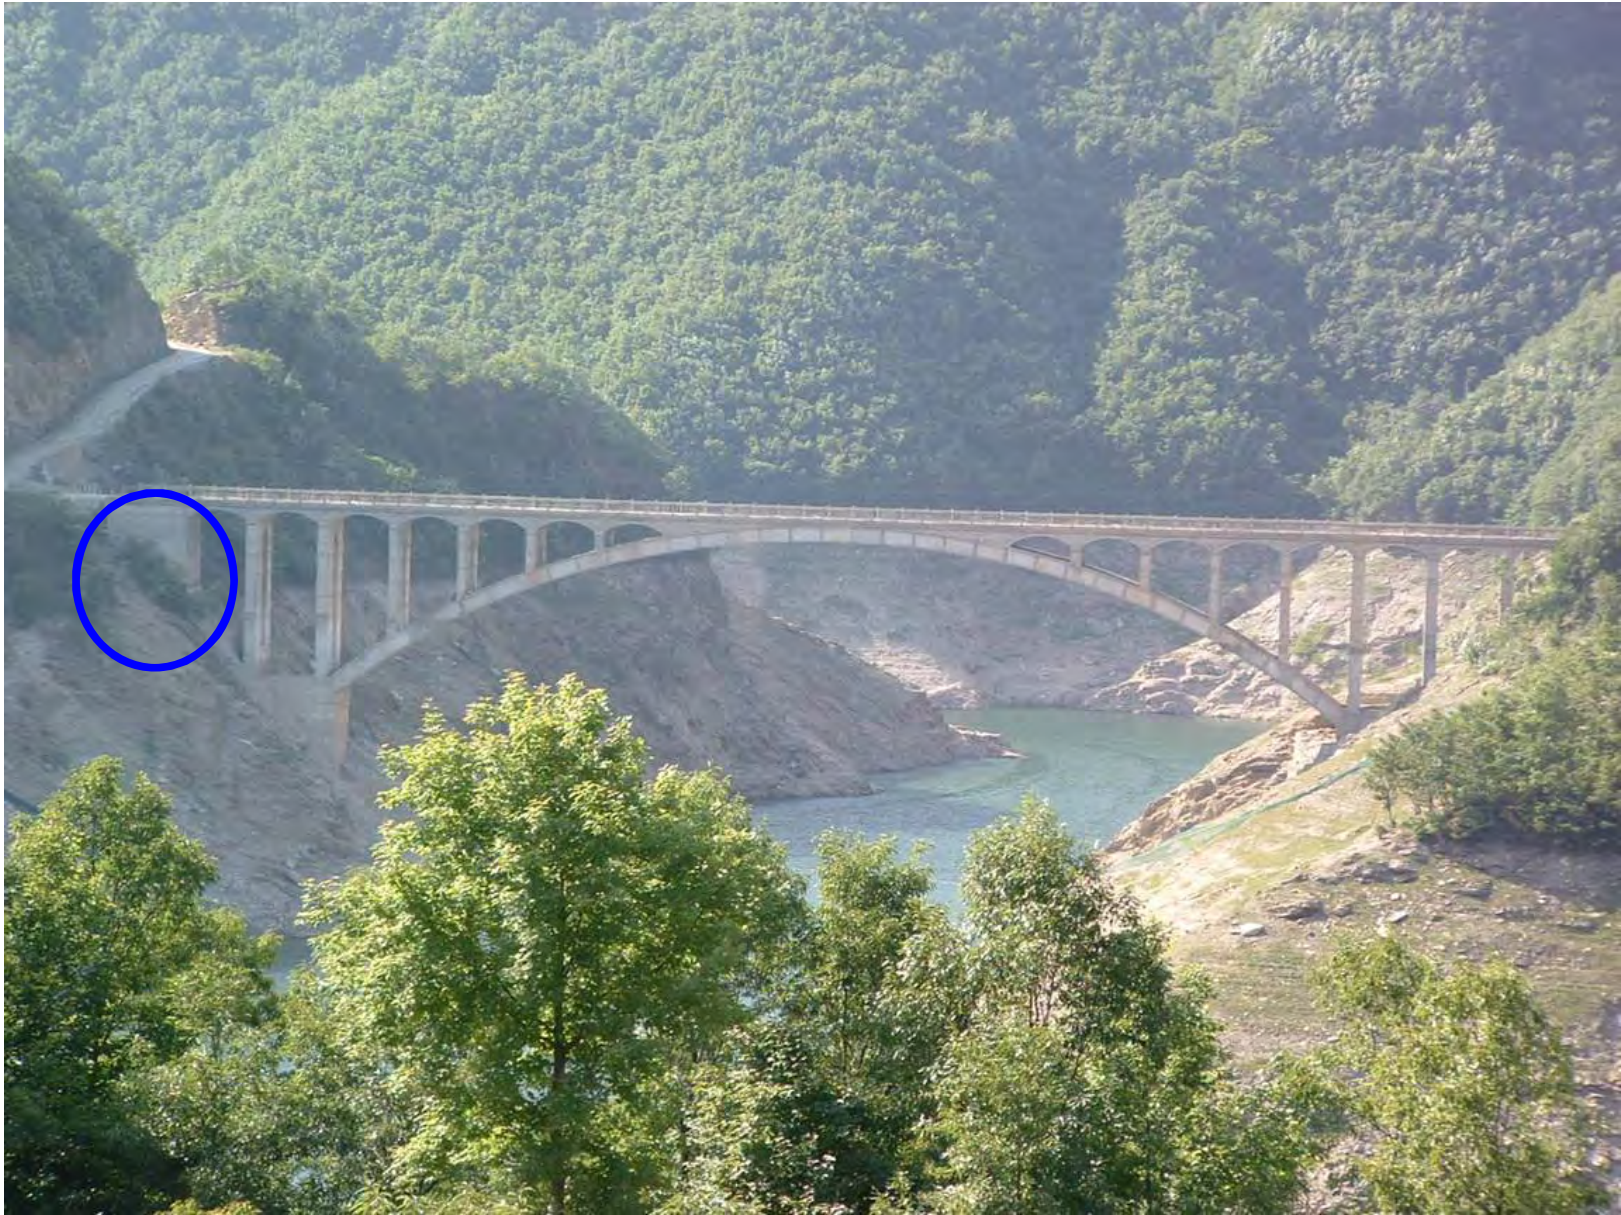
Damage to the abutment walls

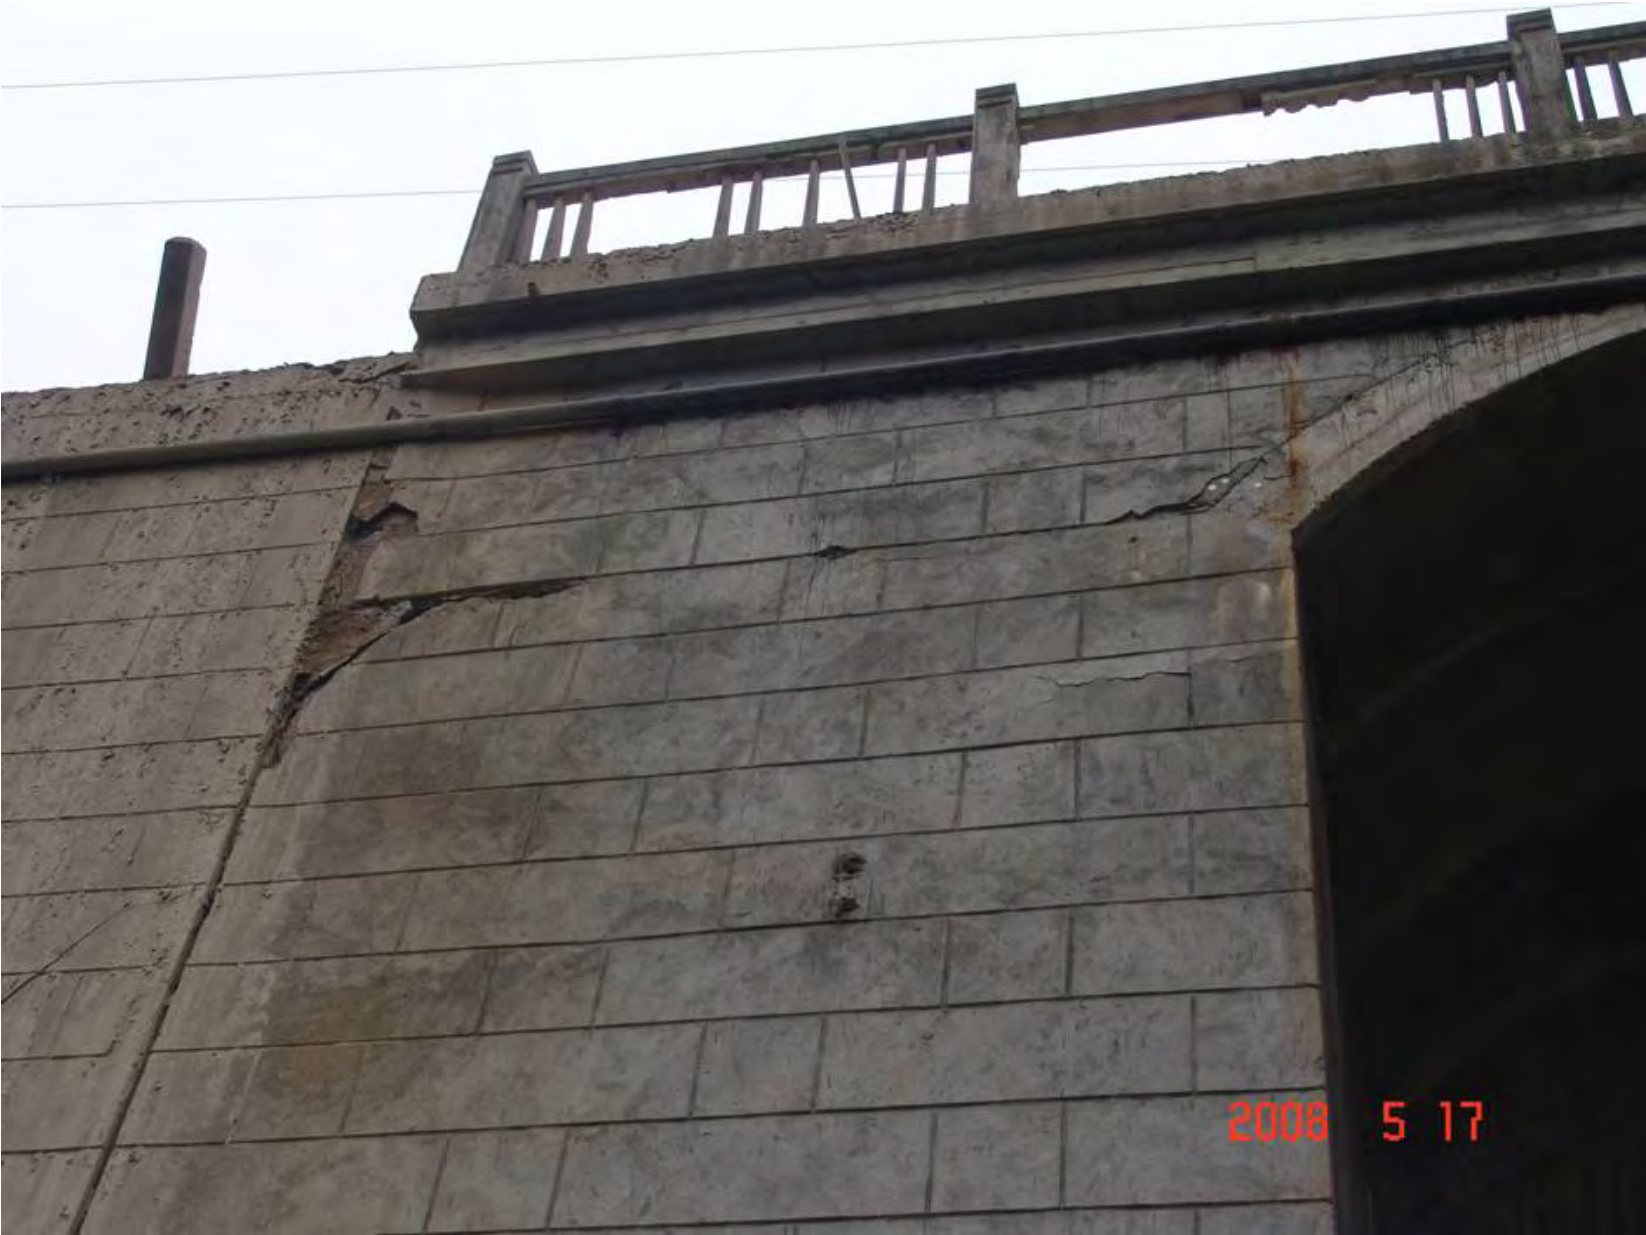
Damage to the abutment walls

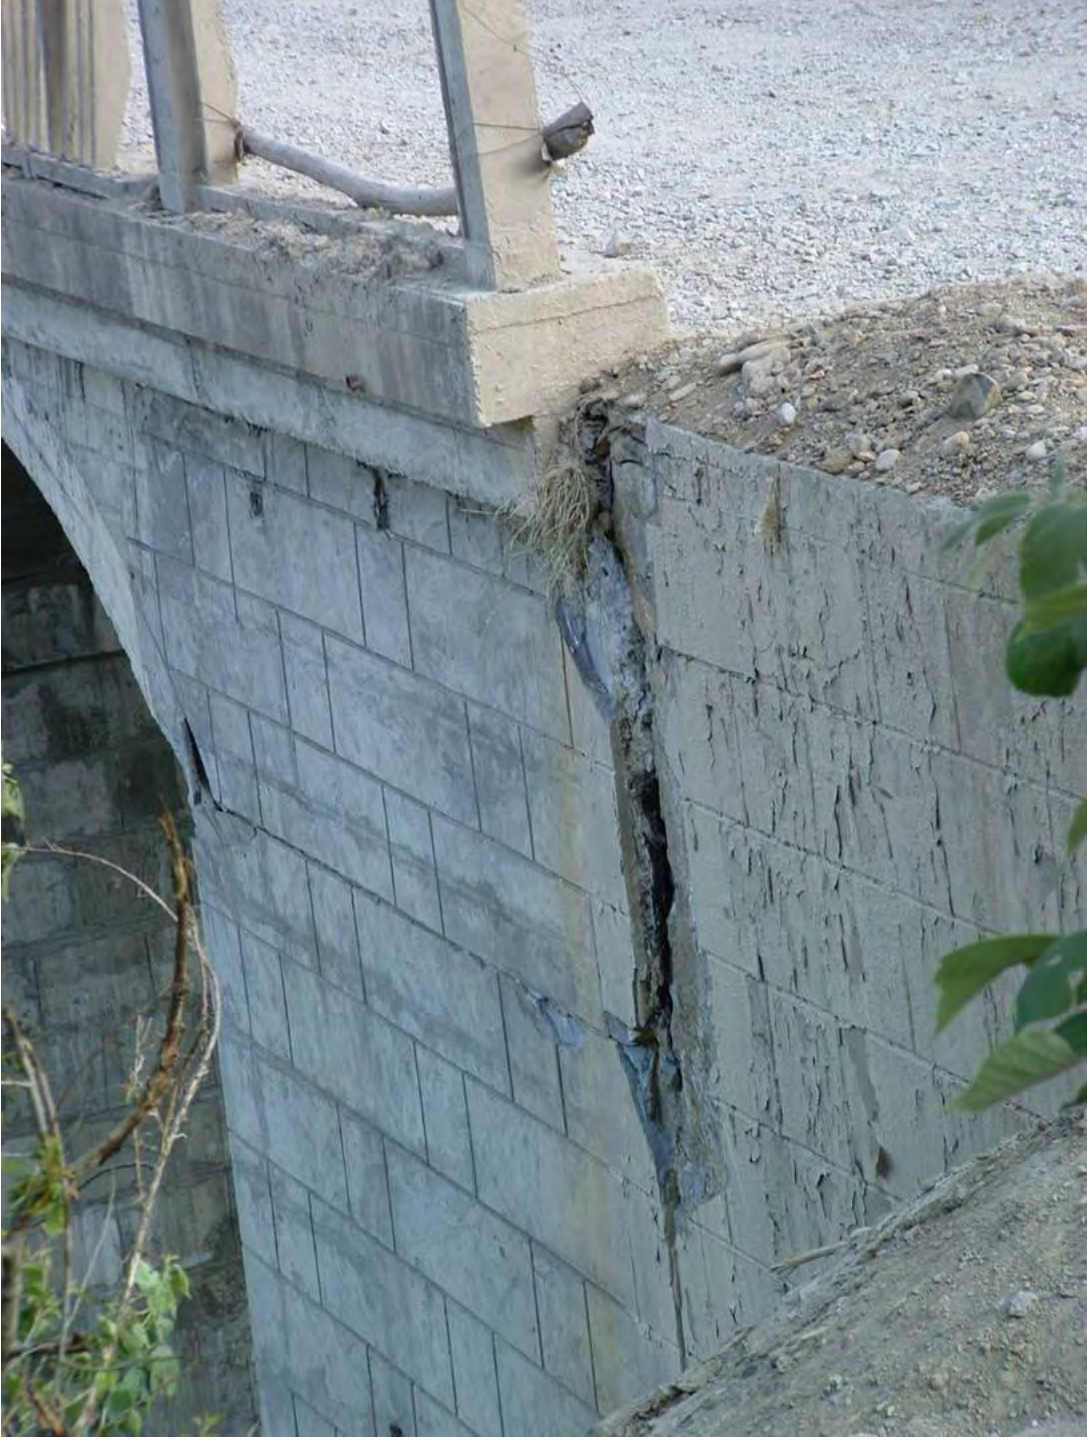
Damage
to deck

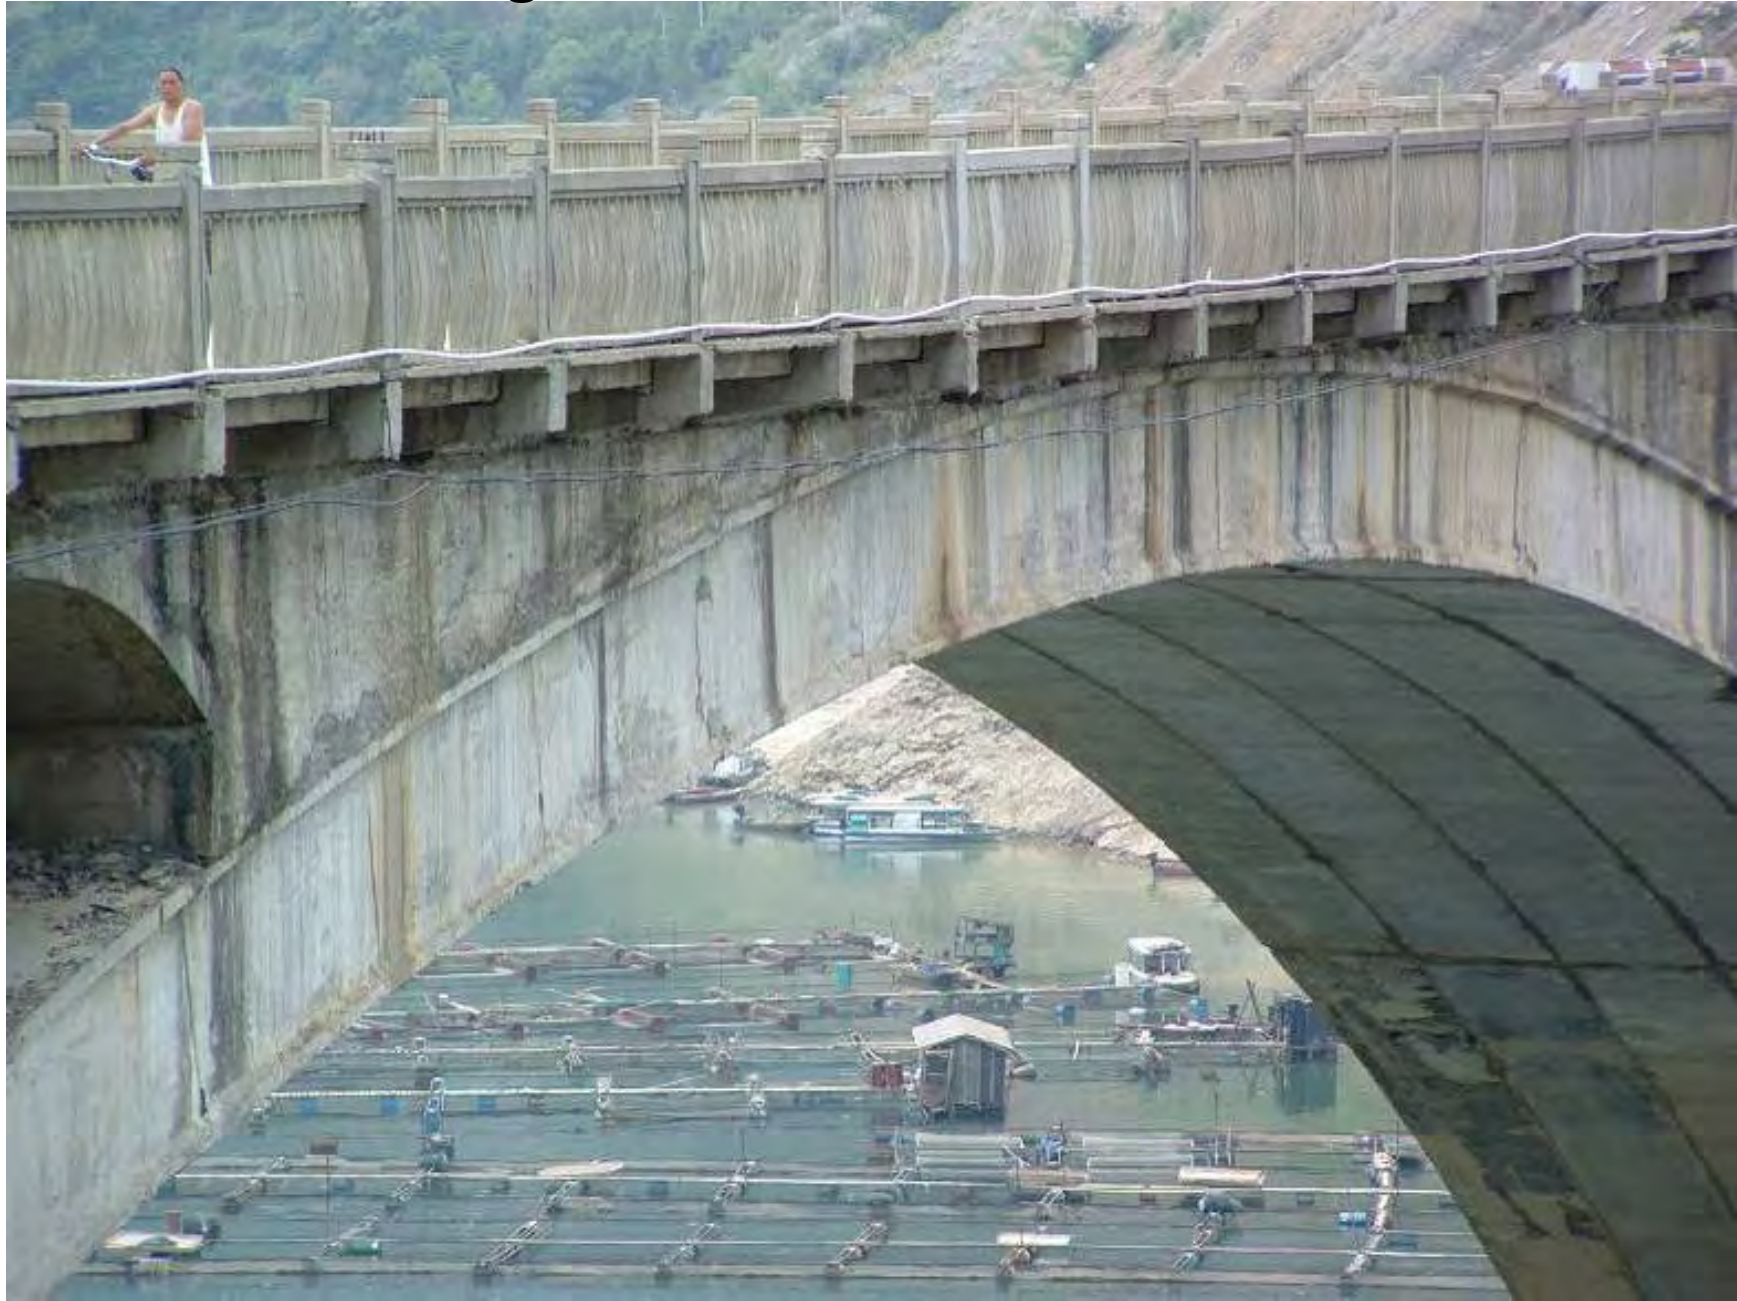
No visible damage middle arch

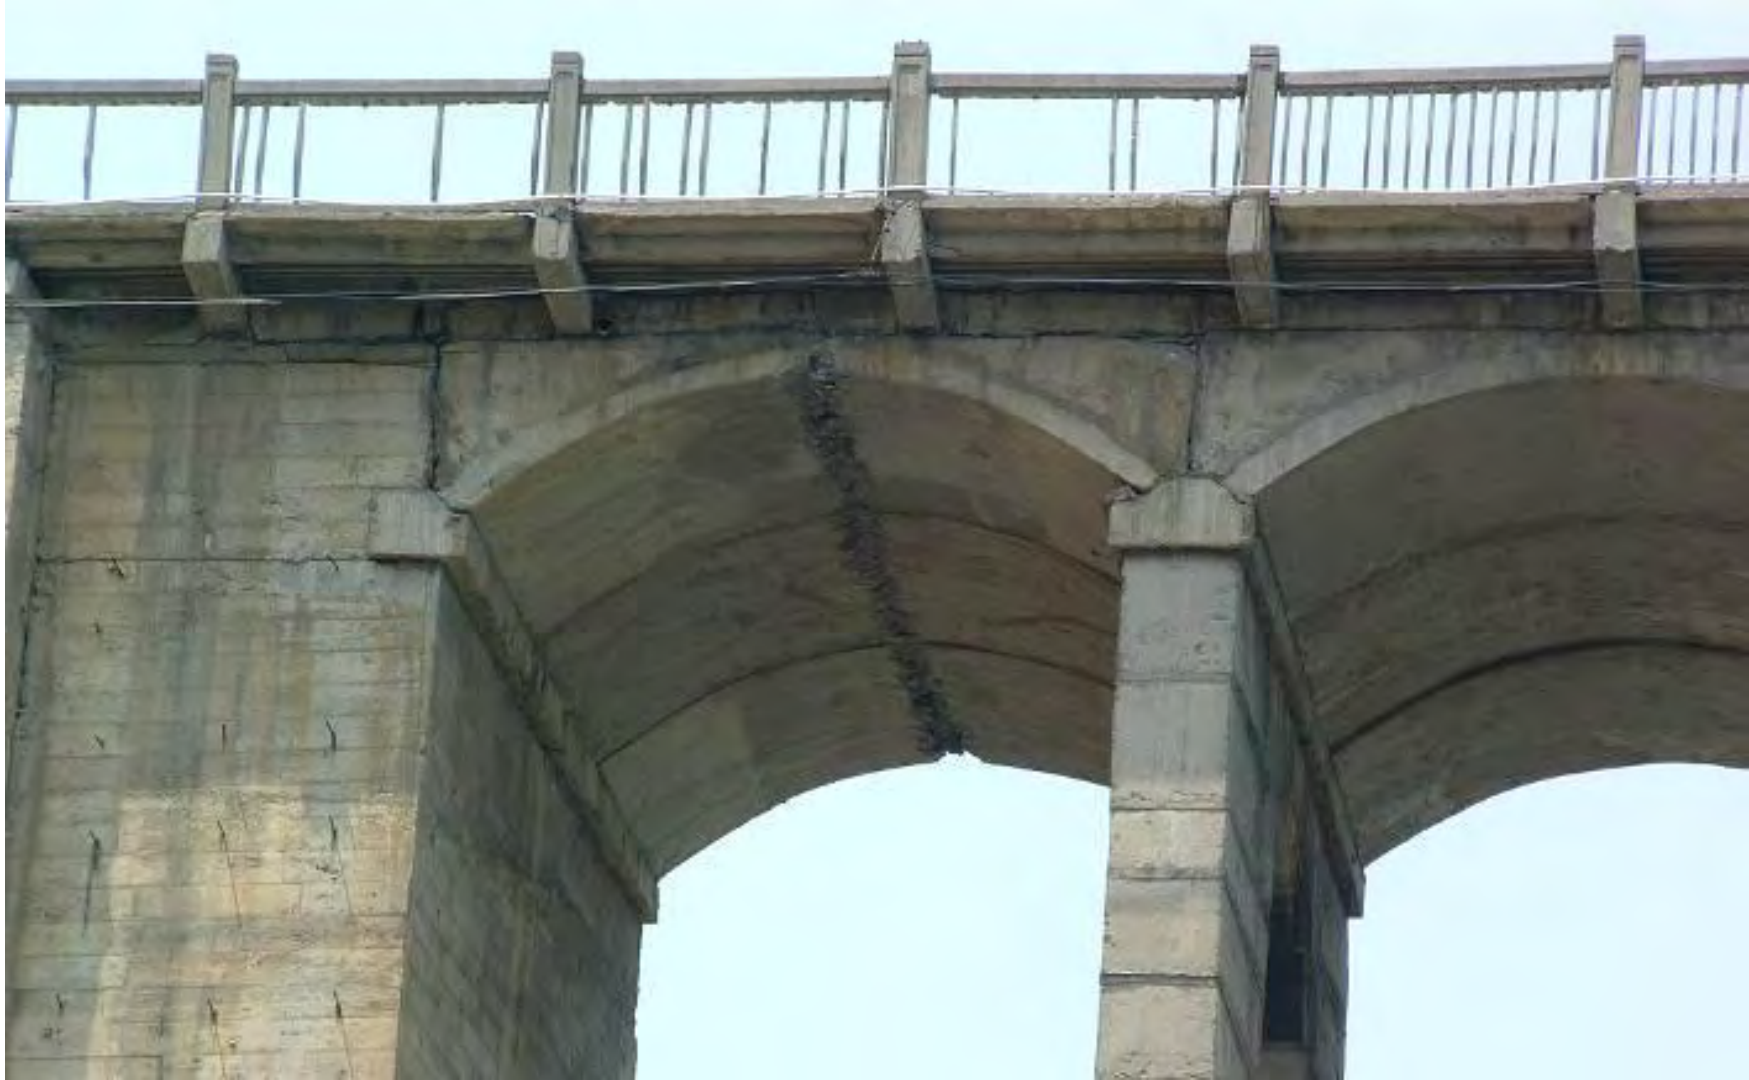
Crushing of concrete in spandrels

This reinforced concrete bridge appears to have had no significant damage to its main spans. However, due to large longitudinal movement during the earthquake, the short interior arches close to the abutments including expansion joints, suffered a lot of damage. Because of this, the bridge cannot be opened to traffic without major repairs.

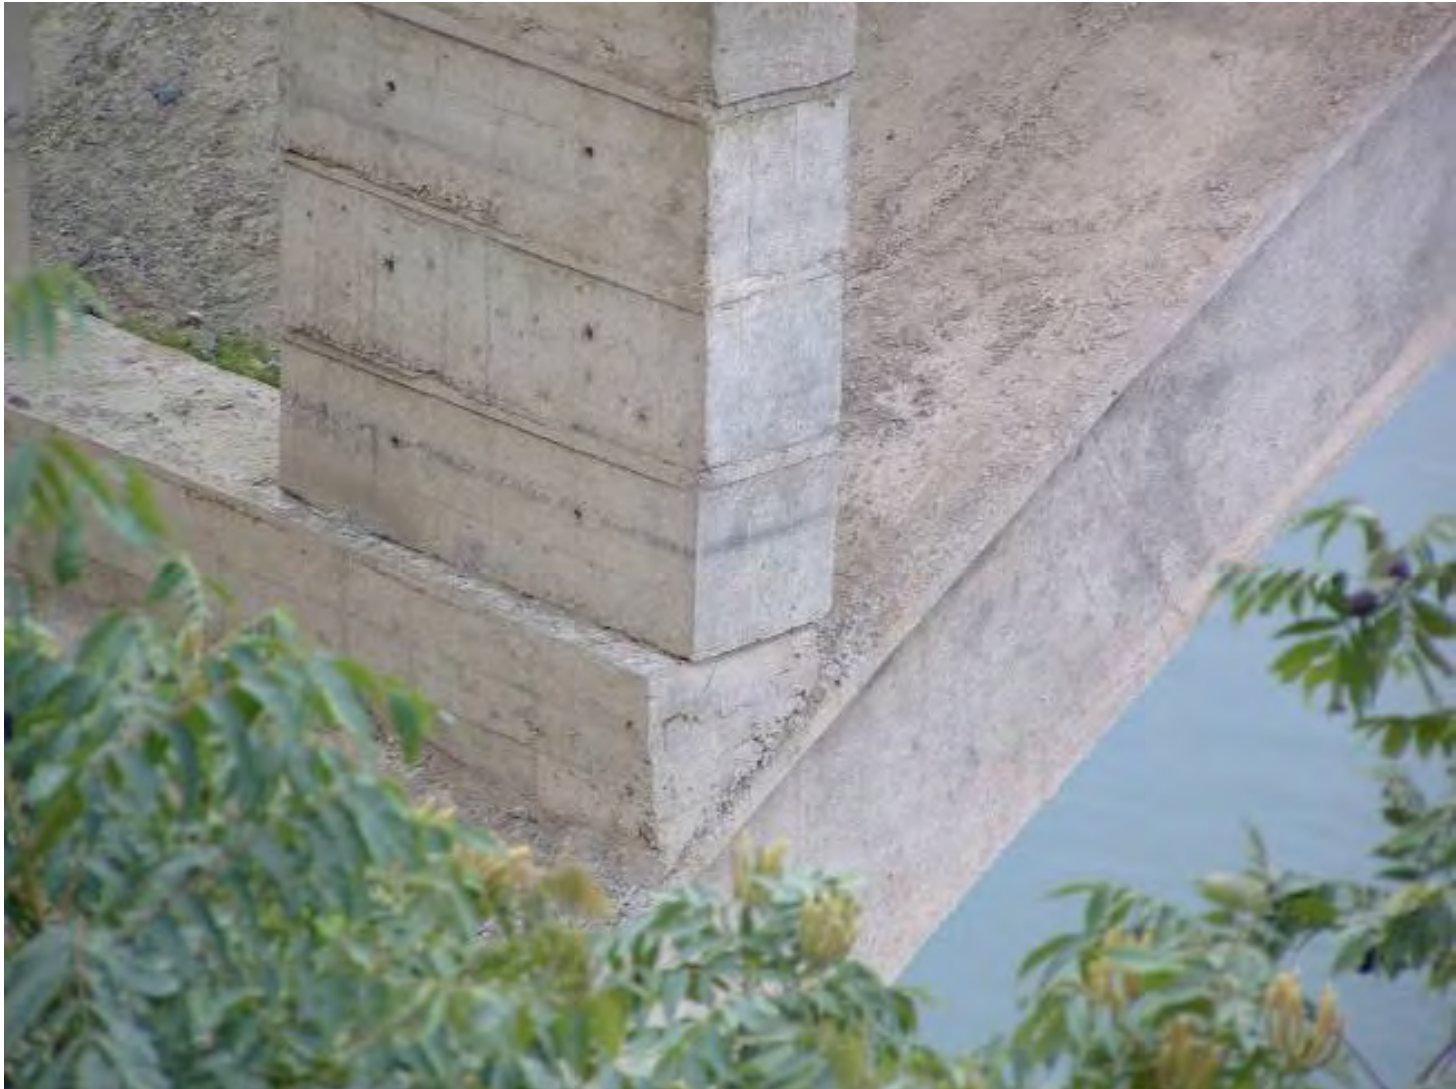
Movement of pylon

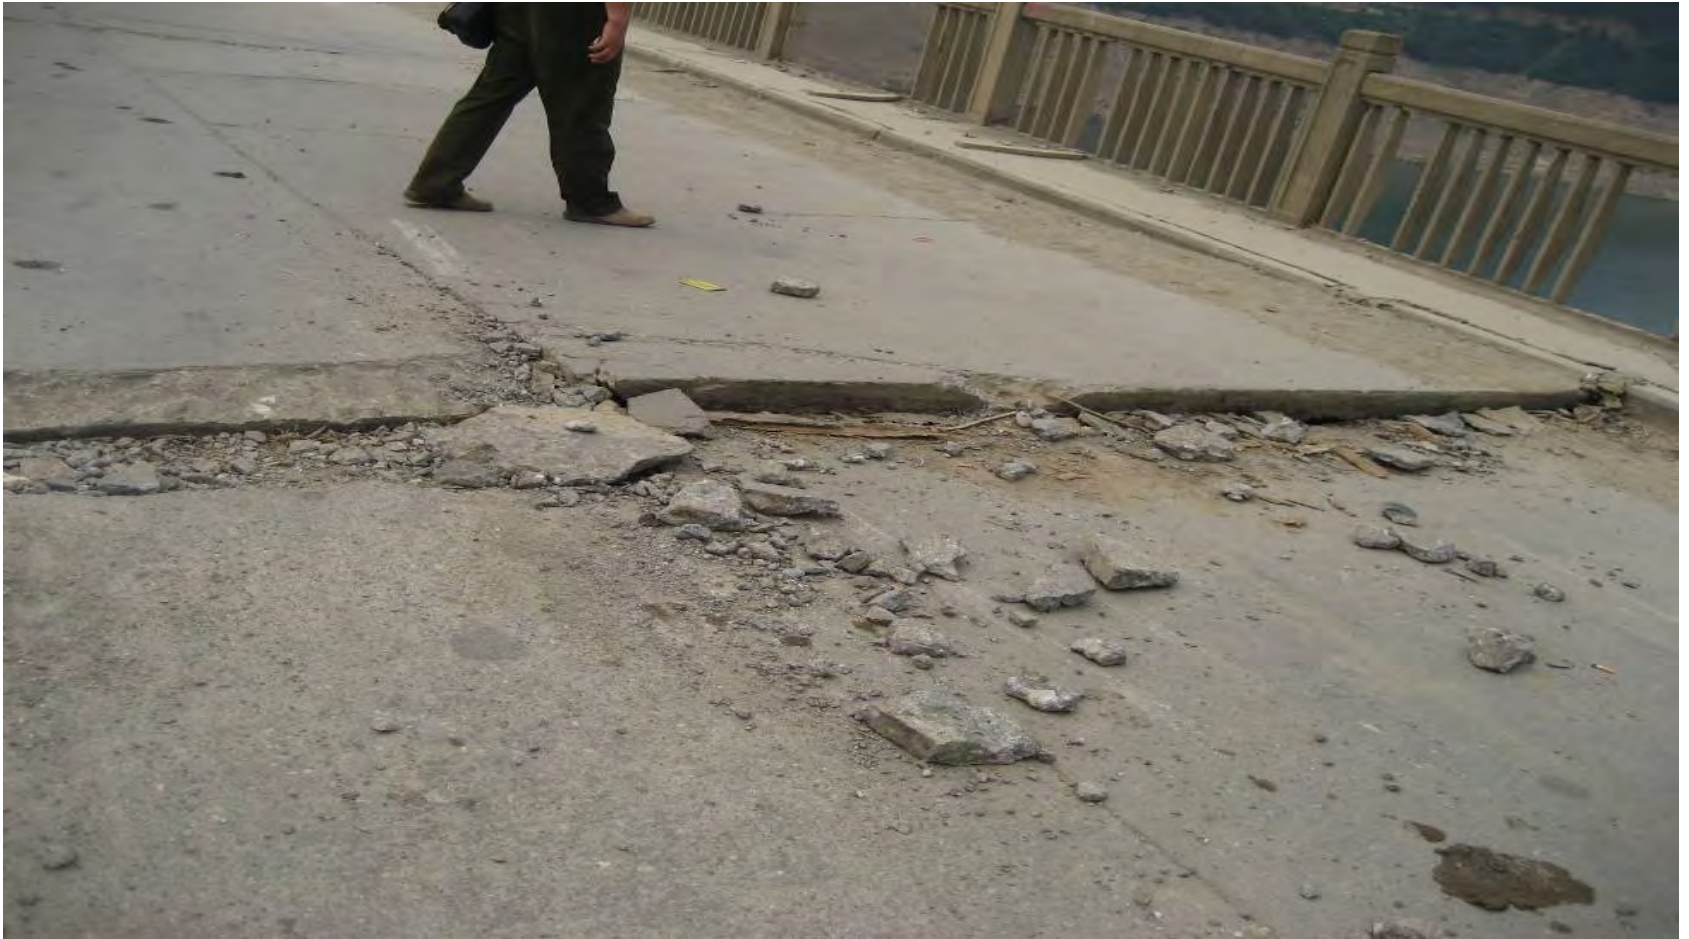
Crack in the deck

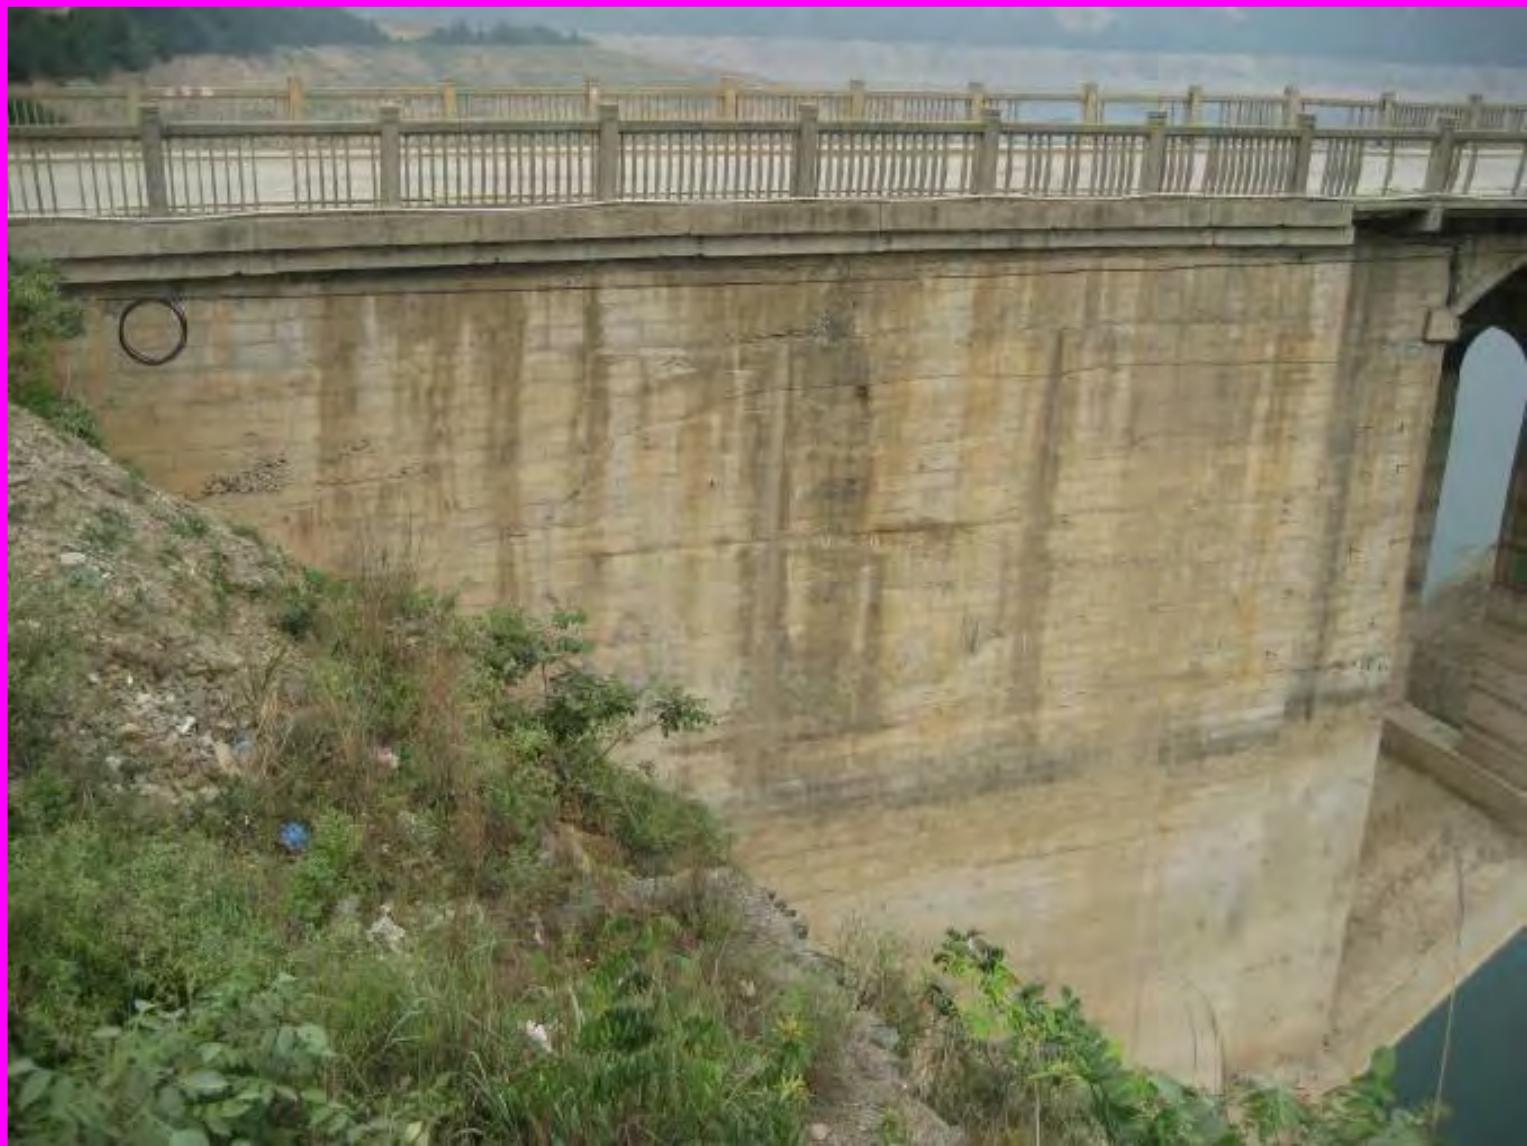
Crack in
abutment

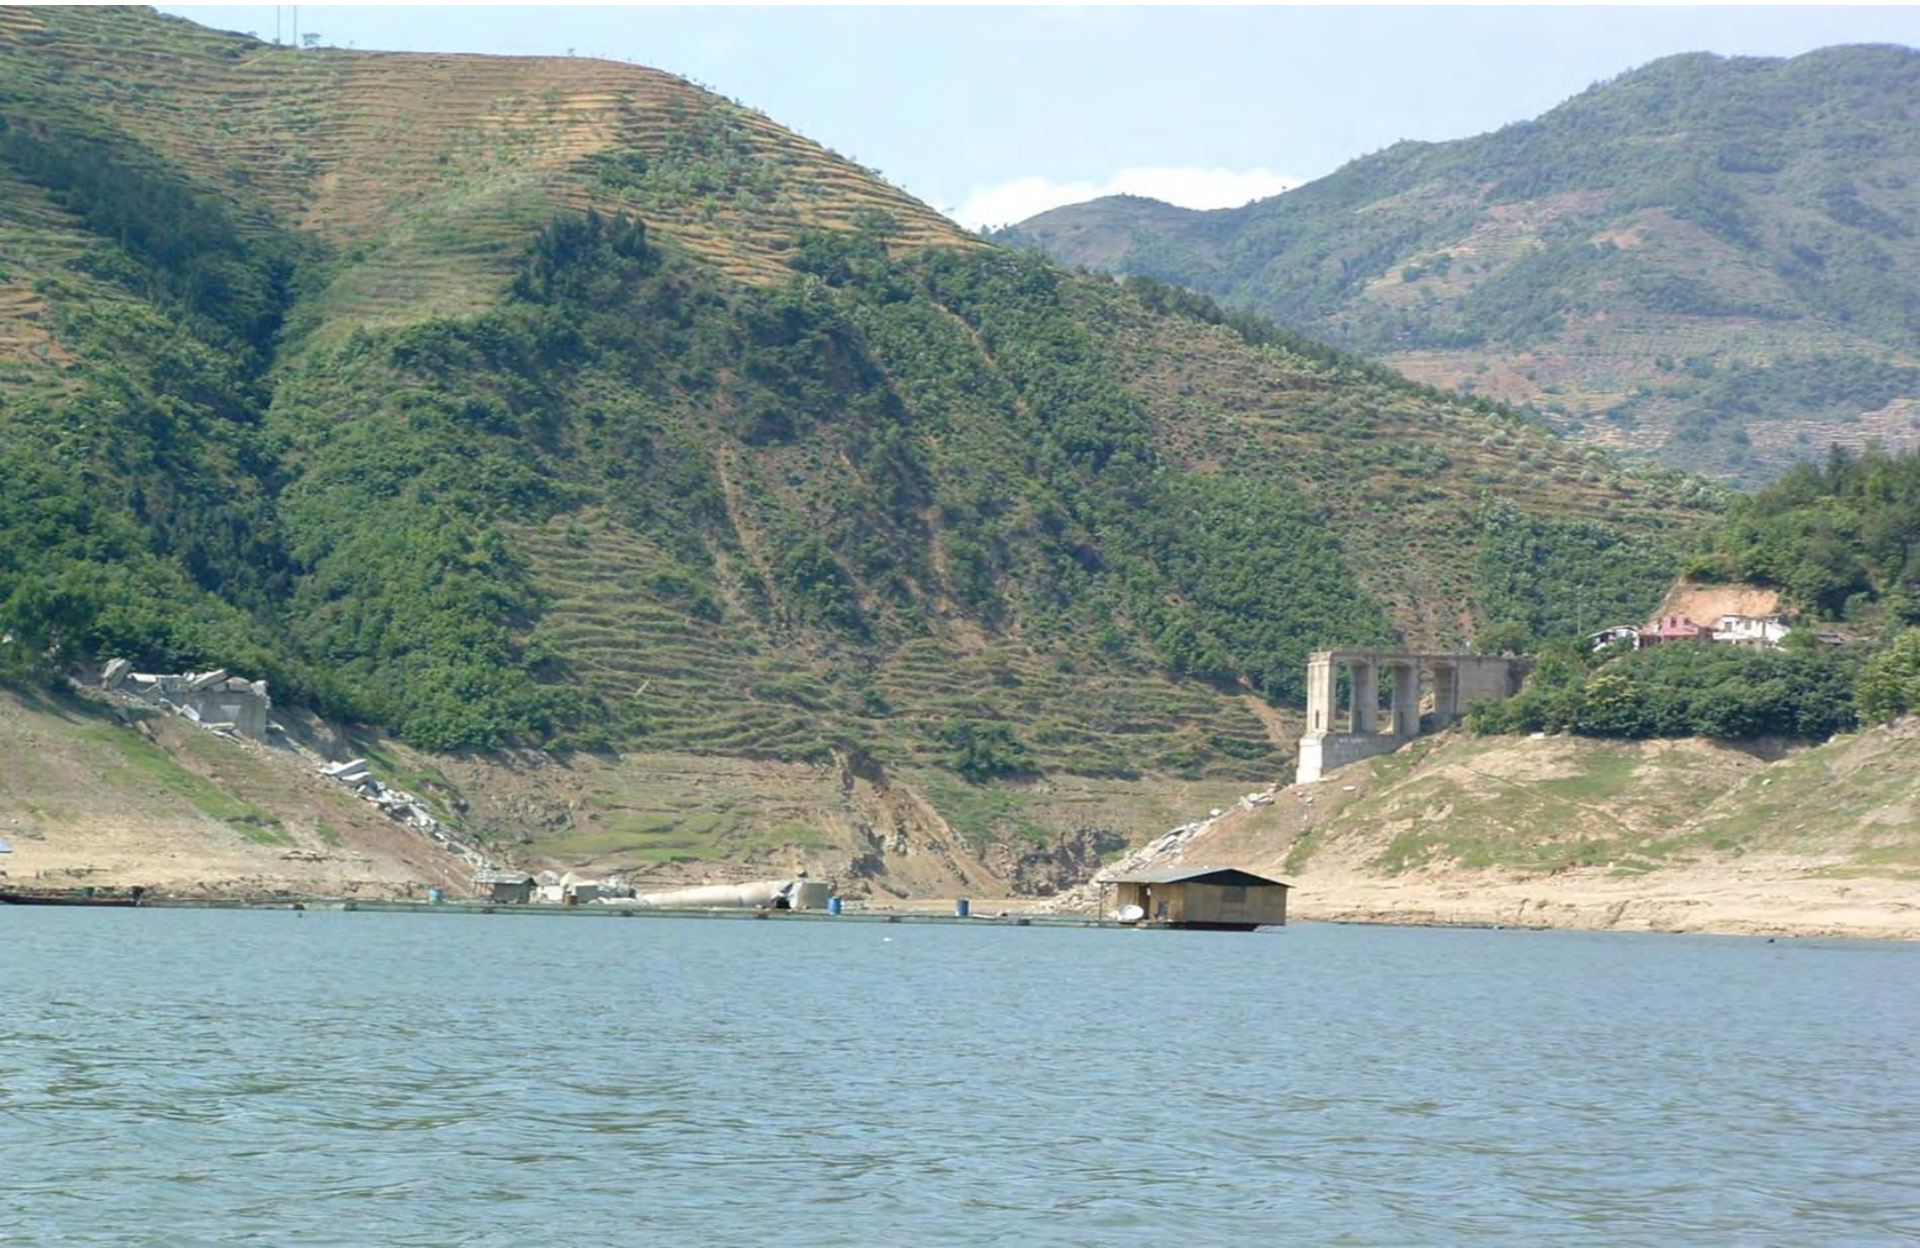
Two-span arch bridge (each span 70m) collapsed closing provincial road 105

There are a number of solutions for the replacement of this bridge on a temporary basis, which include: a military pontoon bridge, some other kind of temporary bridge, as well as relocation of the road, which will eliminate the need for the bridge.

Currently, the relocation of the road seems to be the most favourable solution.

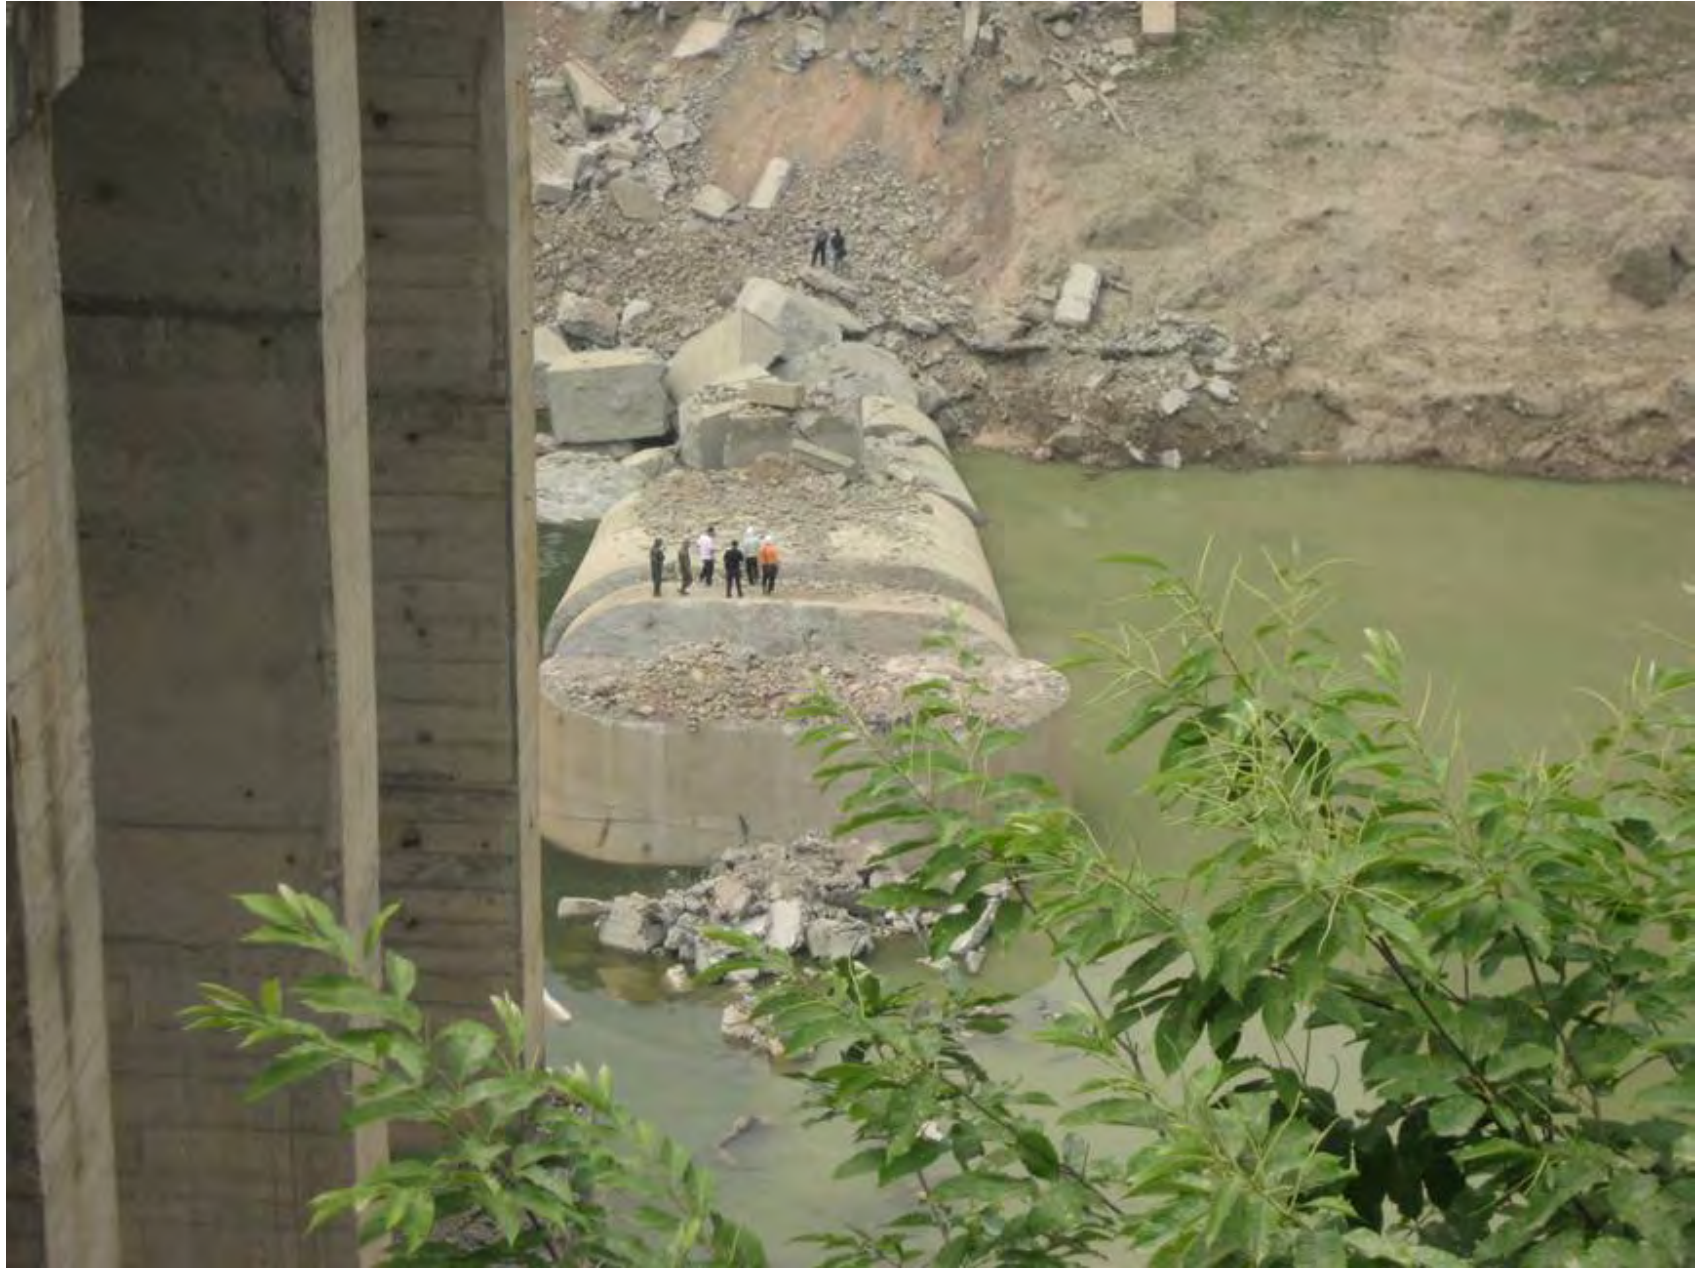
20m tall pier
