Investigation of the Effect of the May 2008 Earthquake on Bridges in China

Original presentation in China by Dr. Banfu Yan of
Hunan University, Changsha, China

Investigation of Earthquake-damaged Bridges in Guangyuan, Mianyang, and Deyang, Sichuan Province

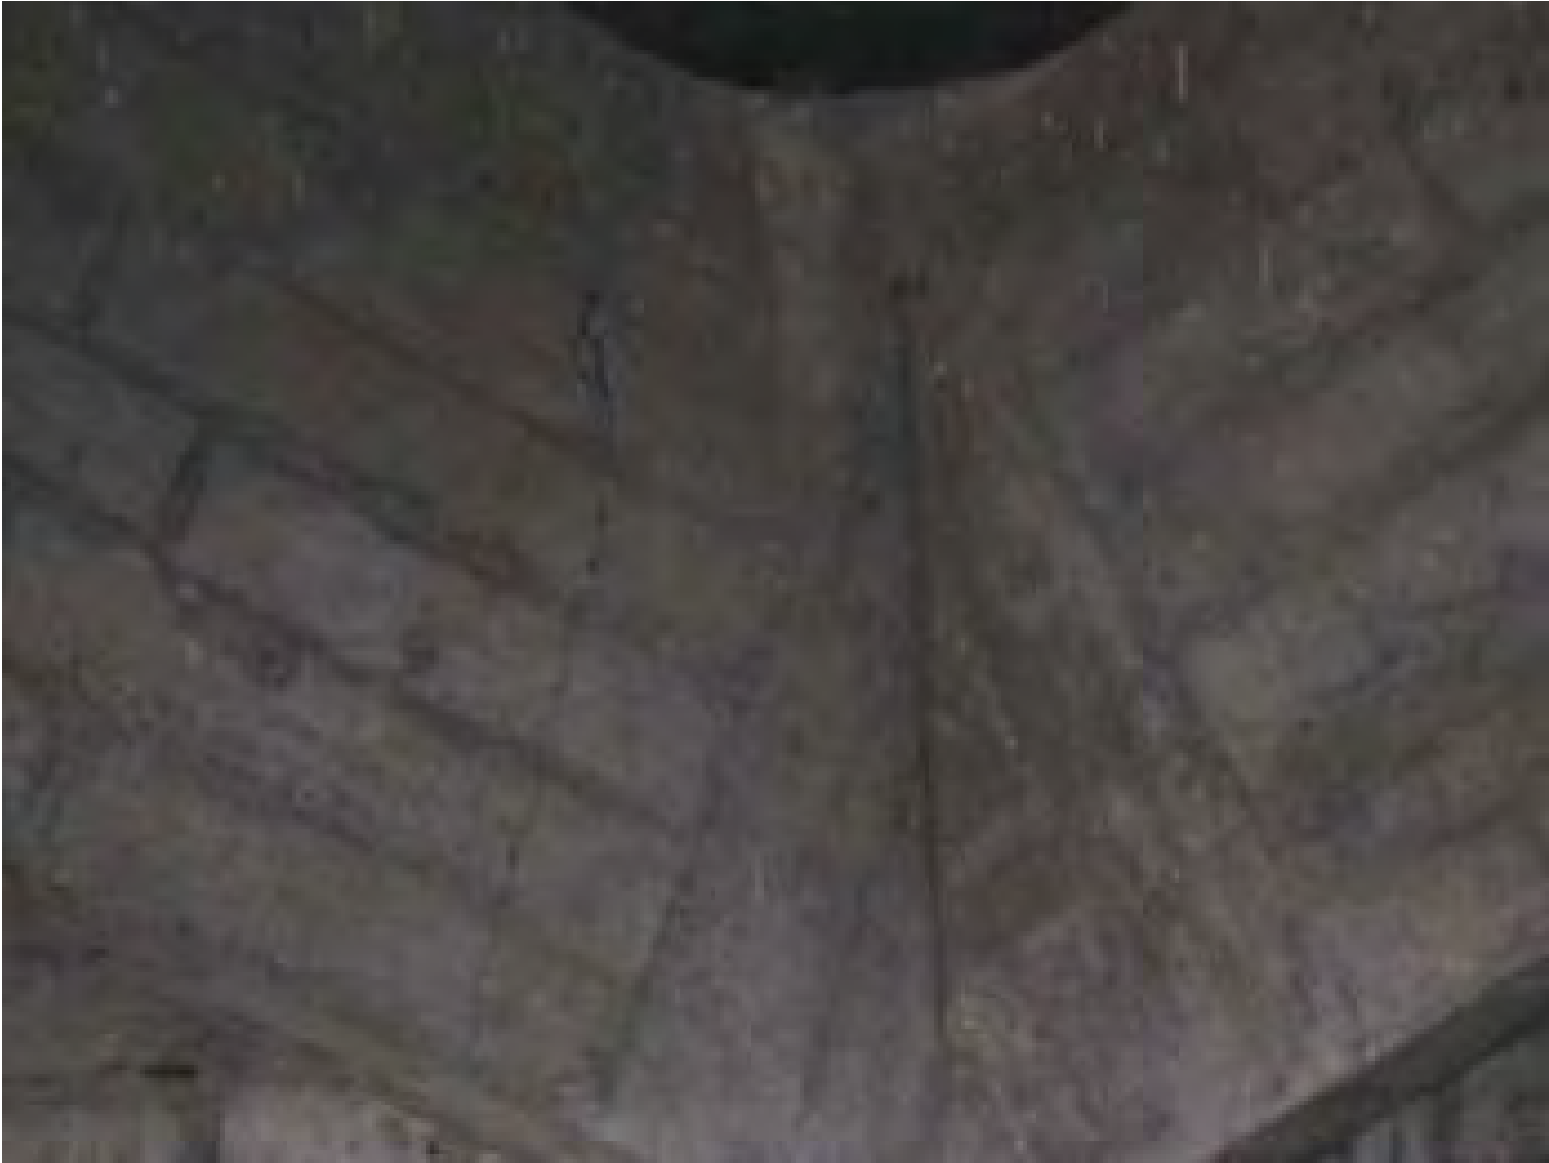
Damage to K-brace

1. In spite of the damage, the bridge is still open to traffic, with the following restrictions: the speed limit was reduced; the gross vehicle weight was reduced; and the traffic was directed to travel on the center of the bridge.
2. The bridge is to be inspected frequently to make sure there is no further damage to any of its components.

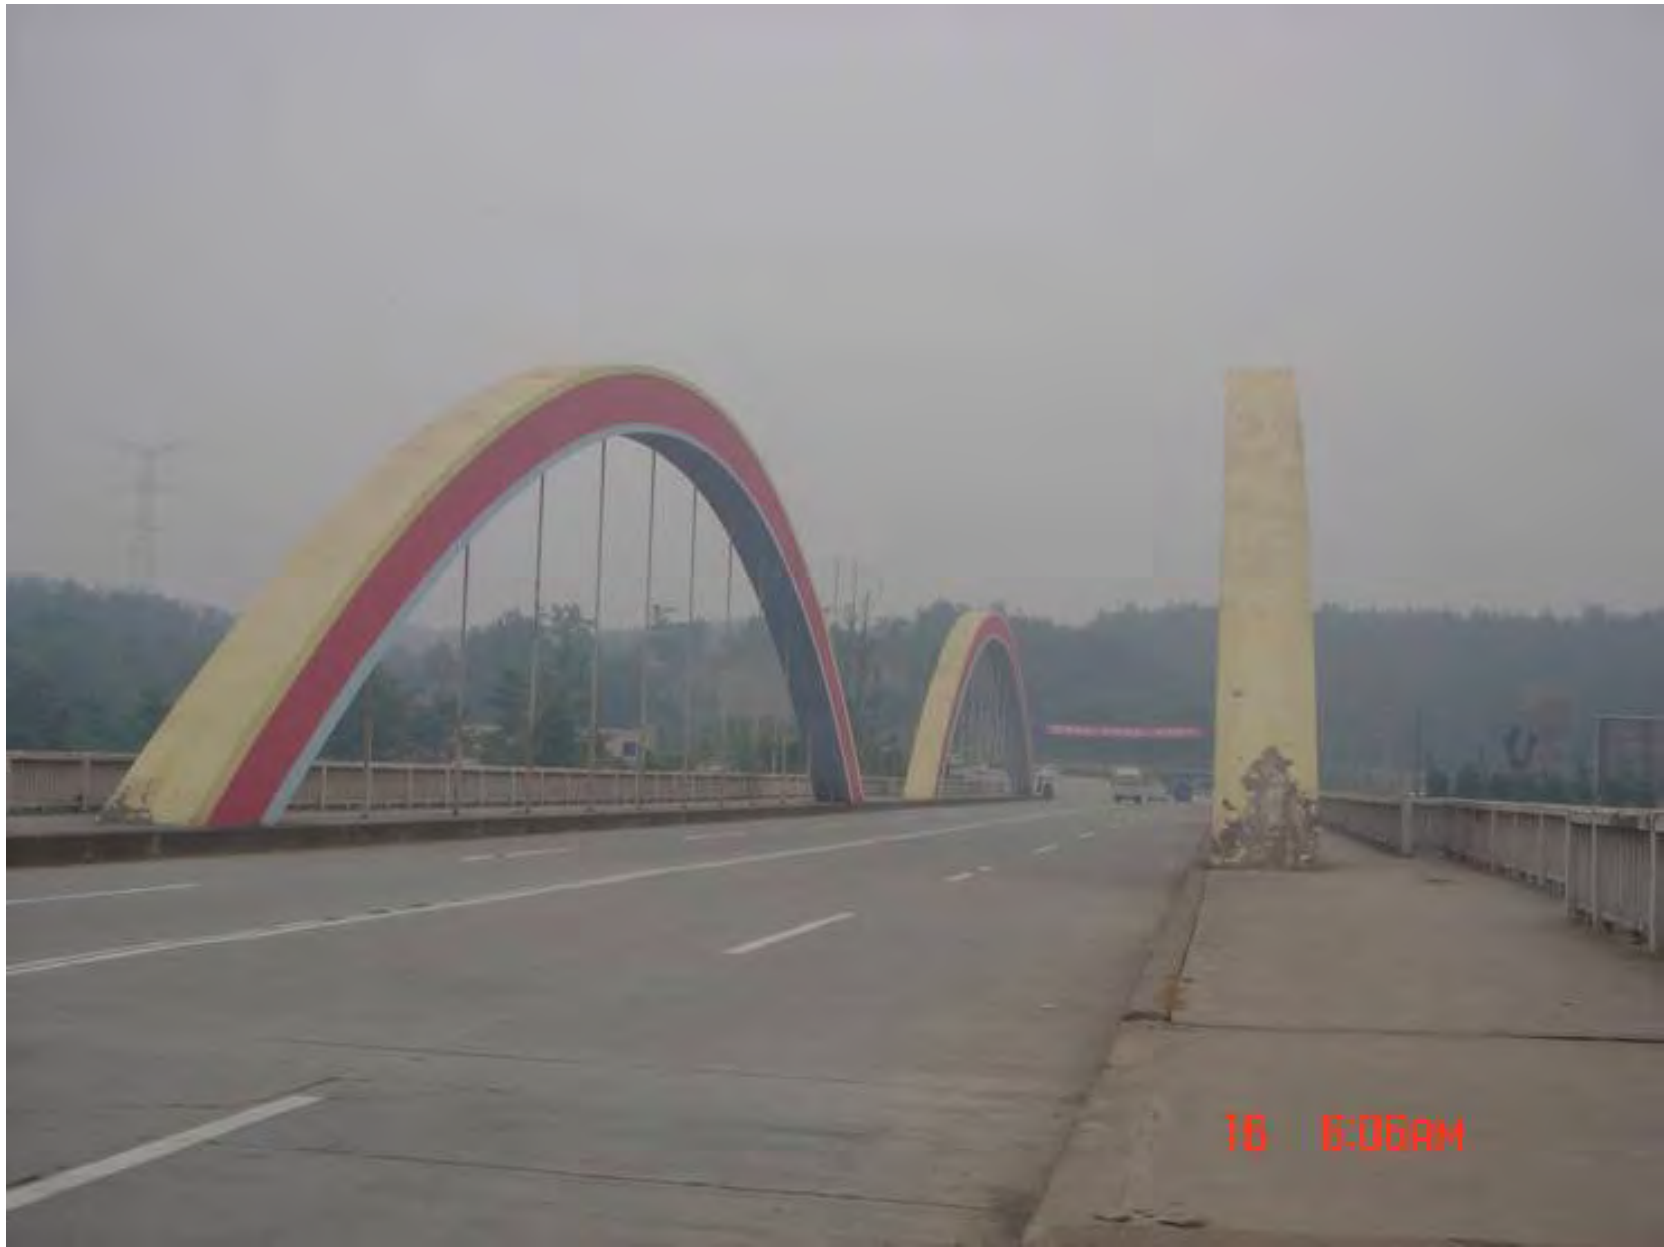
Deck is still in good condition

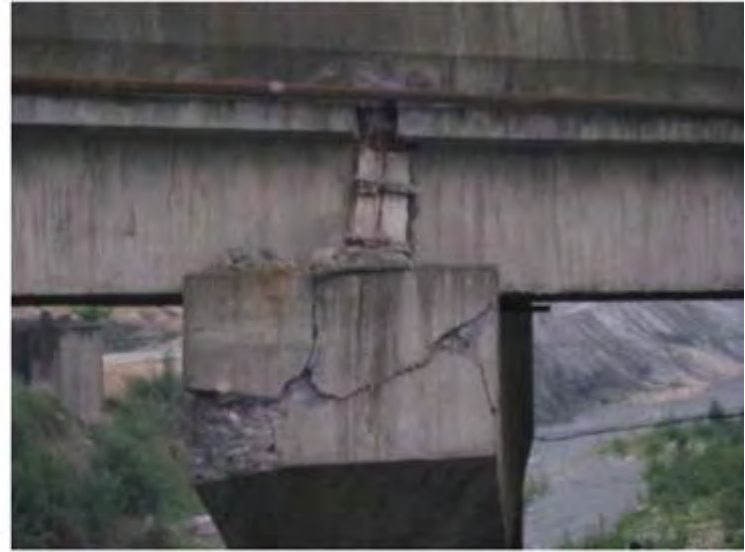
Broken pier cap

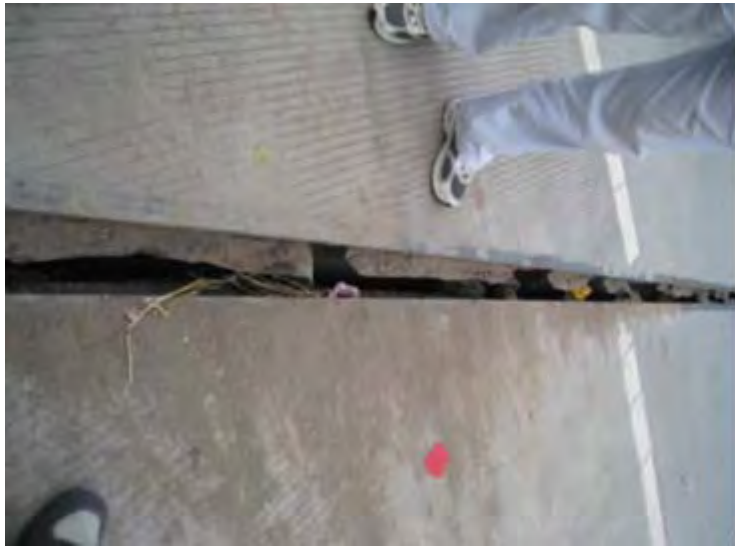
Movement of the expansion joint

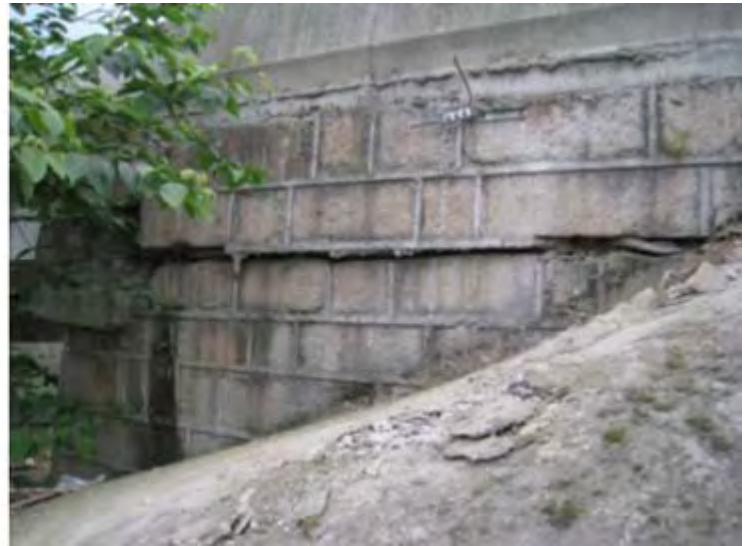
Horizontal crack and movement of the abutment wall

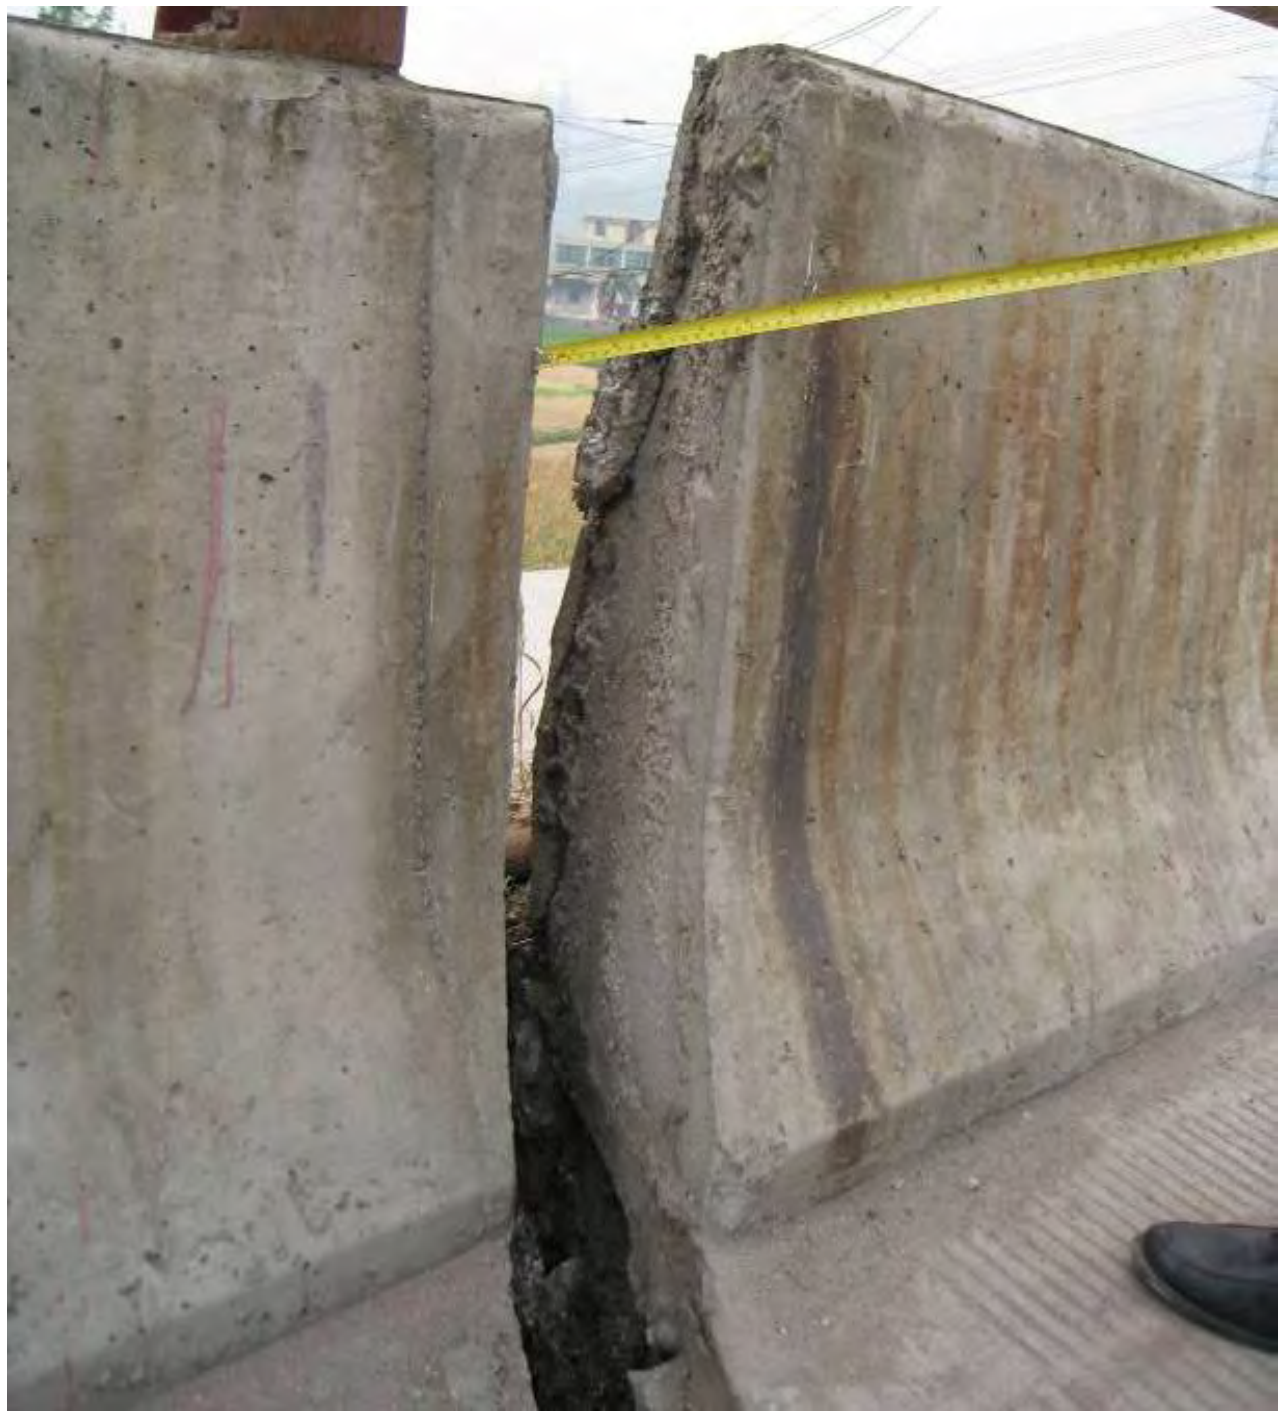
Barrier wall moved

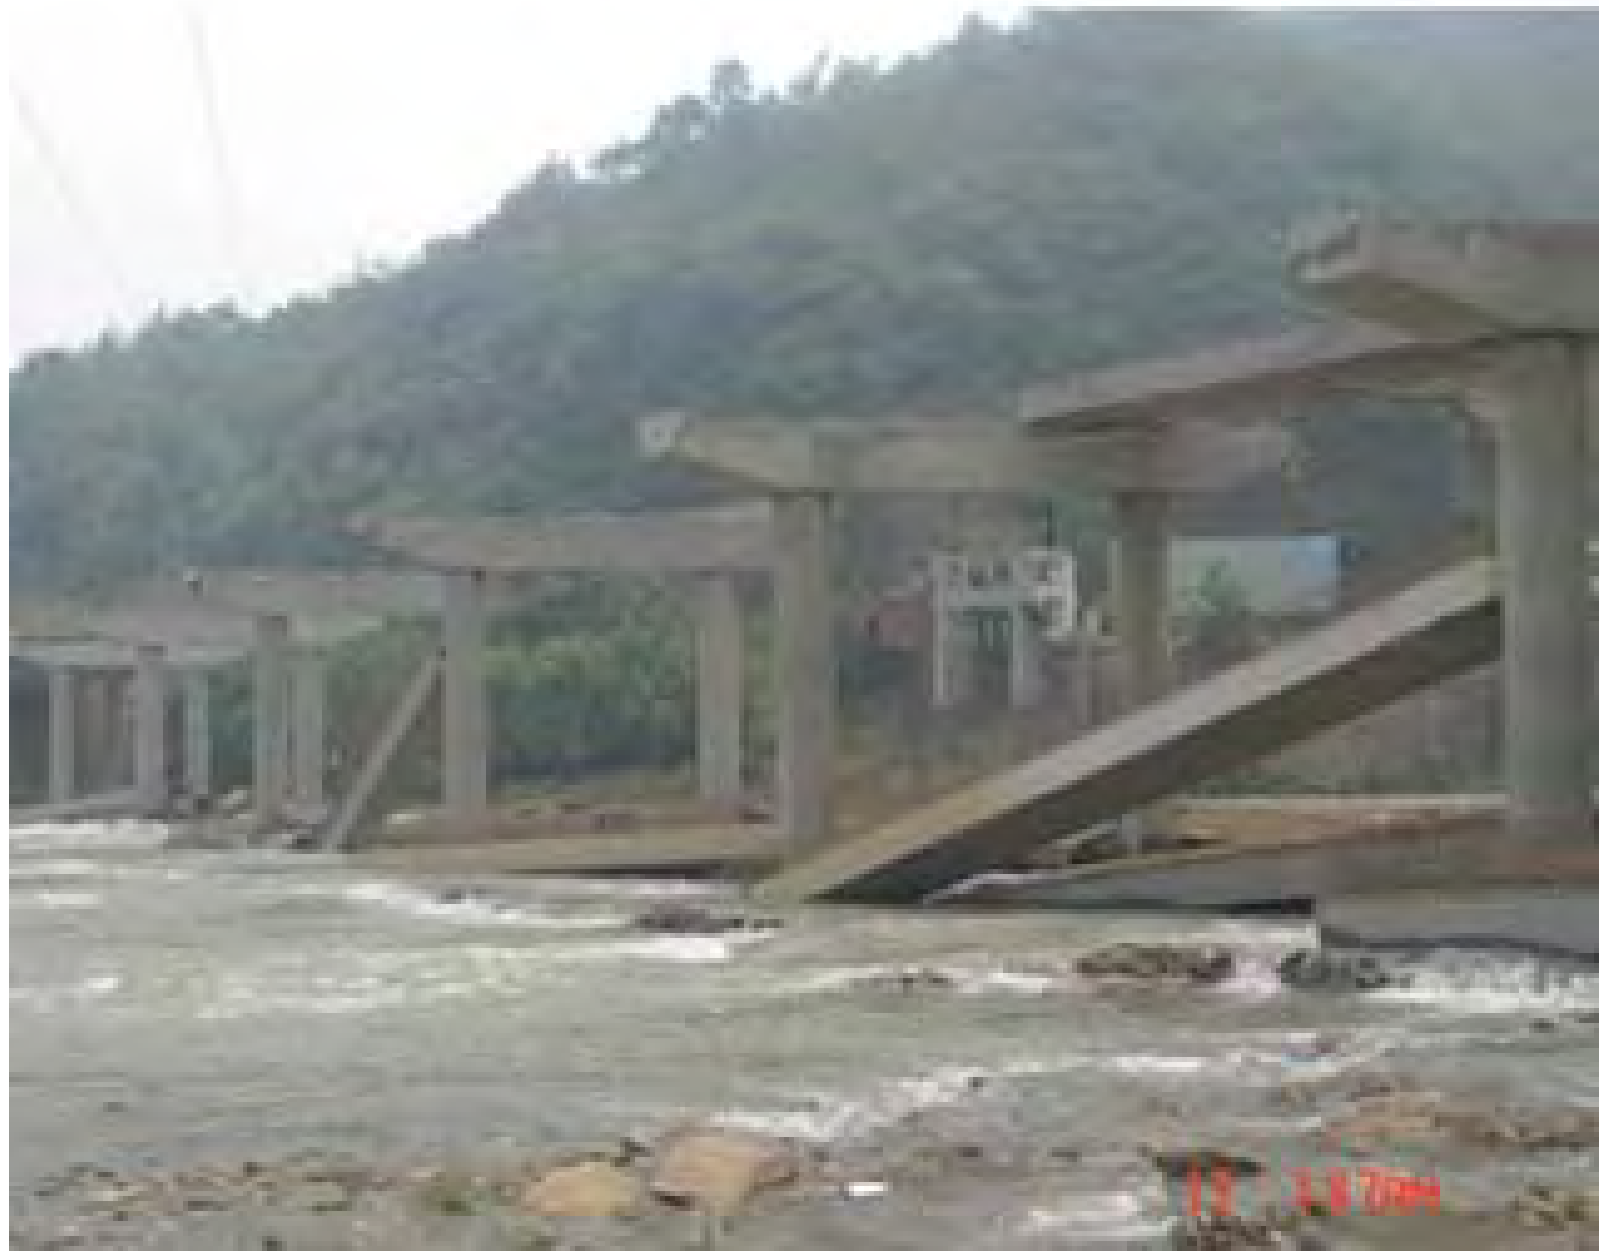
Collapsed girders

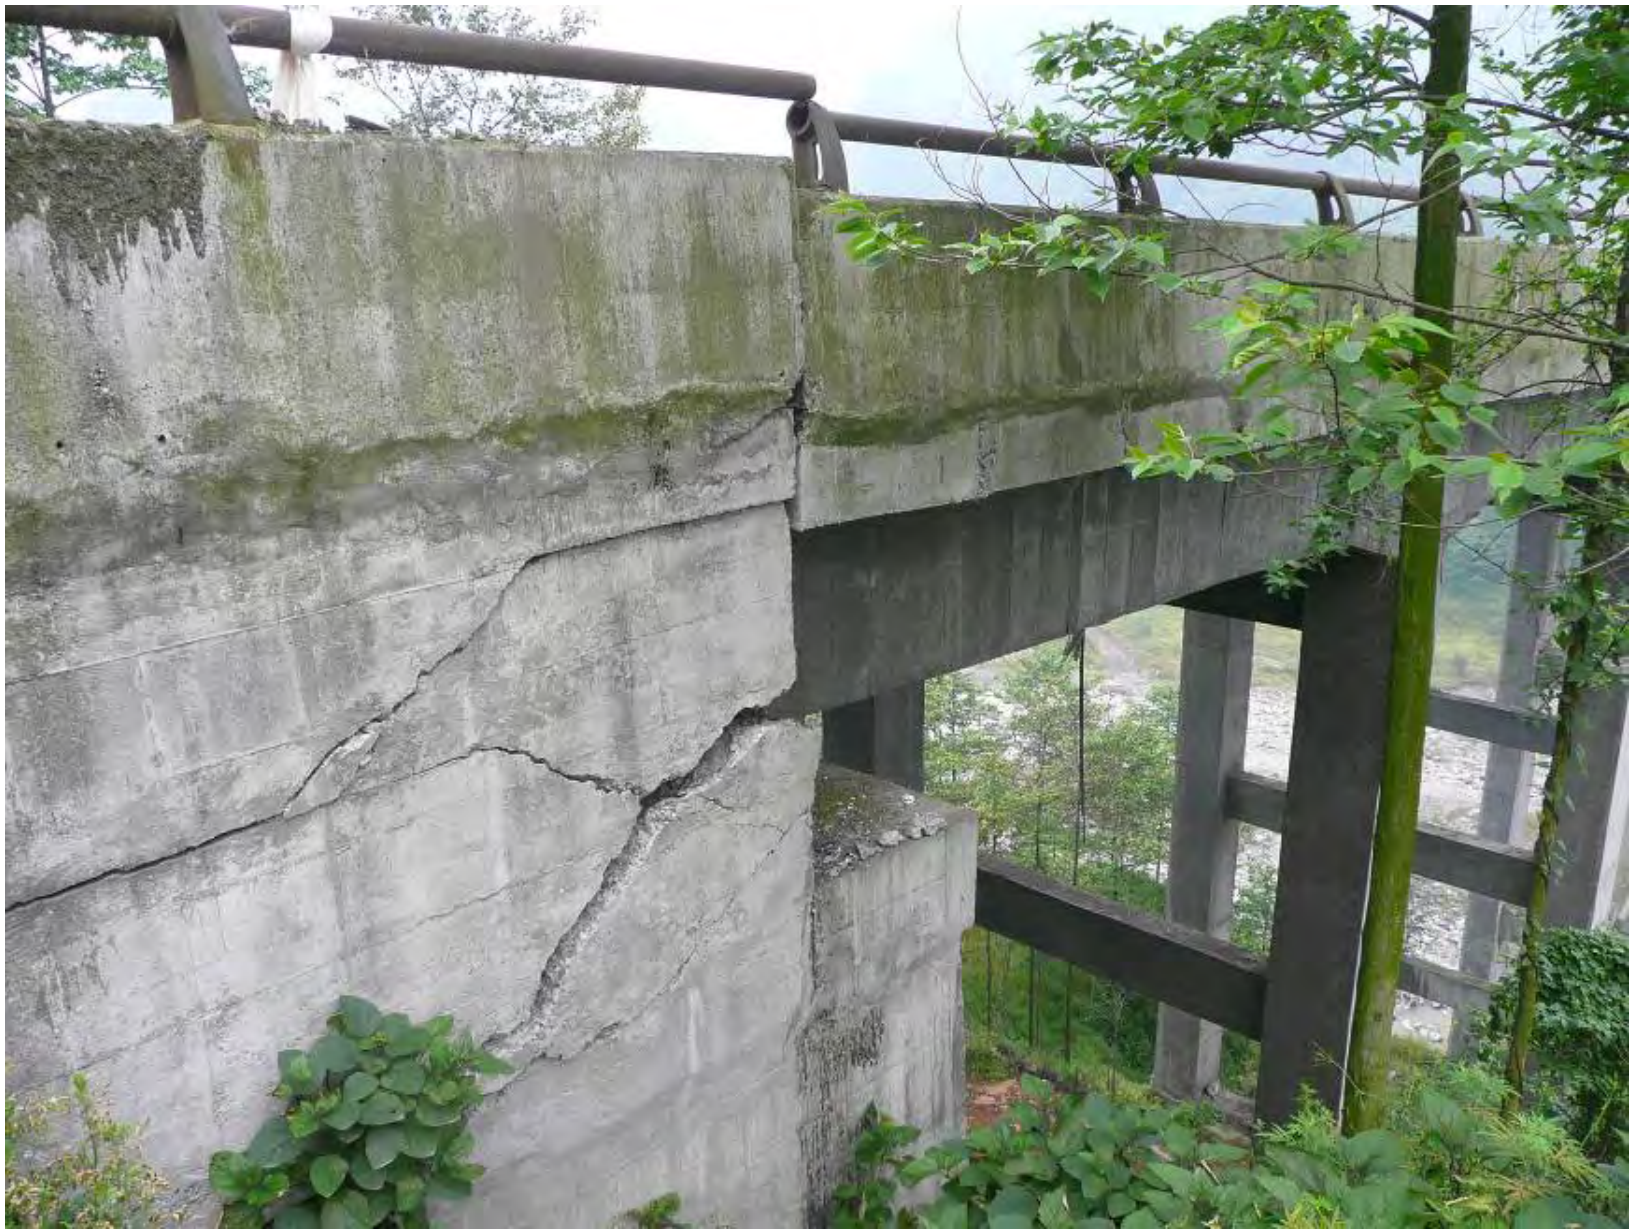
Crack in abutment

The bridge survived the earthquake reasonably well. Most of the damage appears to have been caused by large horizontal forces as is evidenced by the damage to the short interior arch columns.

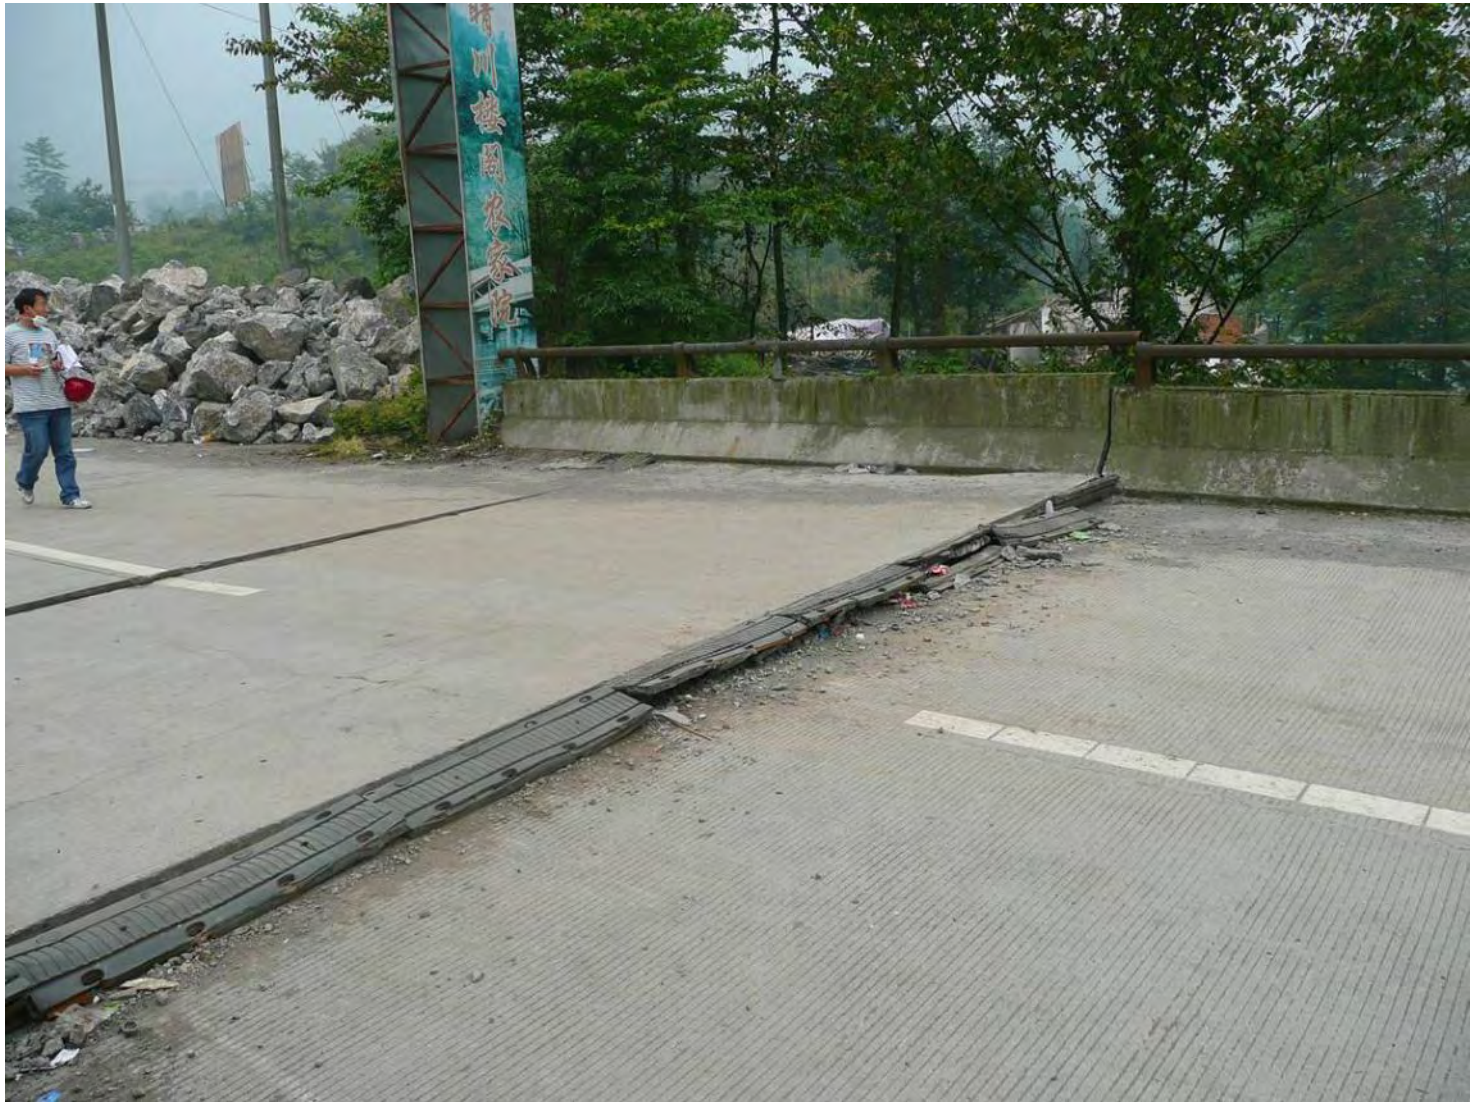
Displacement between the bridge deck and road surface at an expansion joint

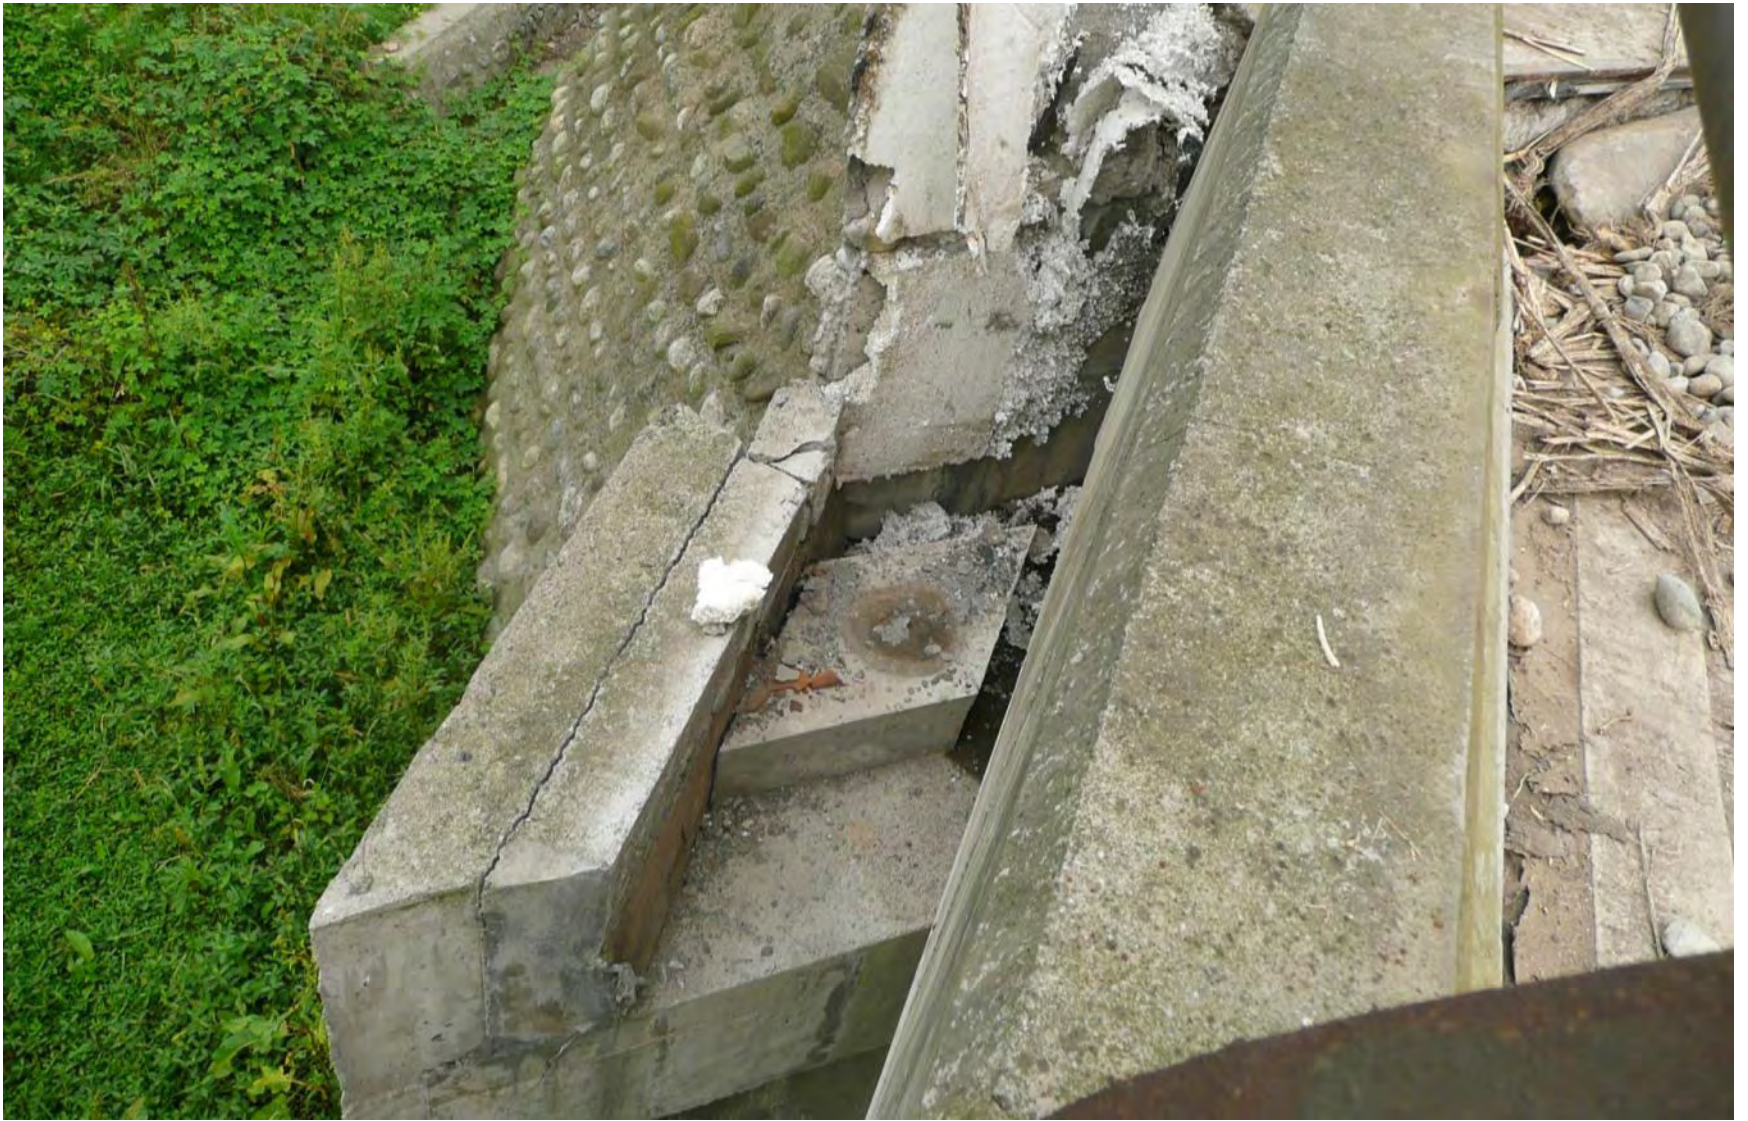
Bearing of one girder

Problem with rubber bearing was observed on some of the bridges. It appears that rubber bearings do not offer enough restraint to prevent girders from falling off the bearings during the sudden movements caused by the earthquake.

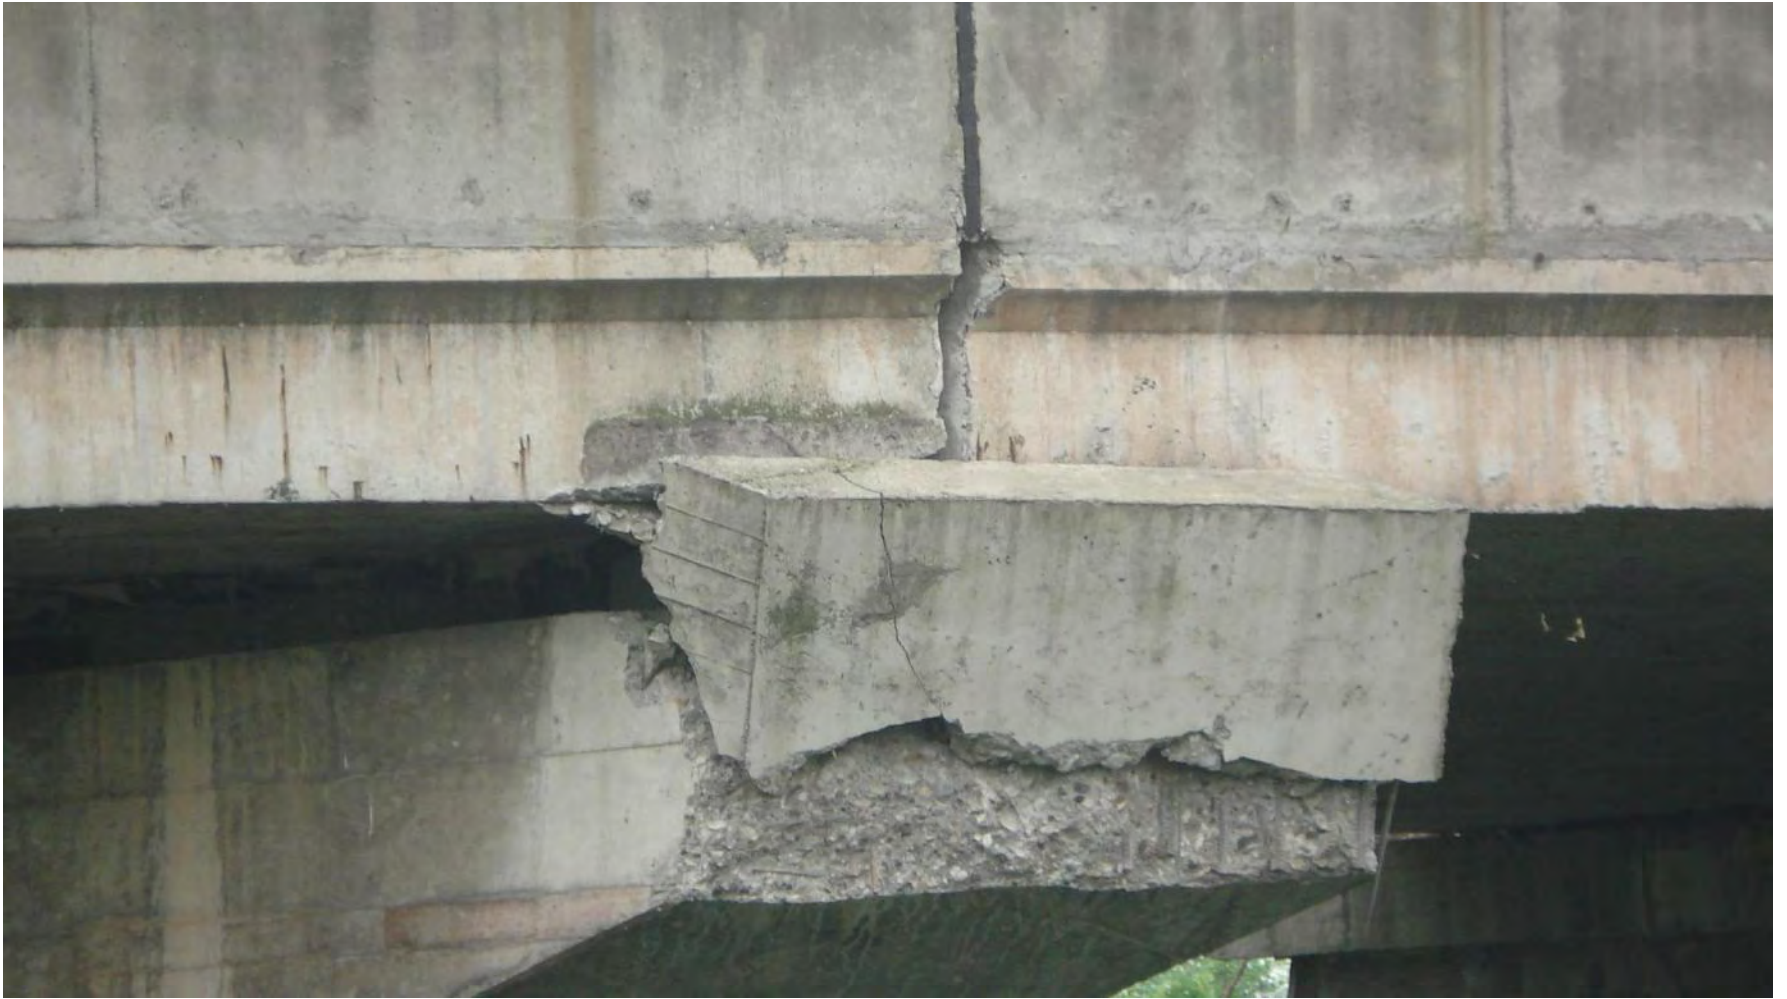
Girder movement on the top of the pier cap

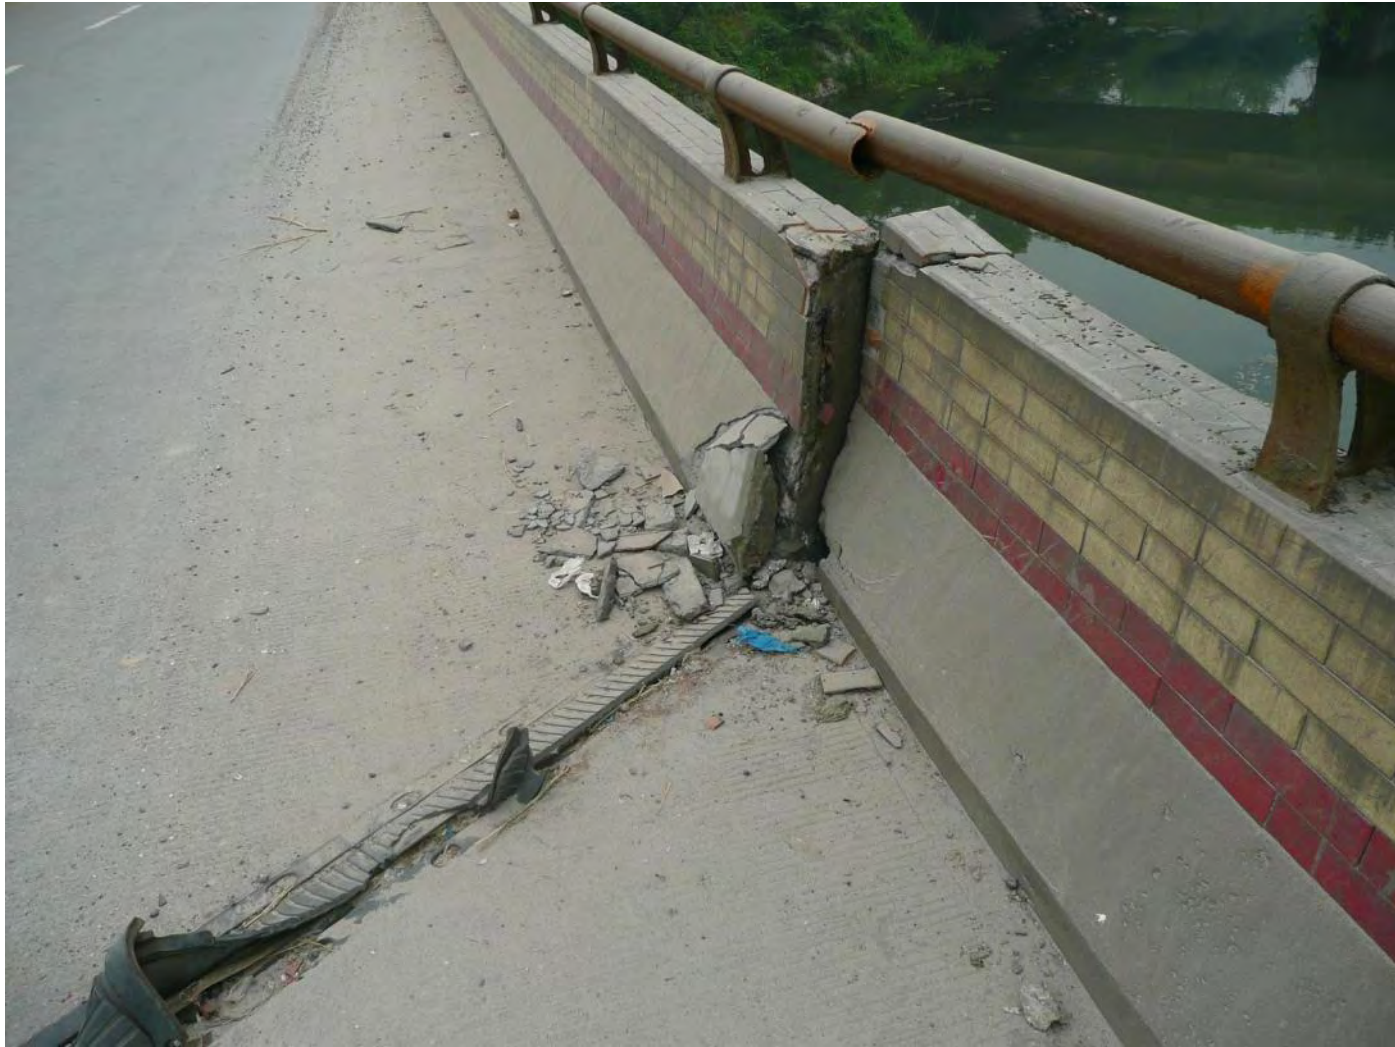
Another example of damage as a result of sudden movements experienced during earthquakes

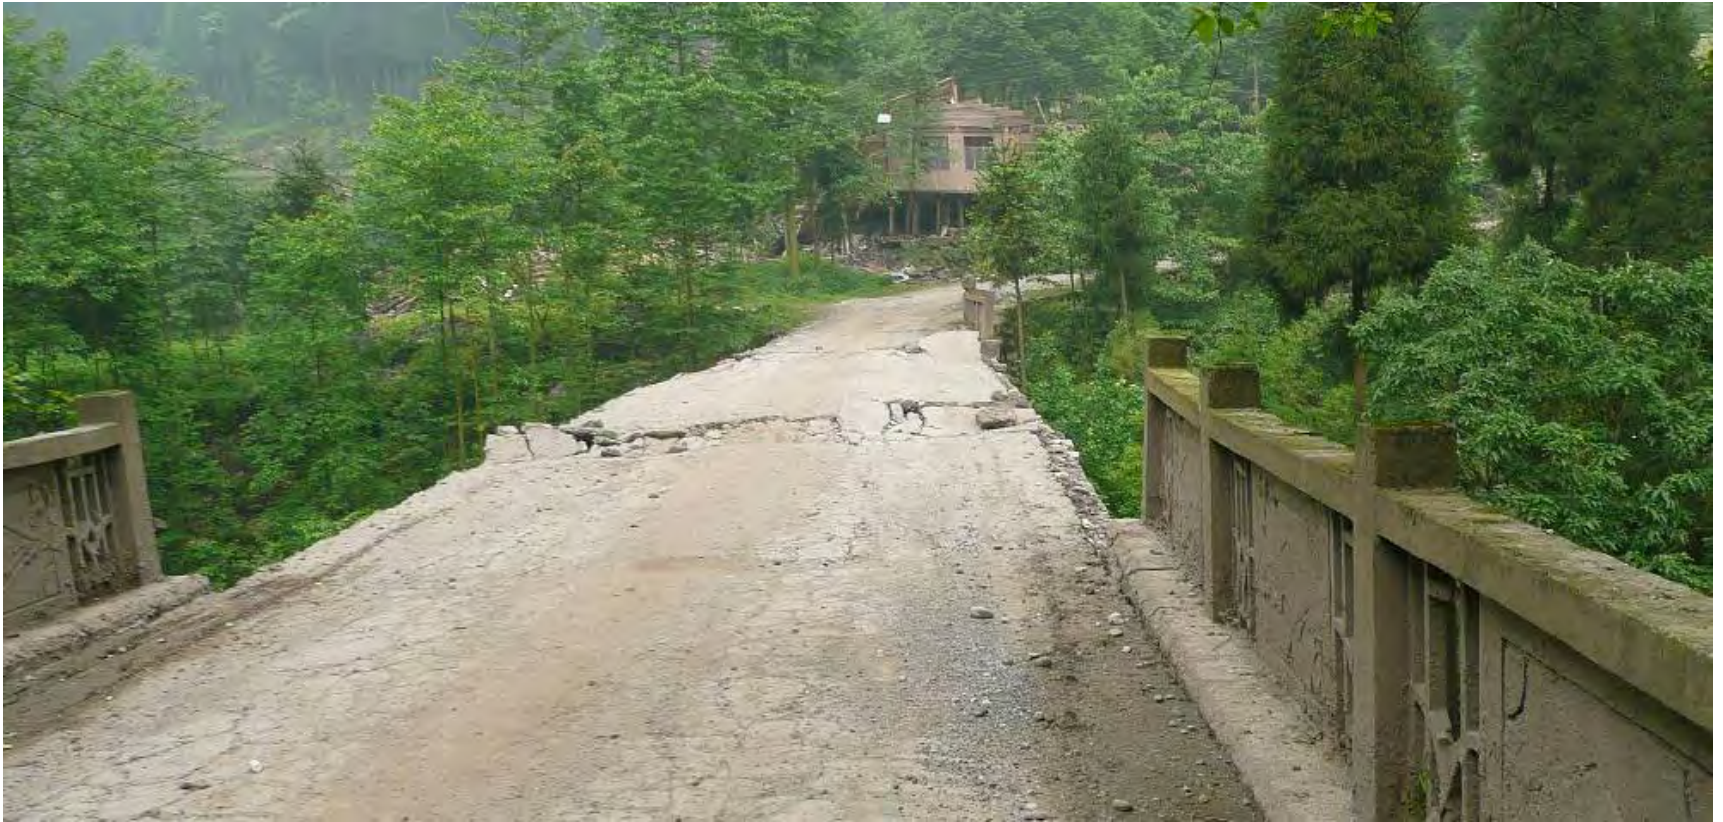
Showing damage to the deck and railing on one side of the solid center of the bridge

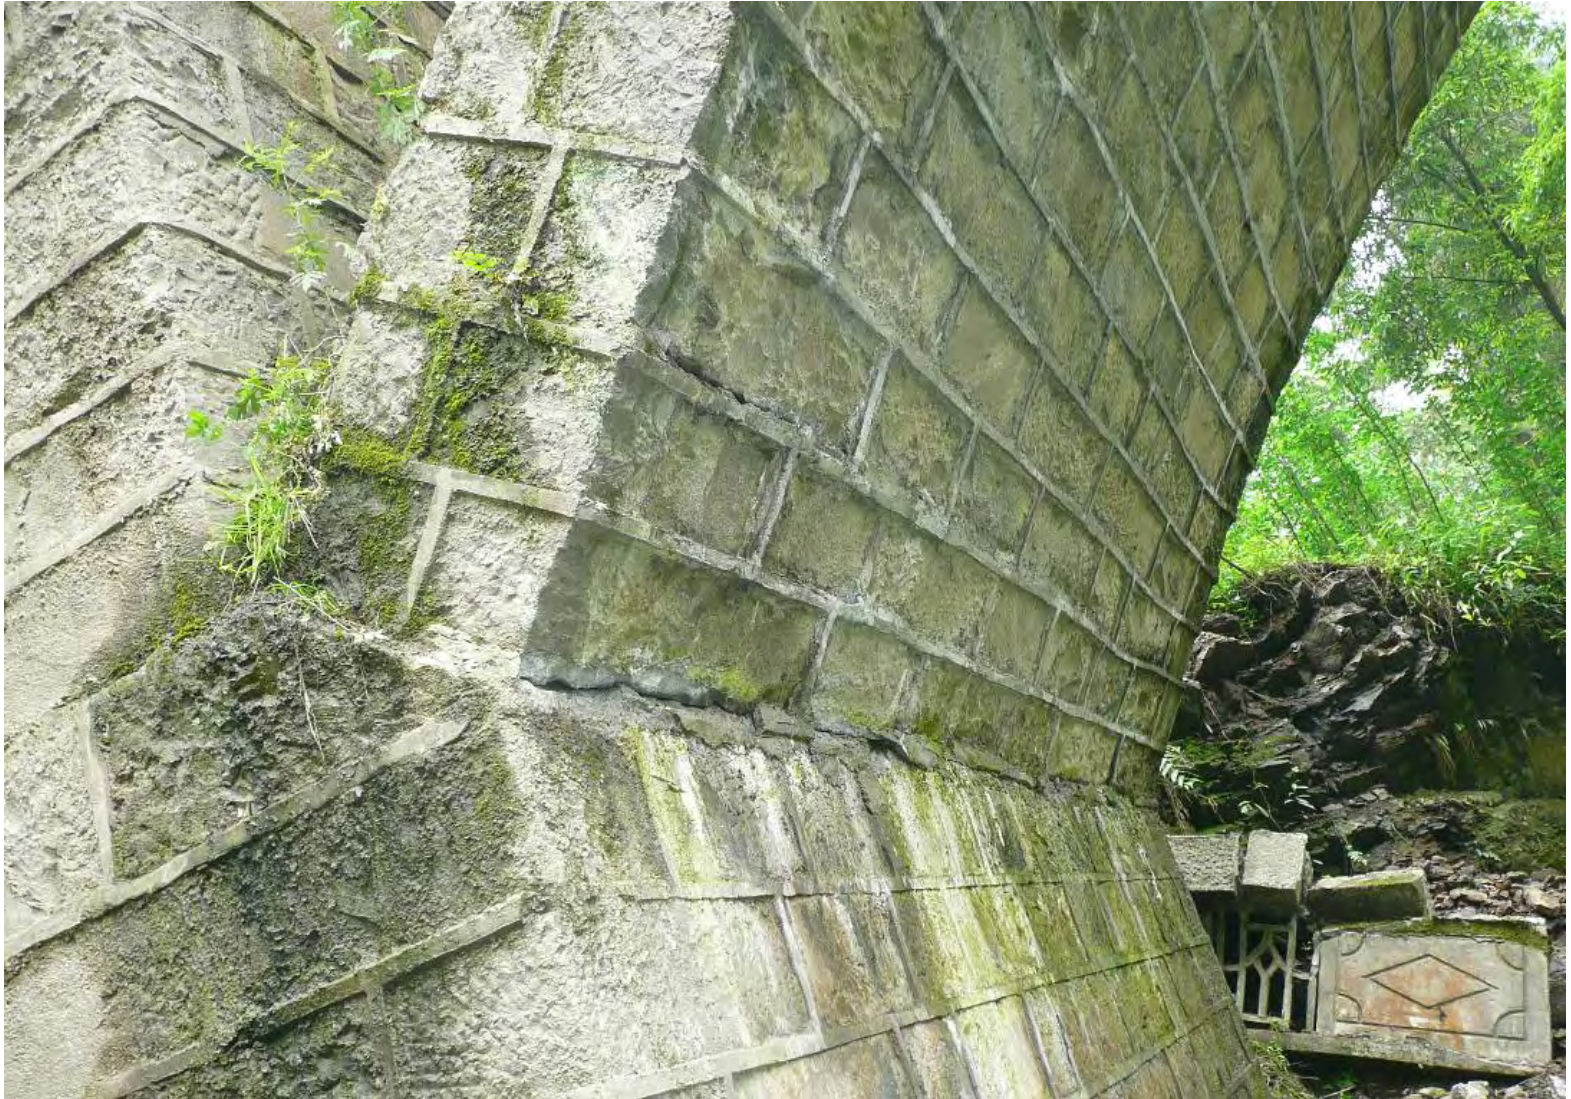
Showing cracks at the bottom of the arch

Cracks at the bottom of the arch were caused by repeated back and forth horizontal movement during the earthquake.

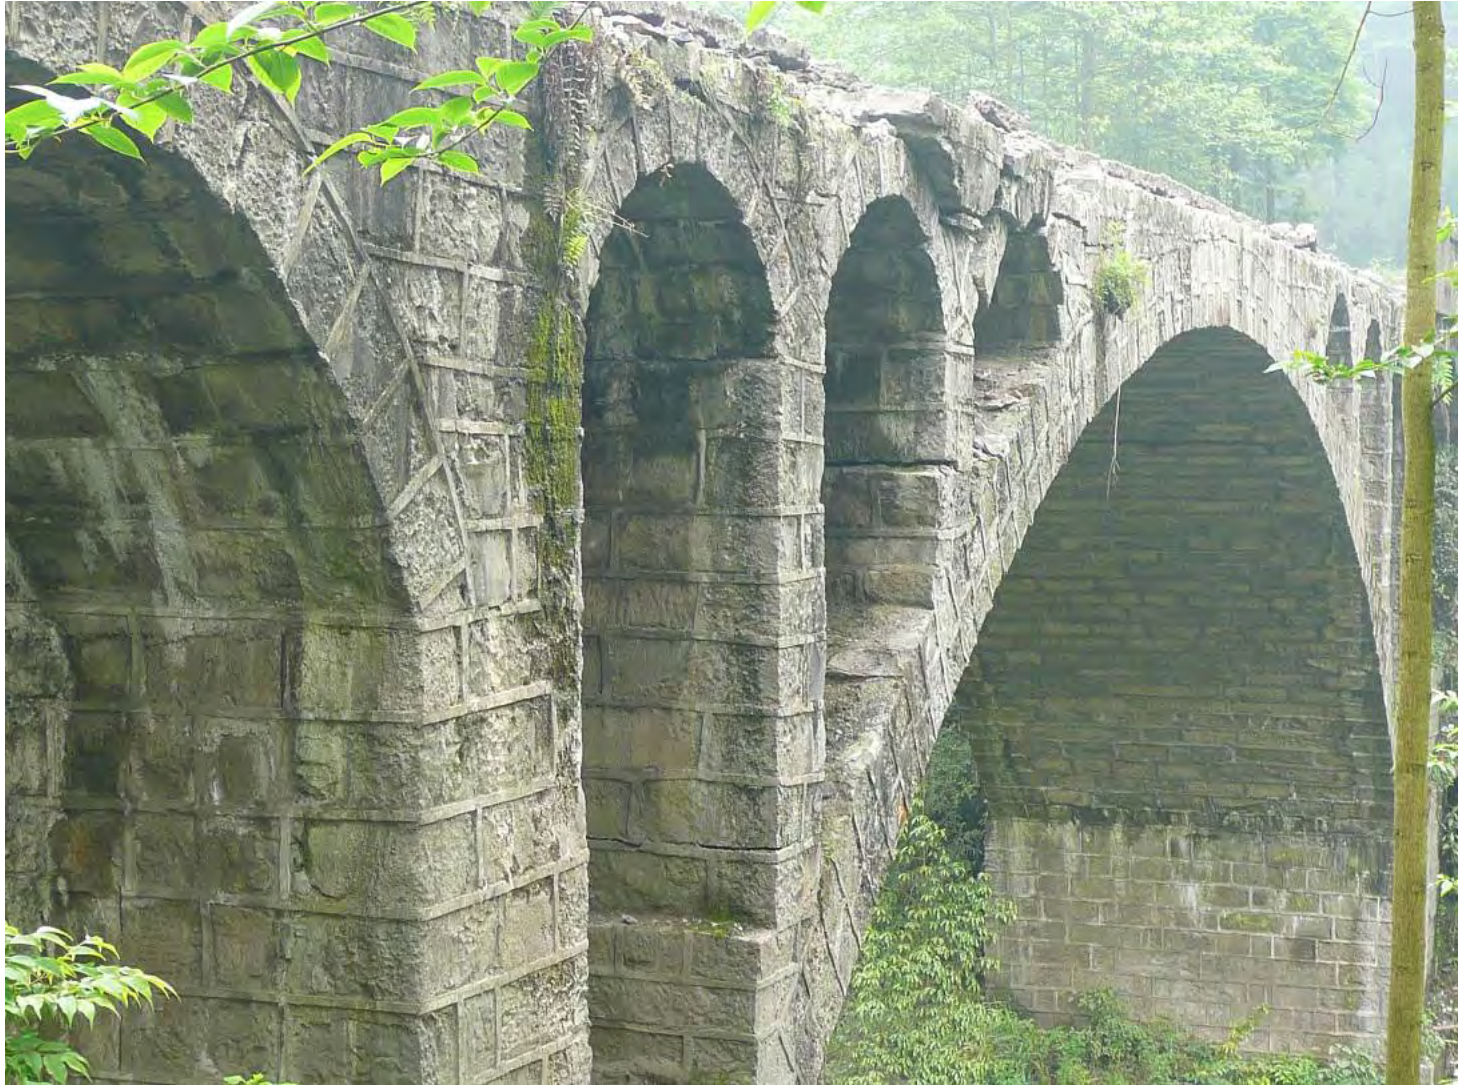
Cracks at the top of the most interior arch

Cracks at the top of the most interior arch were caused by the same movement, but were exaggerated by the resistance of the solid center main arch section.
