Investigation of the Effect of the May 2008 Earthquake on Bridges in China

Original presentation in China by Dr. Banfu Yan of
Hunan University, Changsha, China

Investigation of Earthquake-damaged Bridges in Guangyuan, Mianyang, and Deyang, Sichuan Province

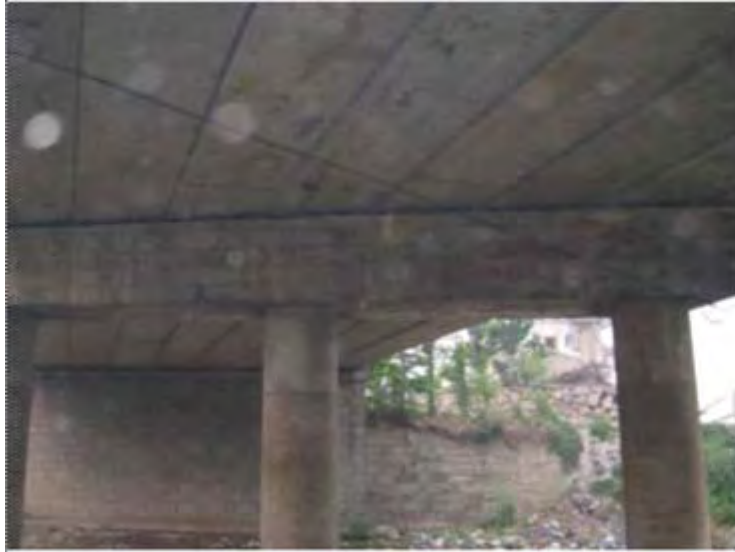
Xiangyangchun Bridge is a short two-span bridge located on a curve, showing damage to various components. No assessment has yet been made regarding required repairs.

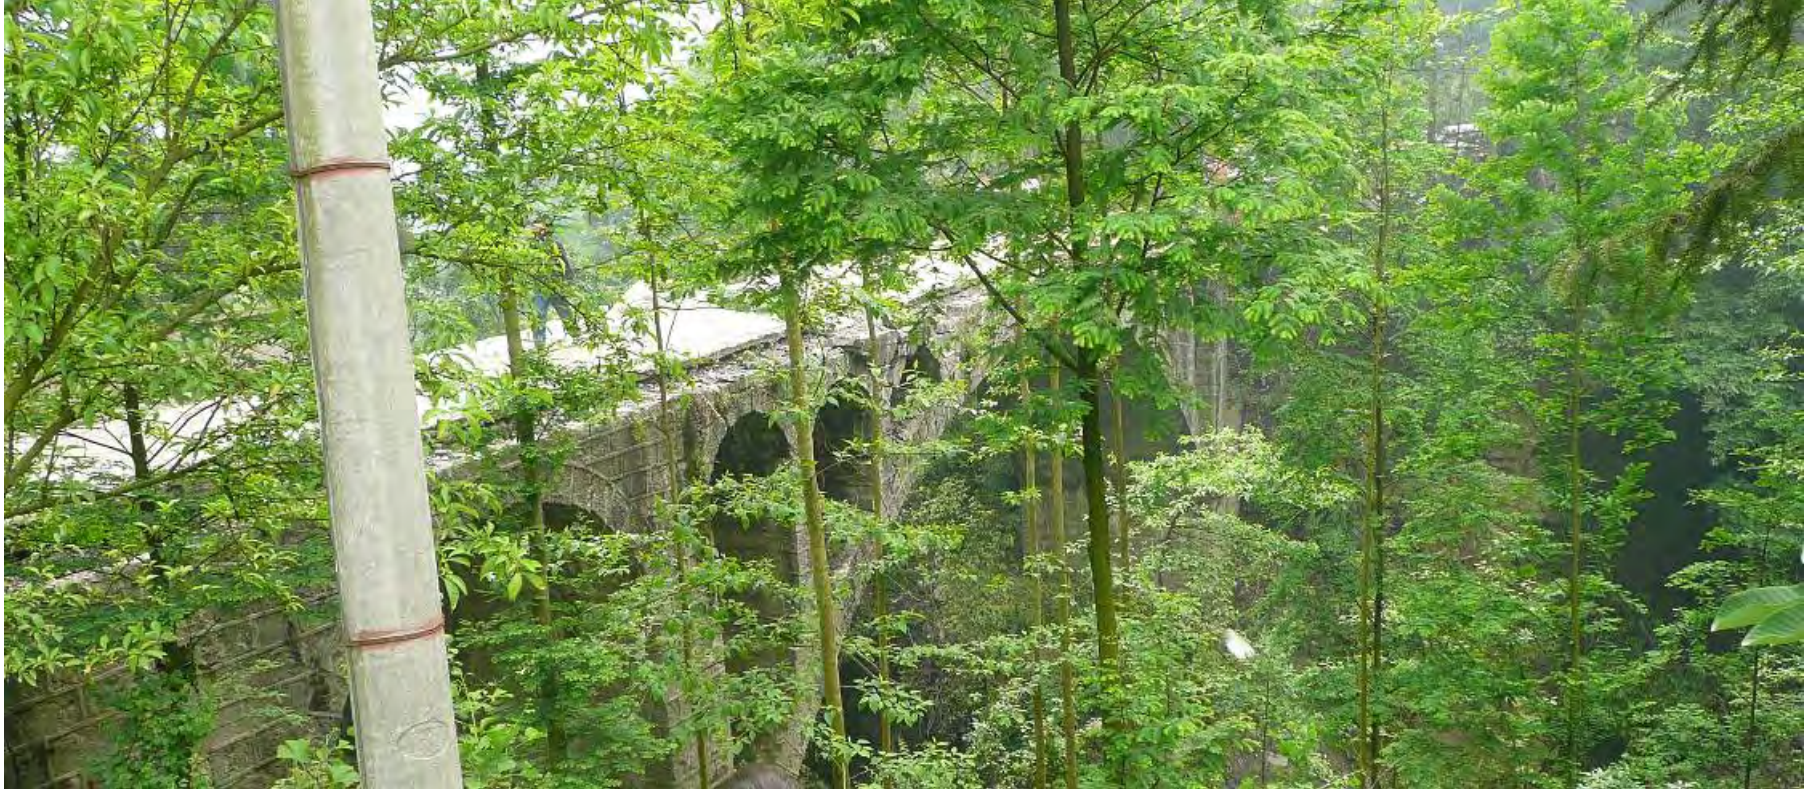
Guantong Bridge

Masonry arch bridge
