# Evaluating the Impact of Erosion on Our Natural Riverbanks

James Blatz, Ph.D., P.Eng.  
Department of Civil Engineering  
University of Manitoba

# What's the Problem?

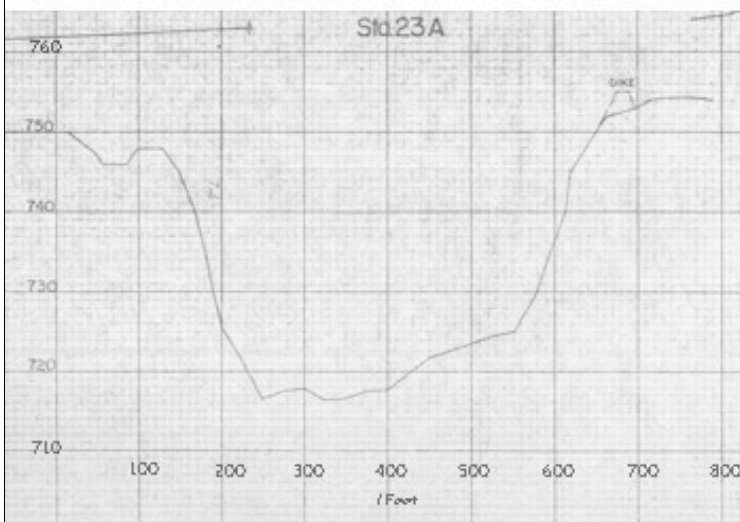
# Kingston Row Section

Original 1951 RRBI cross-section (left) is re-created in Microsoft Excel (right) by picking off the data points at all transitions on the original cross-section. View of the cross-section is looking downstream.

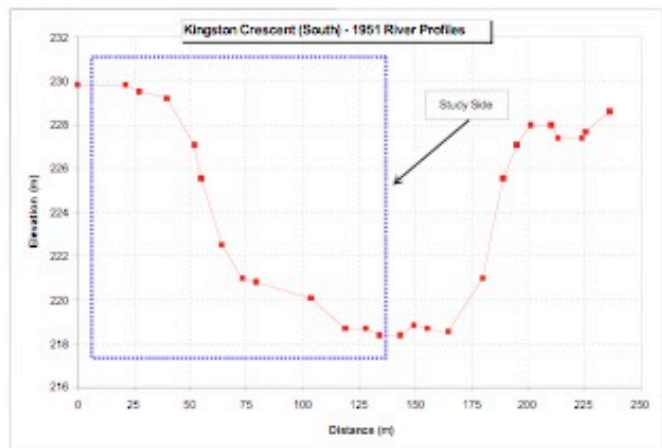
Cross-section is mirrored to have the same orientation (upstream view) as the 1912 and 2000 cross-sections

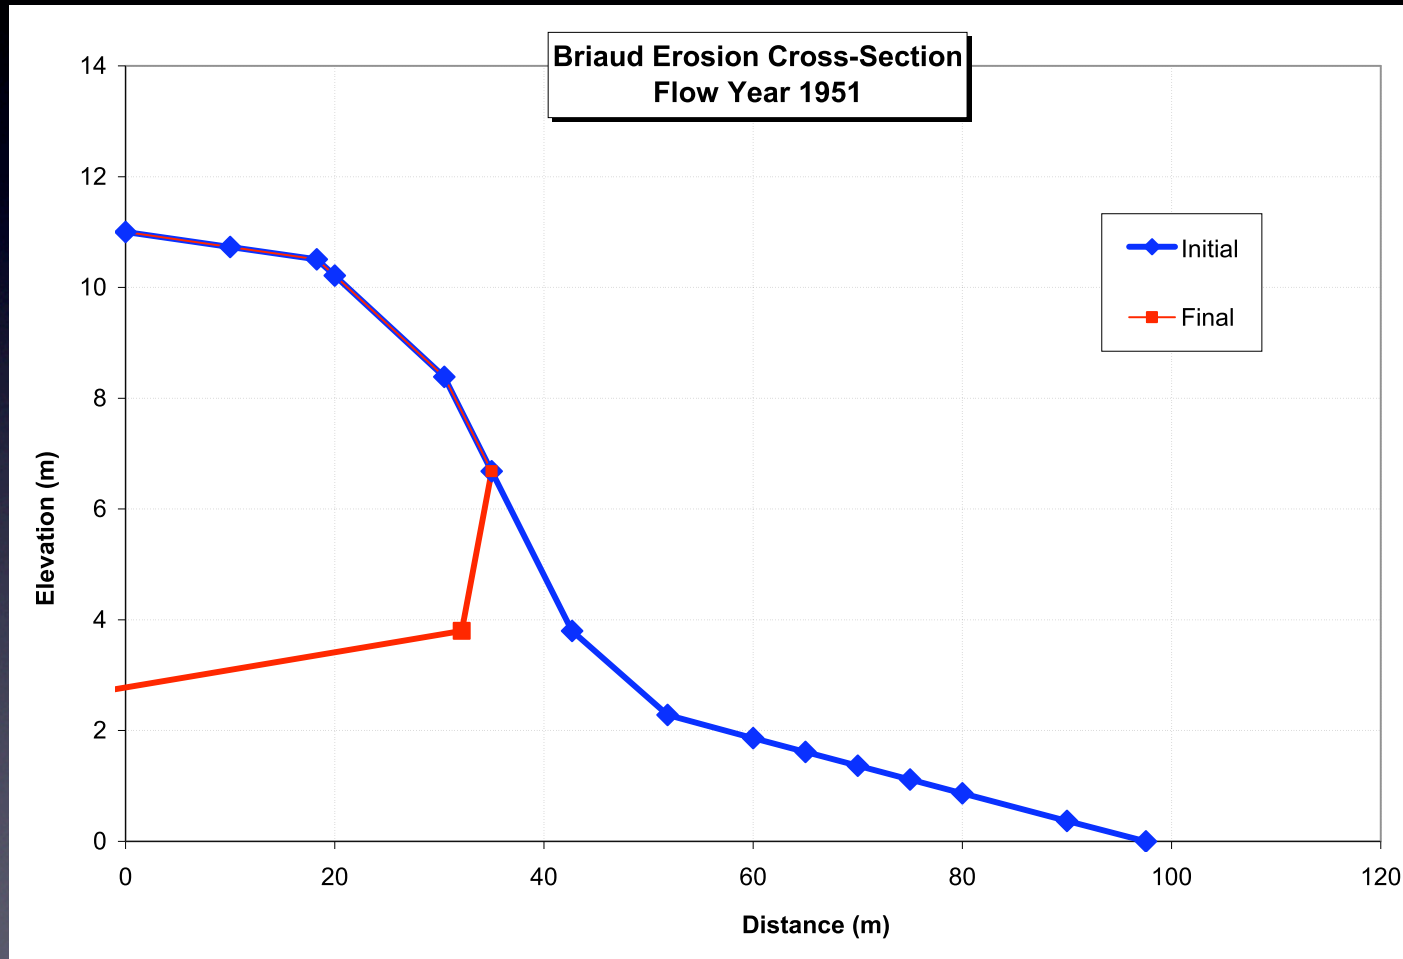
# Comparison of Results

- Compare field measurements based on historical surveys and aerial photographs with theoretical / laboratory based analysis.
- Of course theory matches practice and we now have a flawless method for assessing erosion rates!
- Not quite...

- There is no way riverbanks would erode at the rate shown or to the geometry shown.
- Calculated erosion rates are extremely sensitive to the critical shear stress measured in the EFA analysis.
- The precision of the measures and the eroding fluid are two major issues with the EFA measurements.
- Not all is lost. We can calibrate erodibility curves to field measurements.

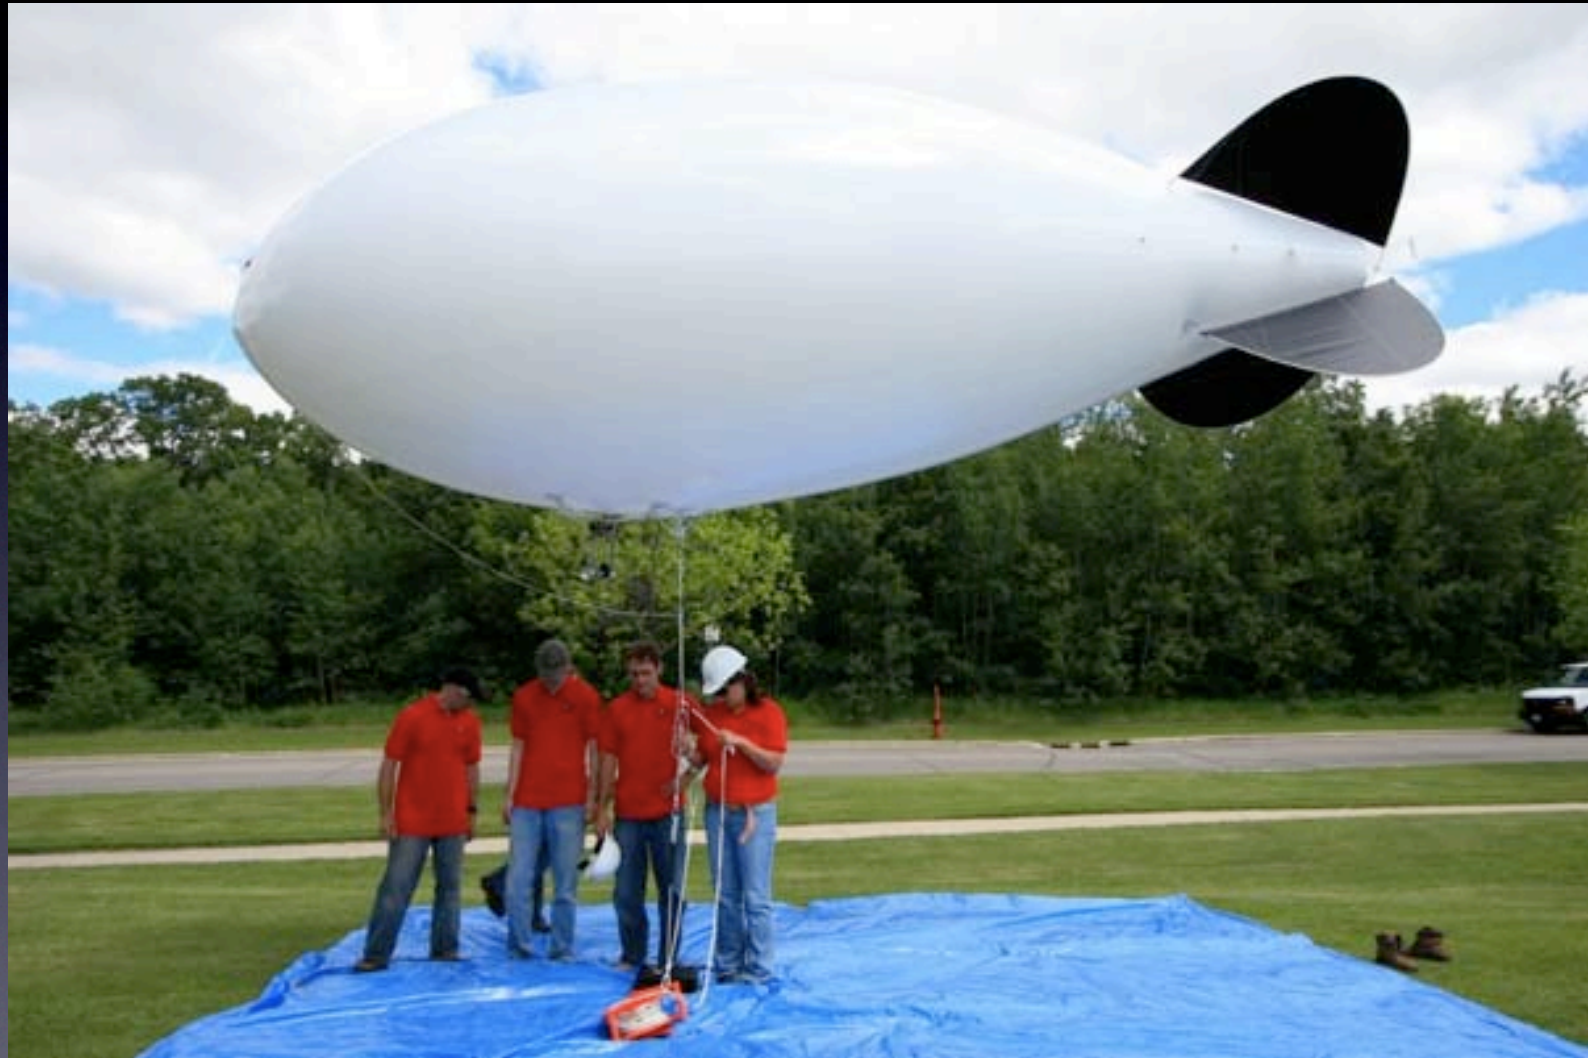
# The GeoBlimp

- Blimp can be deployed in a matter of 1 hour and can get high resolution photos back within 2 hours.
- Photos are georeferenced to a measured datum.
- Provide the ability to photograph banks during optimal times with respect to river level and immediately following failures.
