Investigation of the Effect of the May 2008 Earthquake on Bridges in China

Original presentation in China by Dr. Banfu Yan of
Hunan University, Changsha, China

Investigation of Earthquake-damaged Bridges in Guangyuan, Mianyang, and Deyang, Sichuan Province

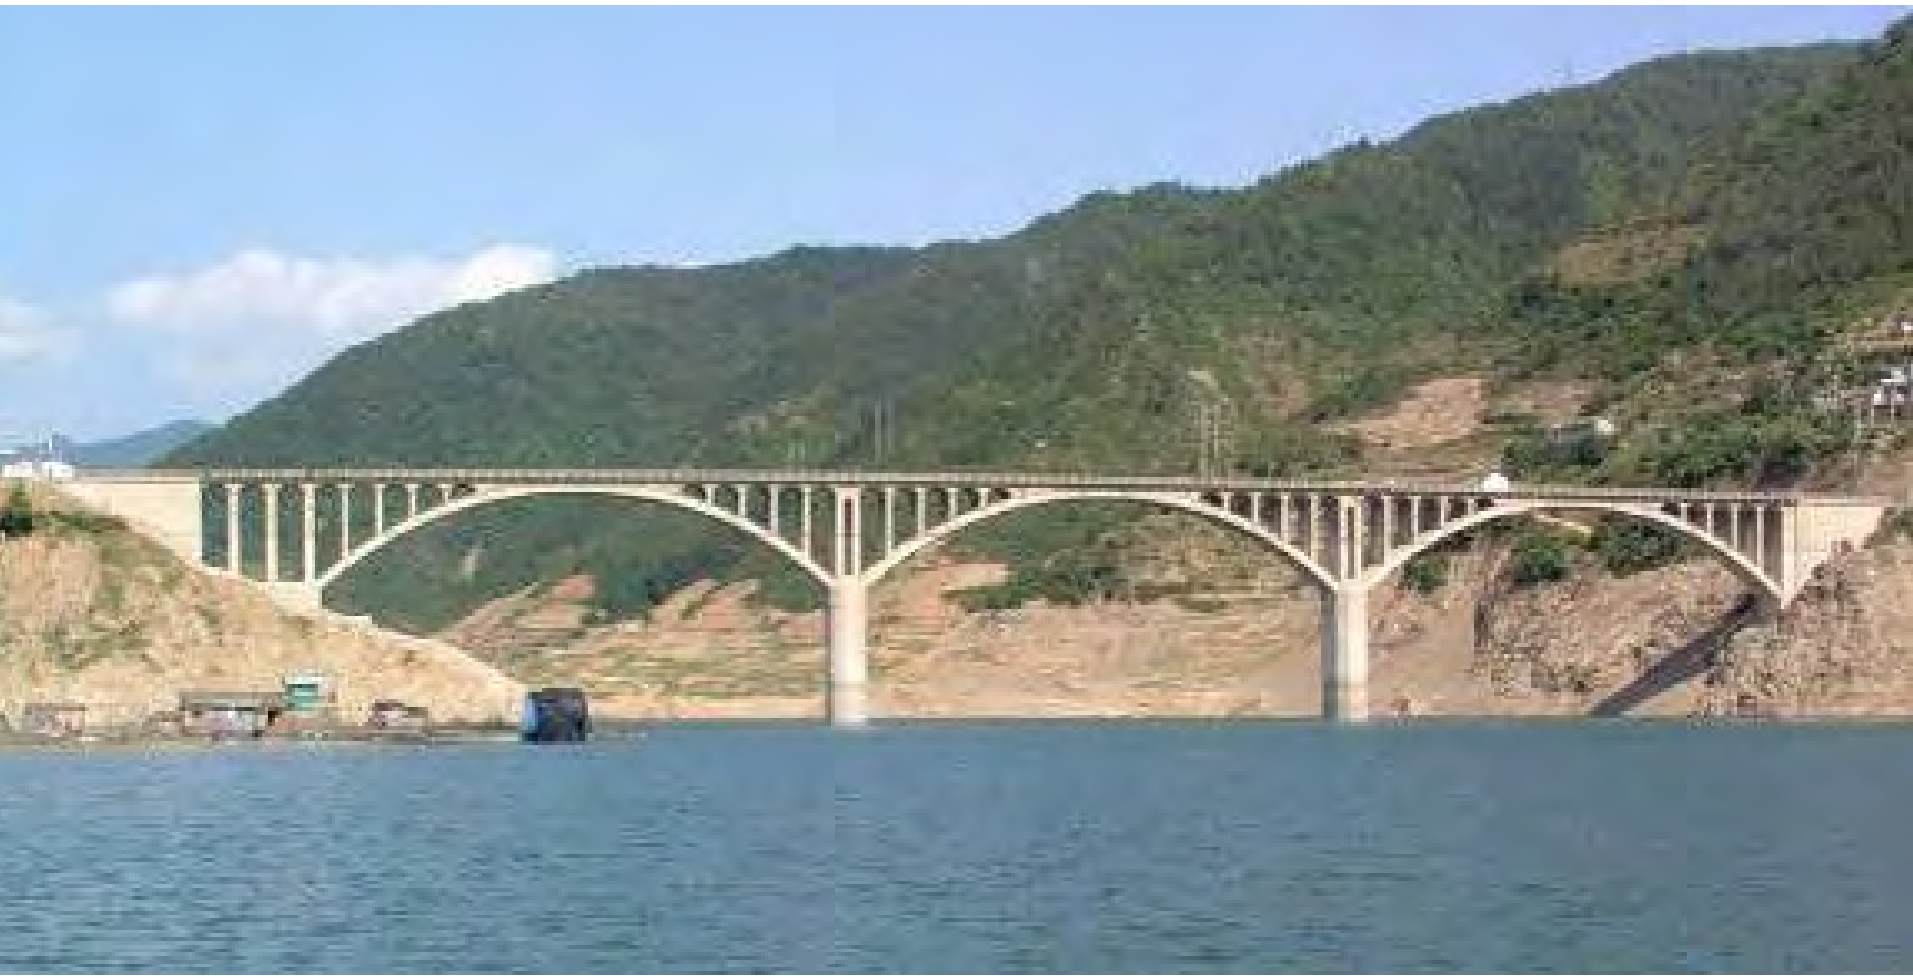
No visible damage middle arch

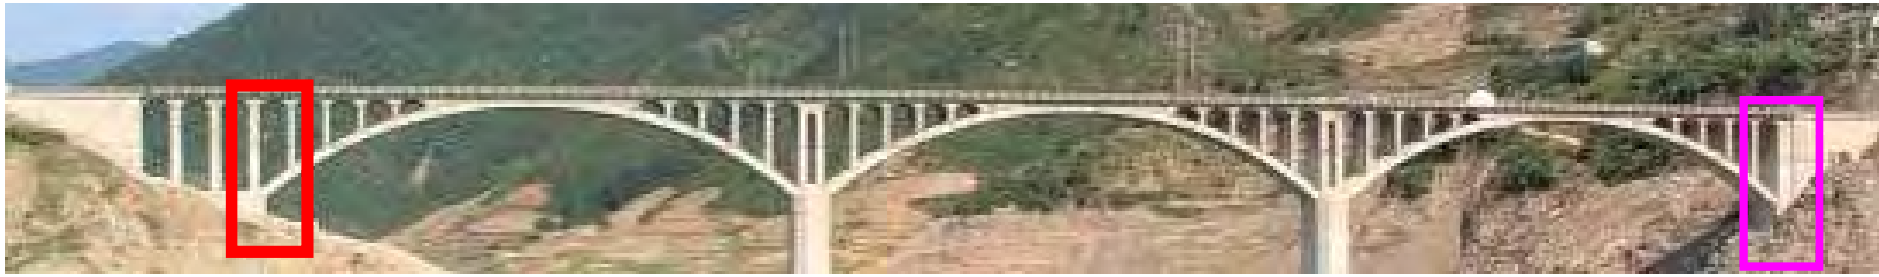
Crushing of concrete in spandrels

This reinforced concrete bridge appears to have had no significant damage to its main spans. However, due to large longitudinal movement during the earthquake, the short interior arches close to the abutments including expansion joints, suffered a lot of damage. Because of this, the bridge cannot be opened to traffic without major repairs.

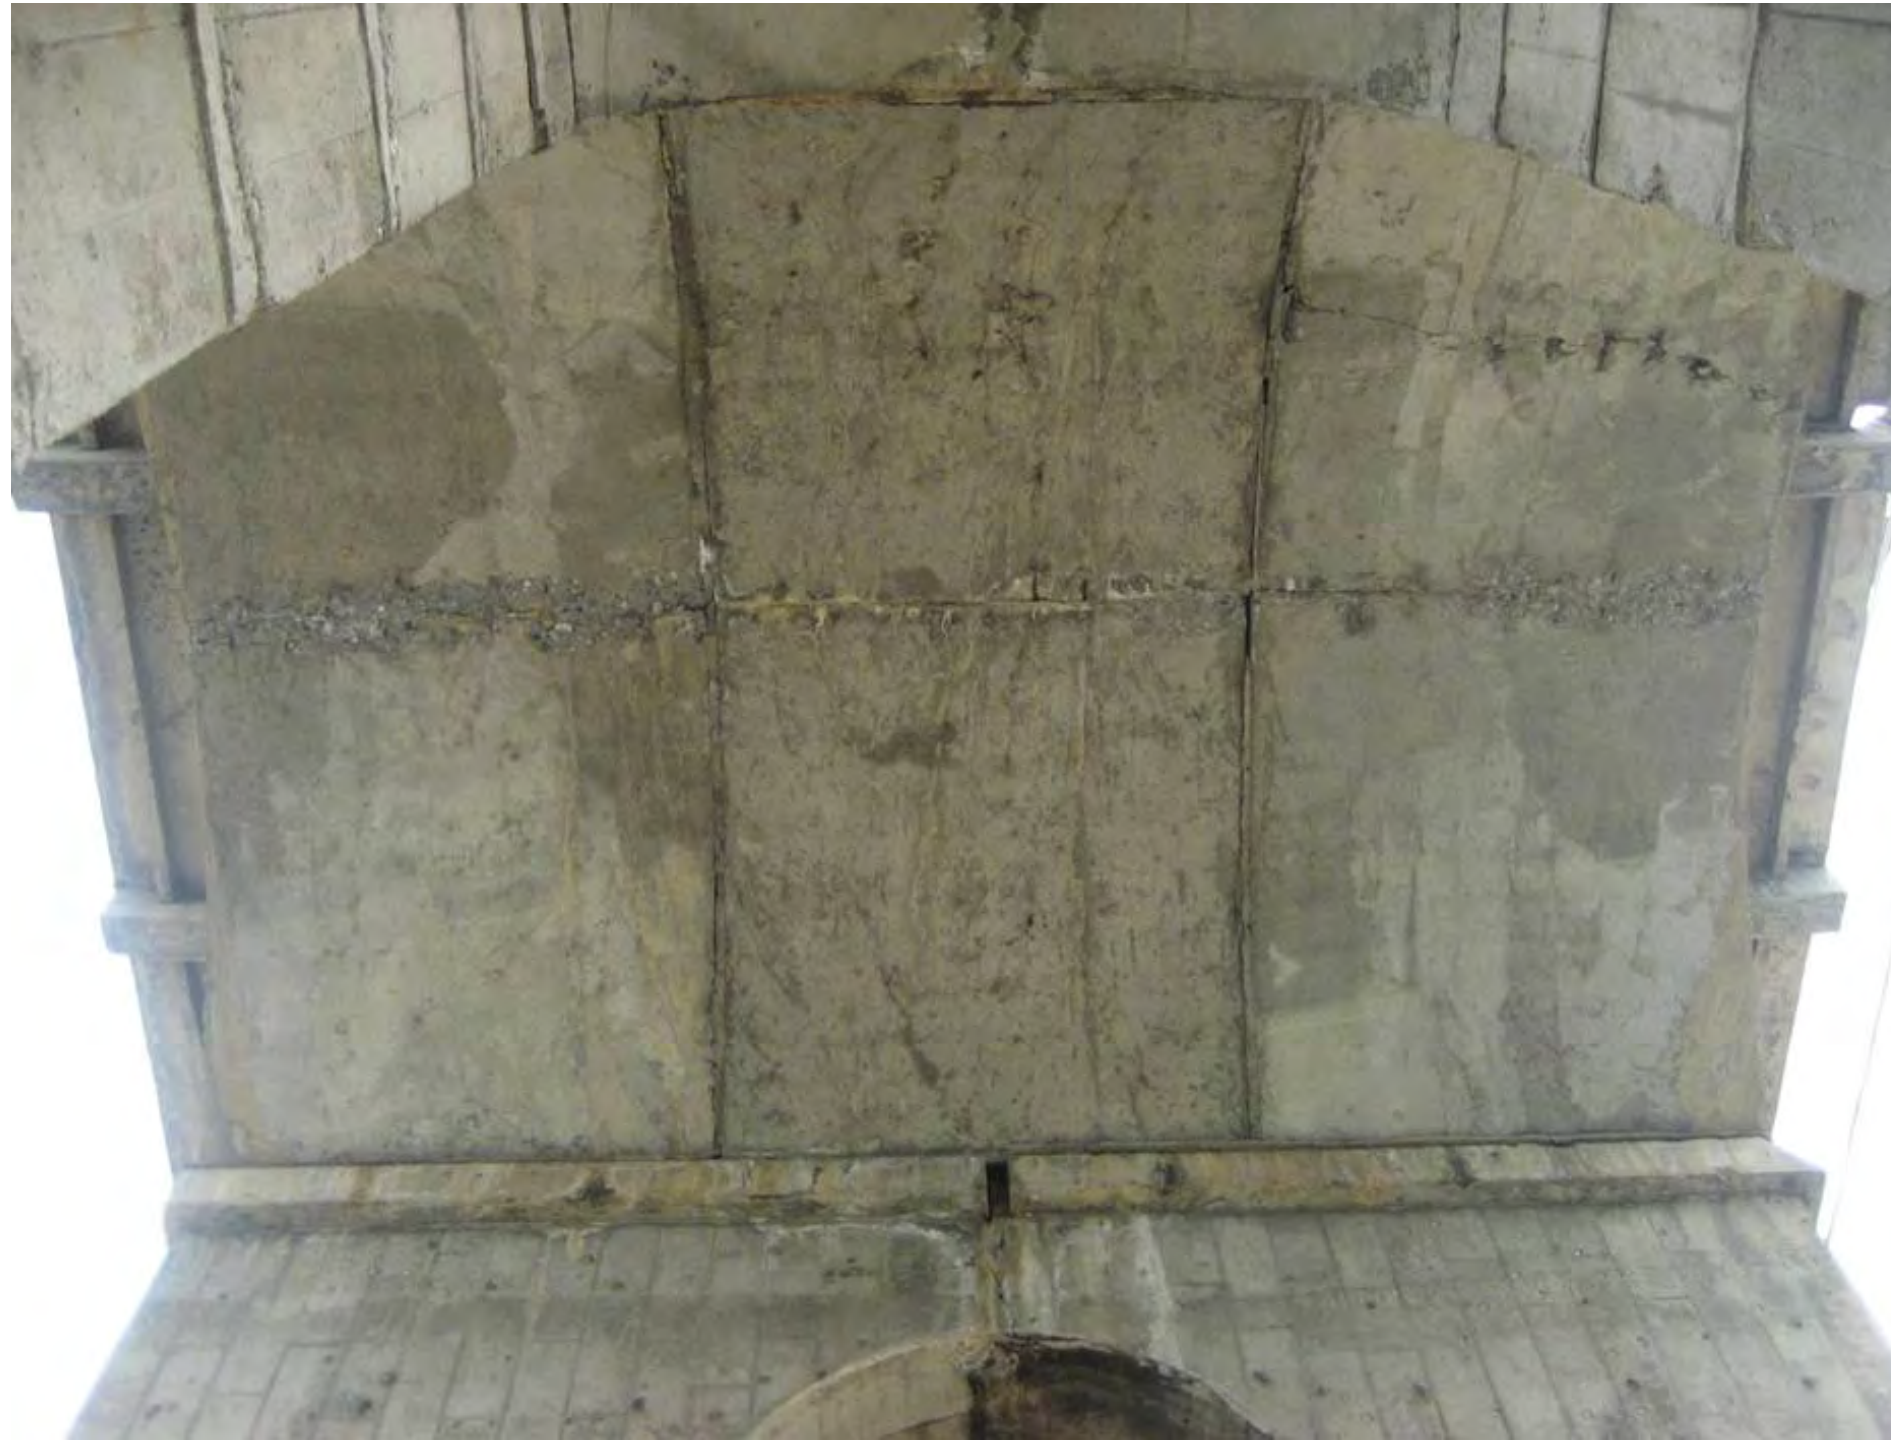
Movement of pylon

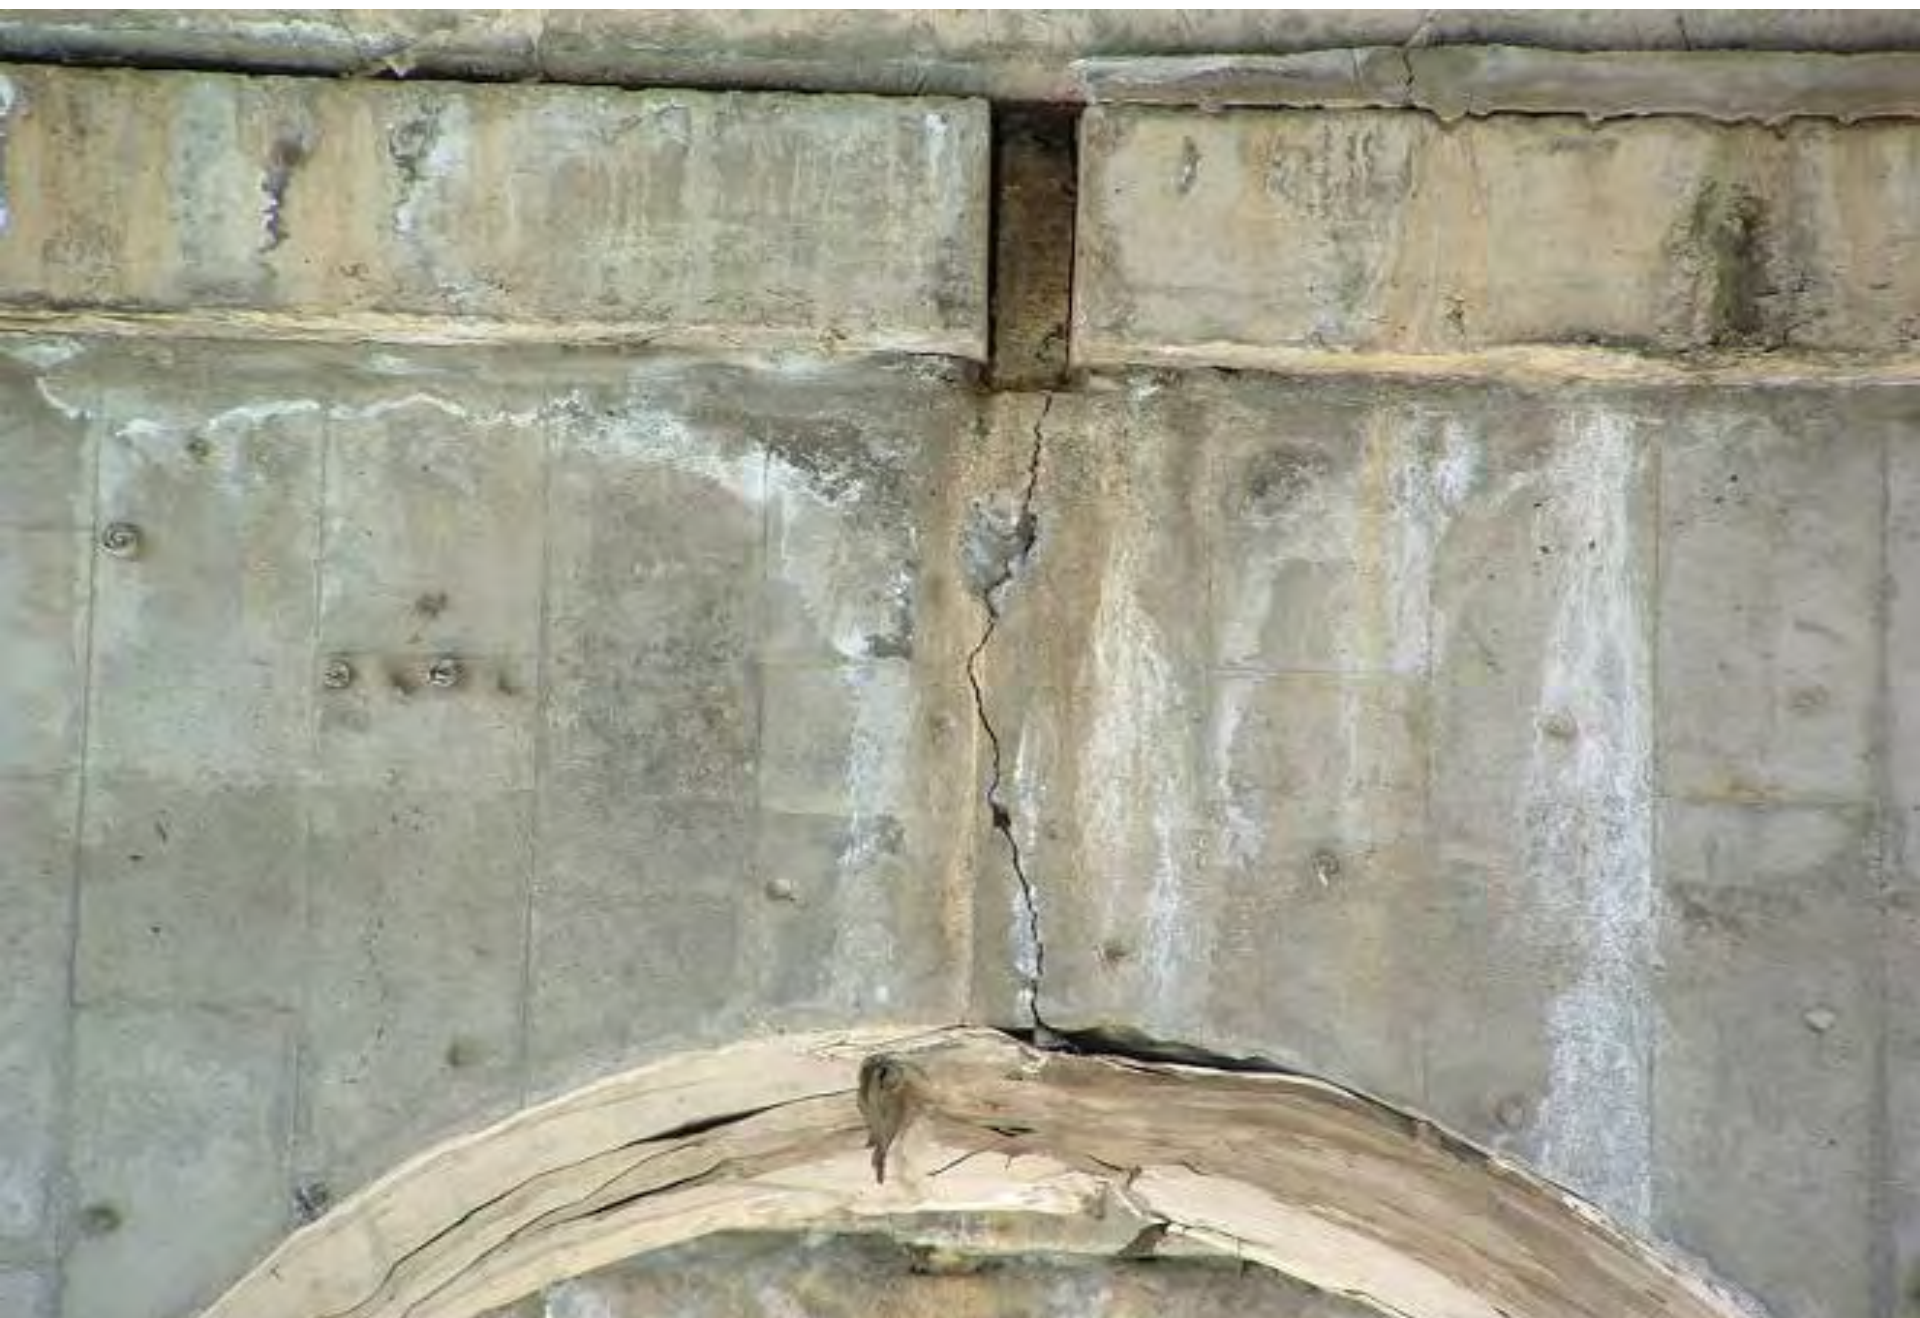
Crack in the deck

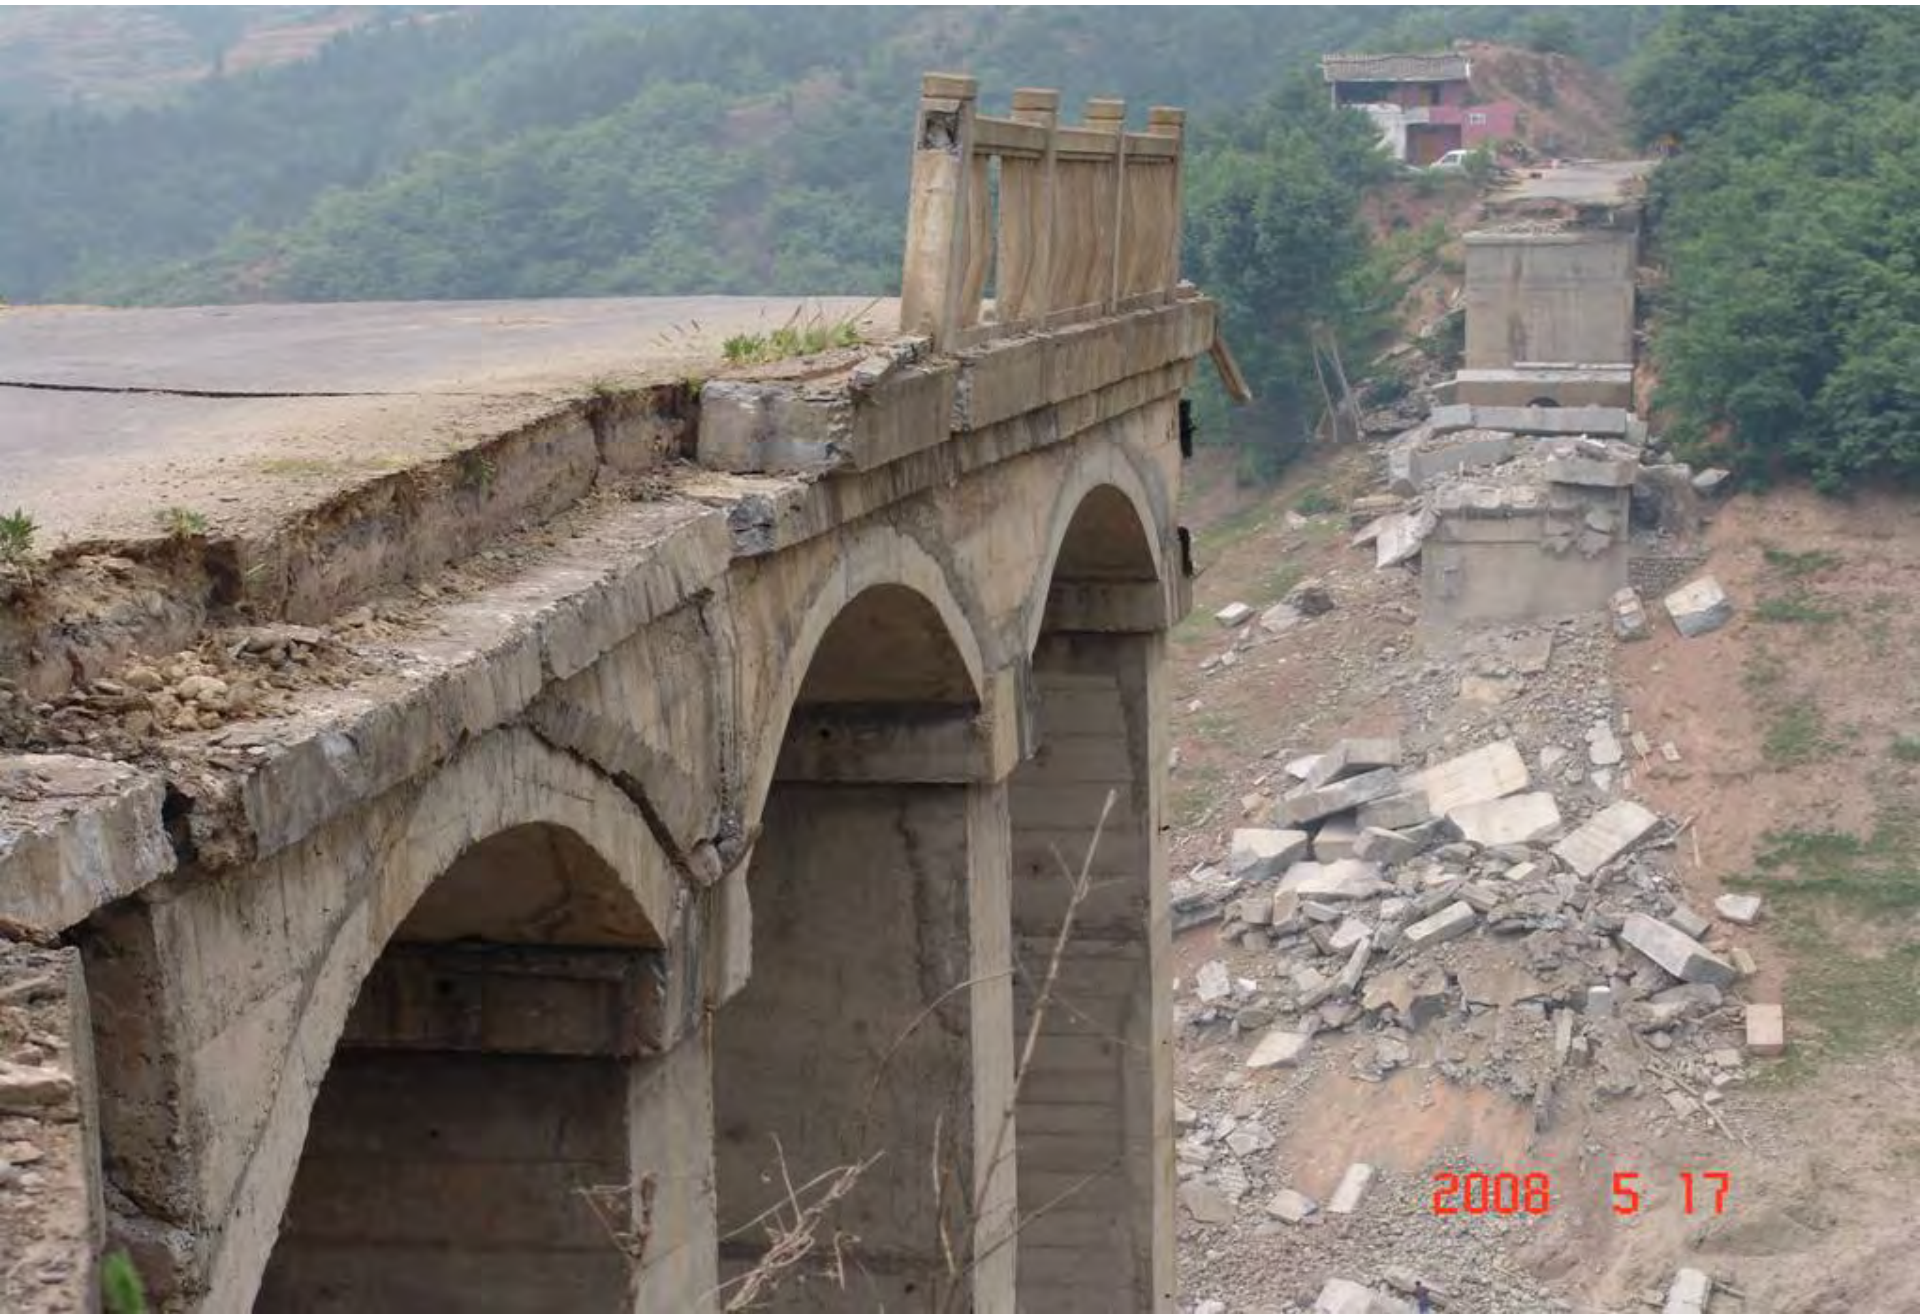
Jingtianba Bridge

Two-span arch bridge (each span 70m) collapsed closing provincial road 105

There are a number of solutions for the replacement of this bridge on a temporary basis, which include: a military pontoon bridge, some other kind of temporary bridge, as well as relocation of the road, which will eliminate the need for the bridge.

Currently, the relocation of the road seems to be the most favourable solution.

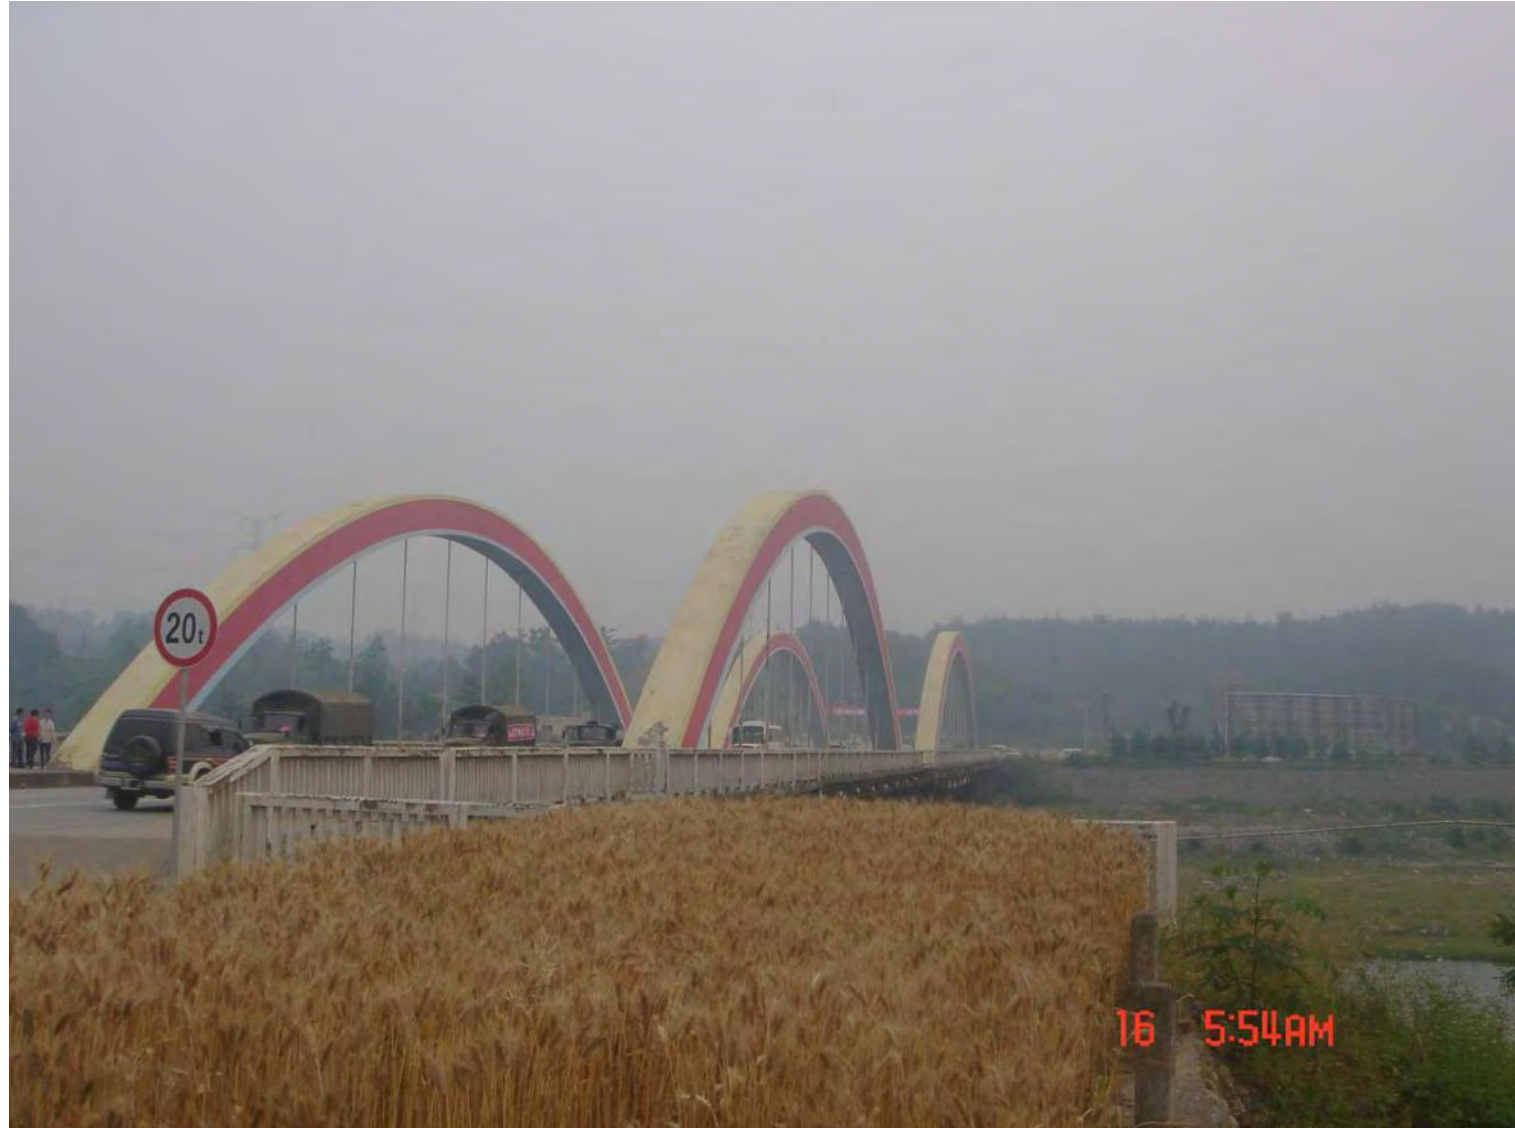
Anzhou Bridge

This is a two span arch bridge showing damage to various of its components.

It is hoped the bridge can be repaired.

1. In spite of the damage, the bridge is still open to traffic, with the following restrictions: the speed limit was reduced; the gross vehicle weight was reduced; and the traffic was directed to travel on the center of the bridge.
2. The bridge is to be inspected frequently to make sure there is no further damage to any of its components.

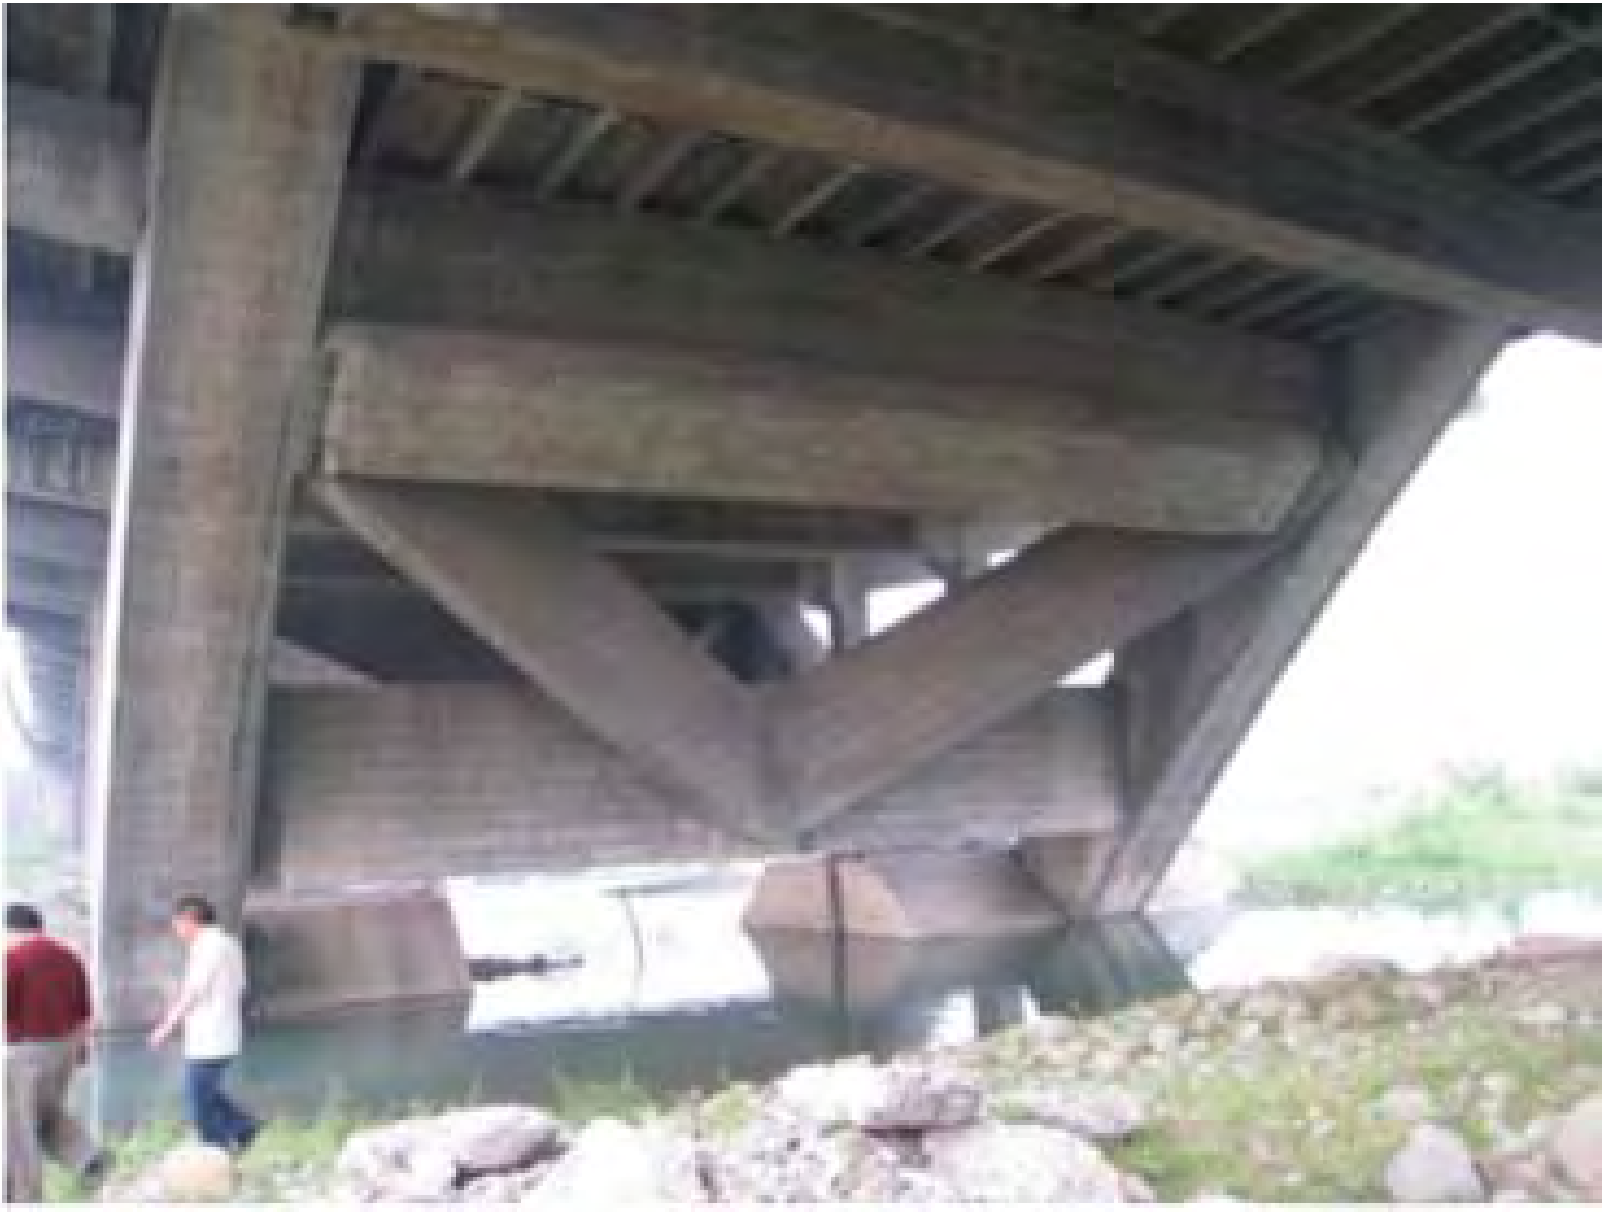
Damage to K-brace

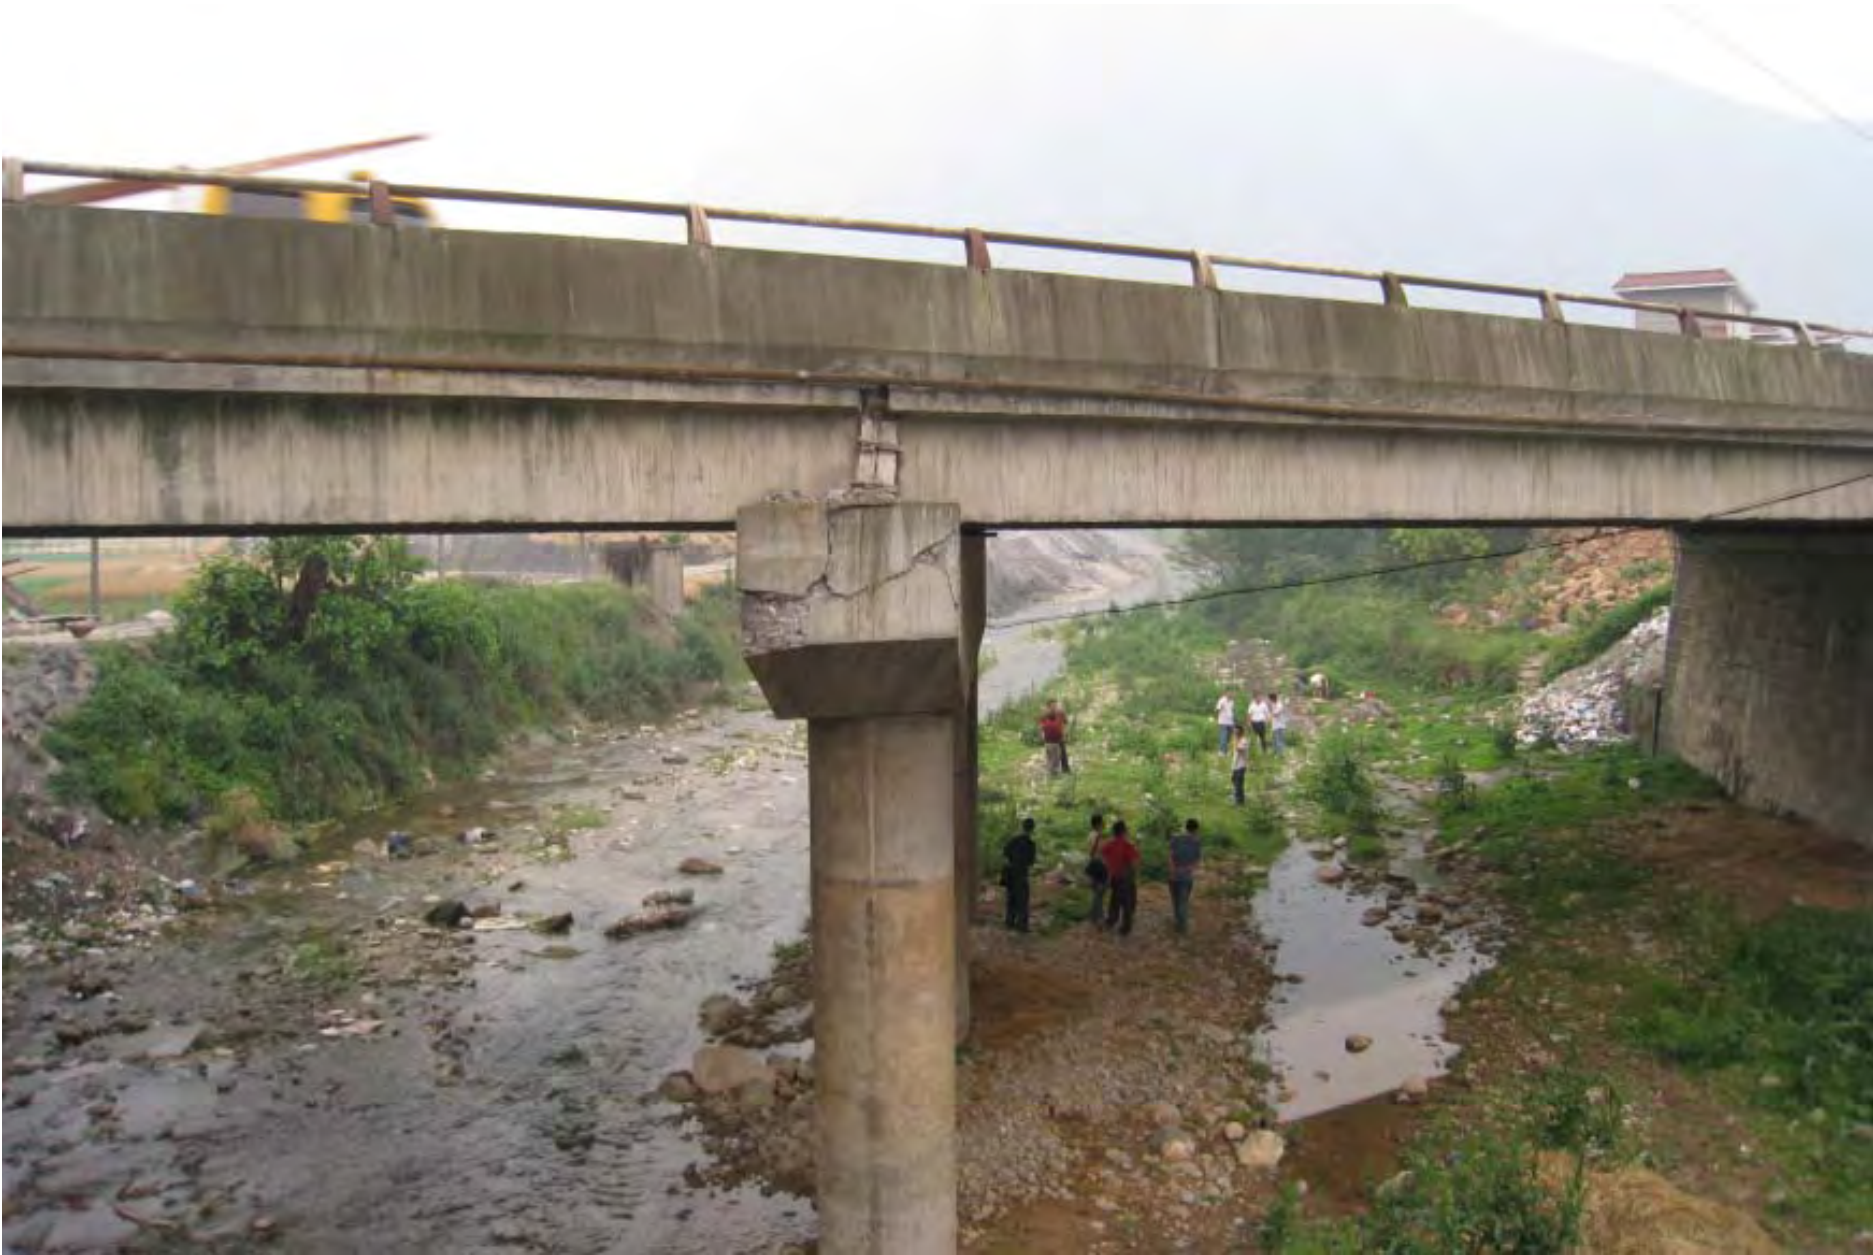
Xiangyangchun Bridge is a short two-span bridge located on a curve, showing damage to various components. No assessment has yet been made regarding required repairs.

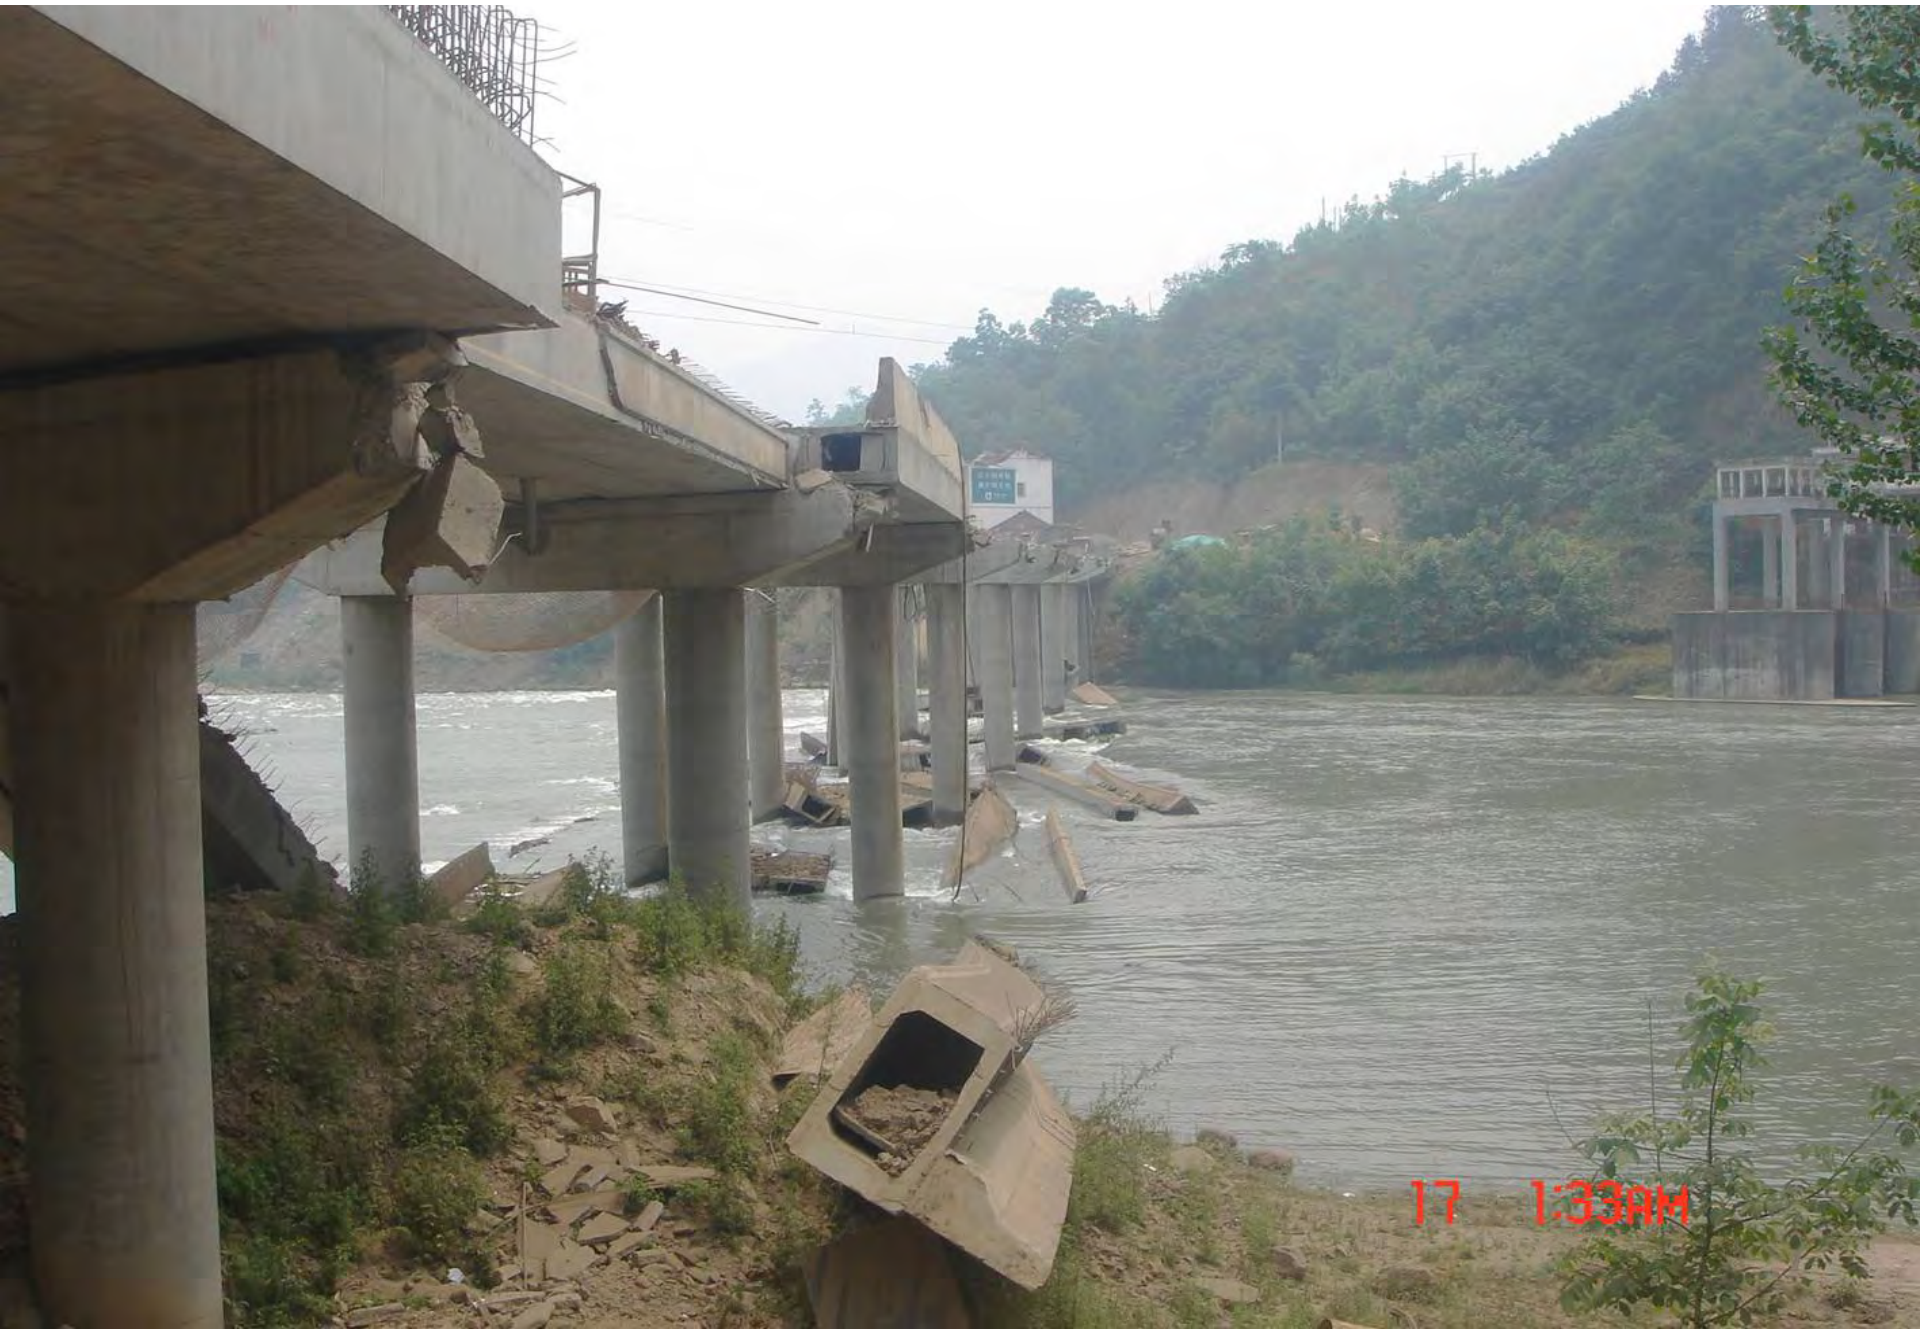
Nanba bridge under construction during earthquake

Collapsed girders

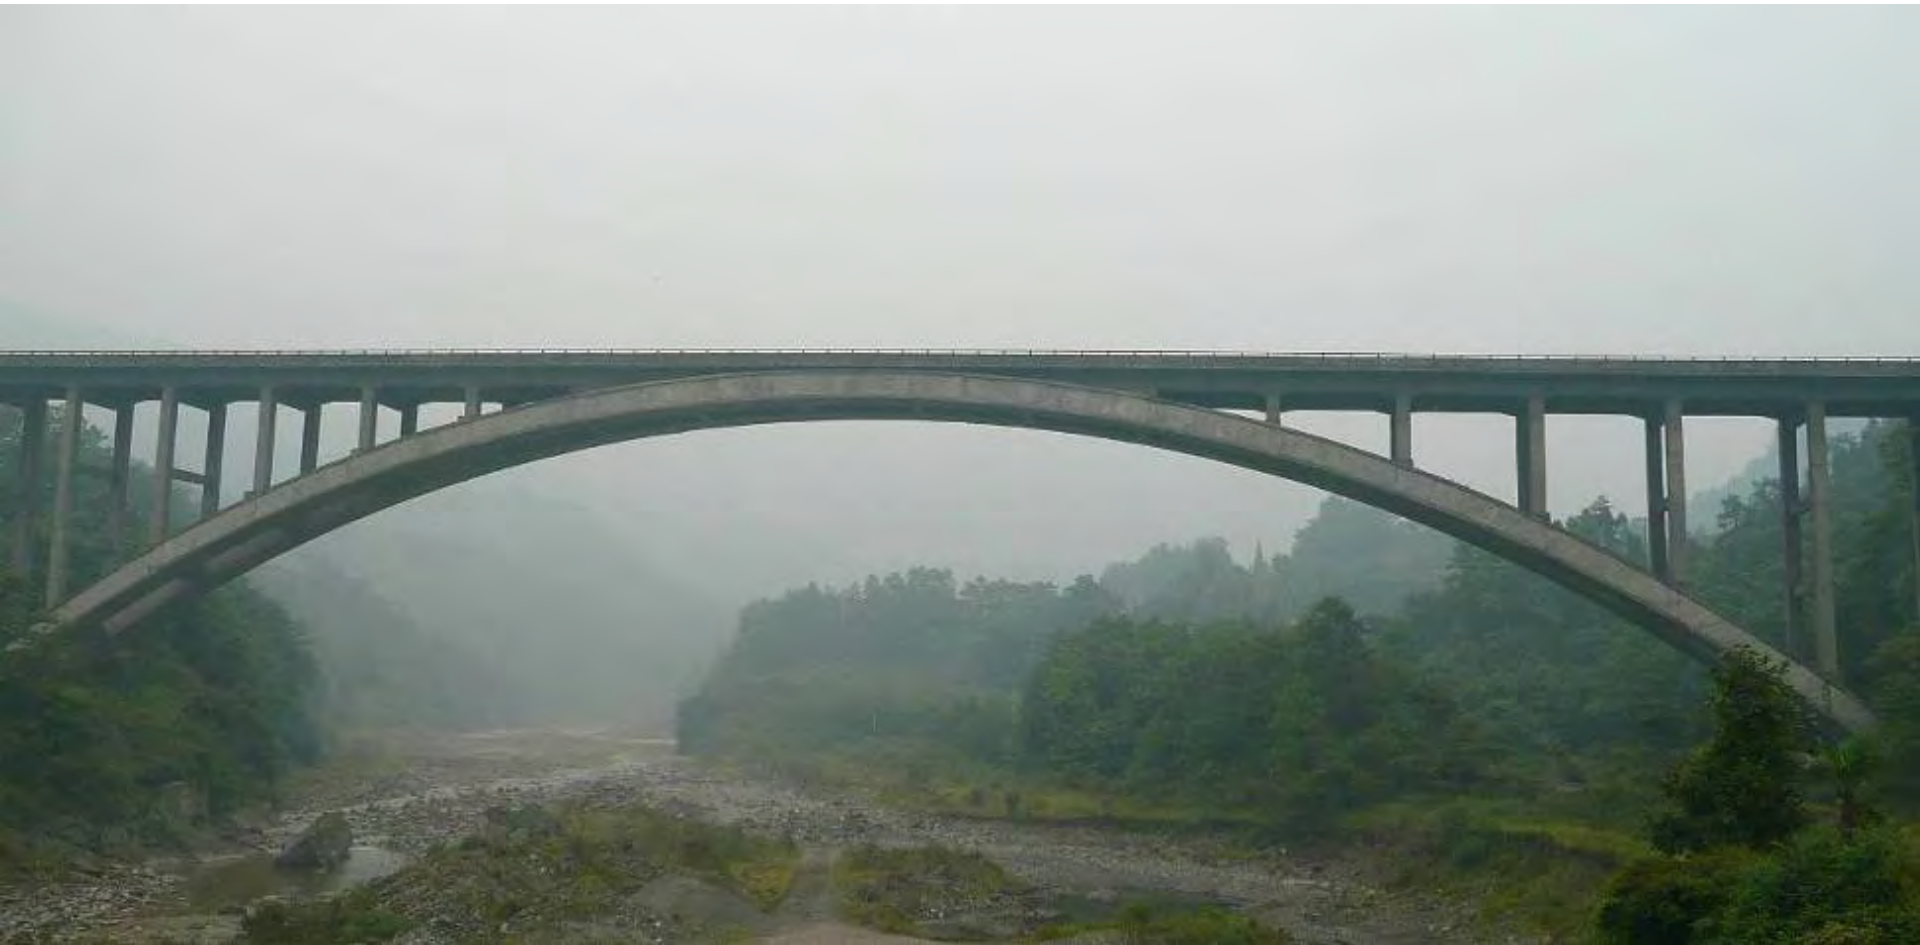
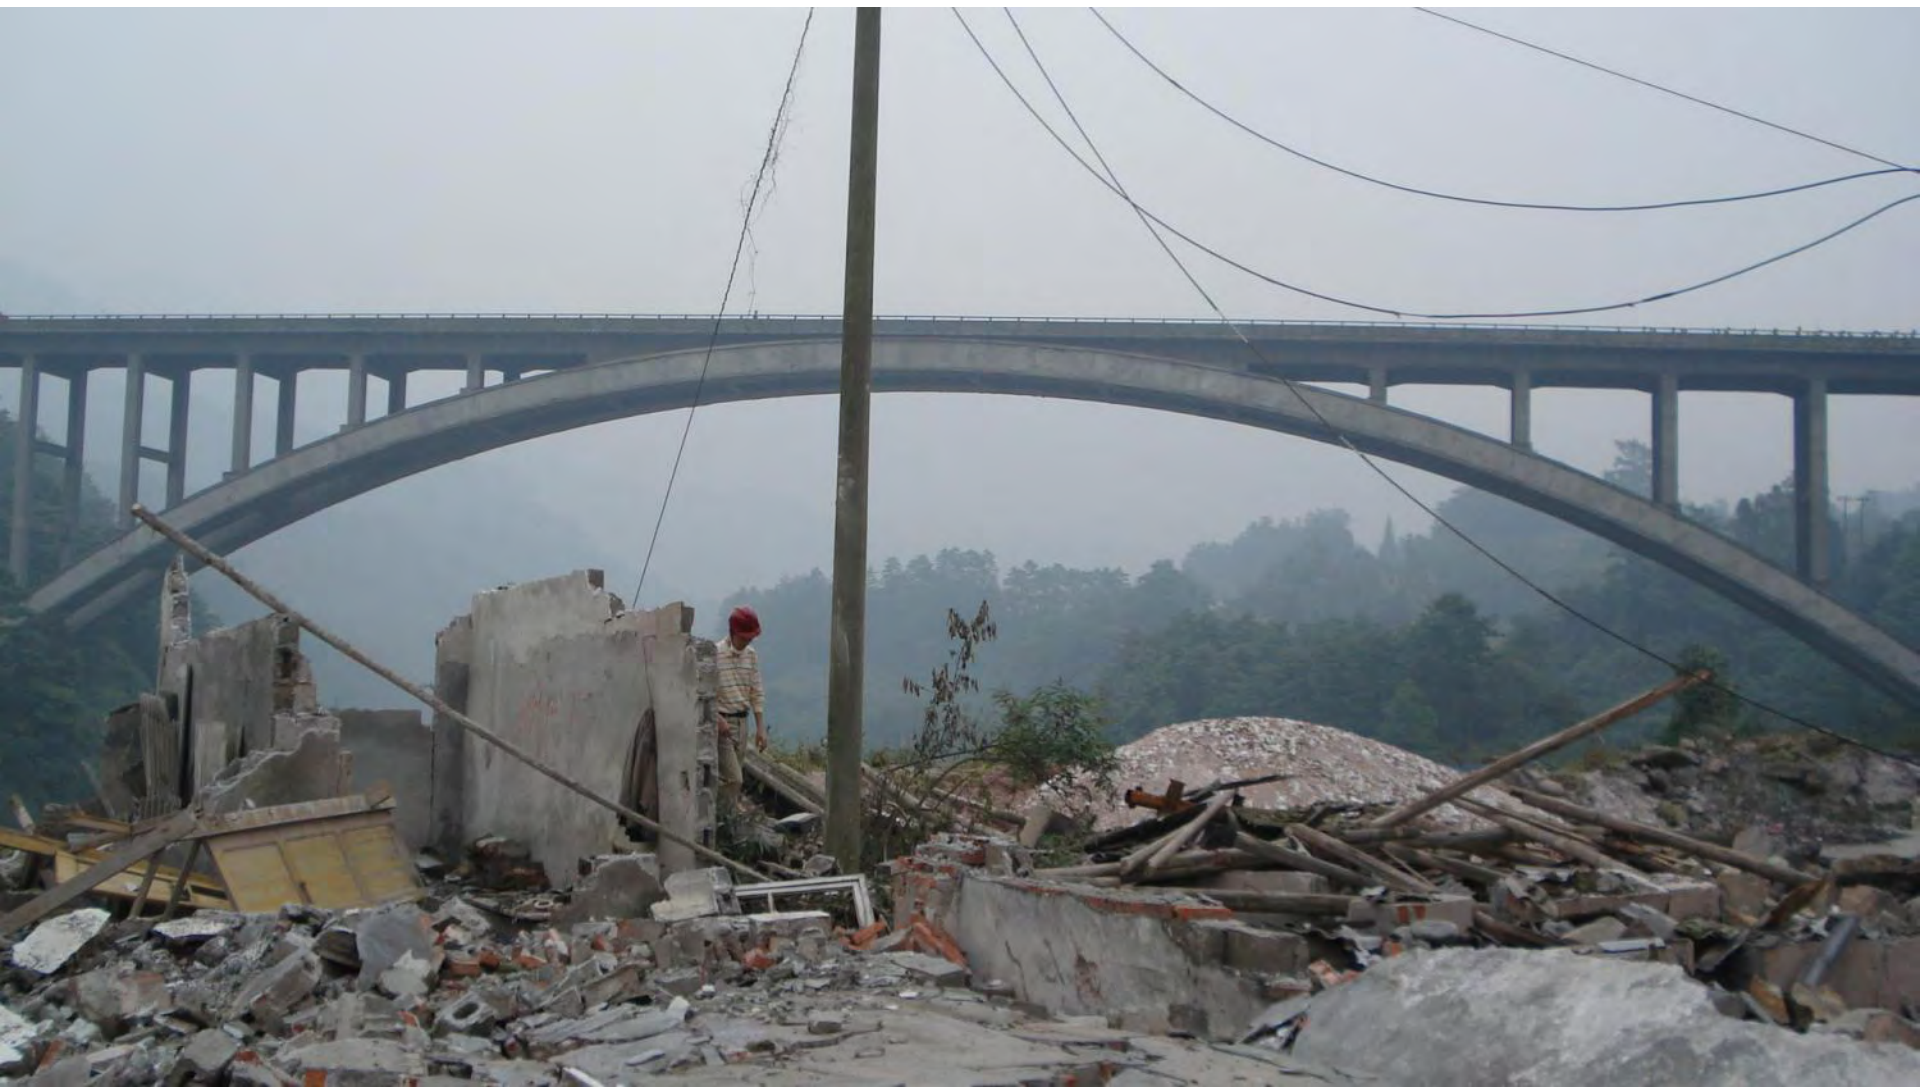
Jinhua Bridge

The bridge survived the earthquake reasonably well. Most of the damage appears to have been caused by large horizontal forces as is evidenced by the damage to the short interior arch columns.
