Investigation of the Effect of the May 2008 Earthquake on Bridges in China

Original presentation in China by Dr. Banfu Yan of
Hunan University, Changsha, China

Investigation of Earthquake-damaged Bridges in Guangyuan, Mianyang, and Deyang, Sichuan Province

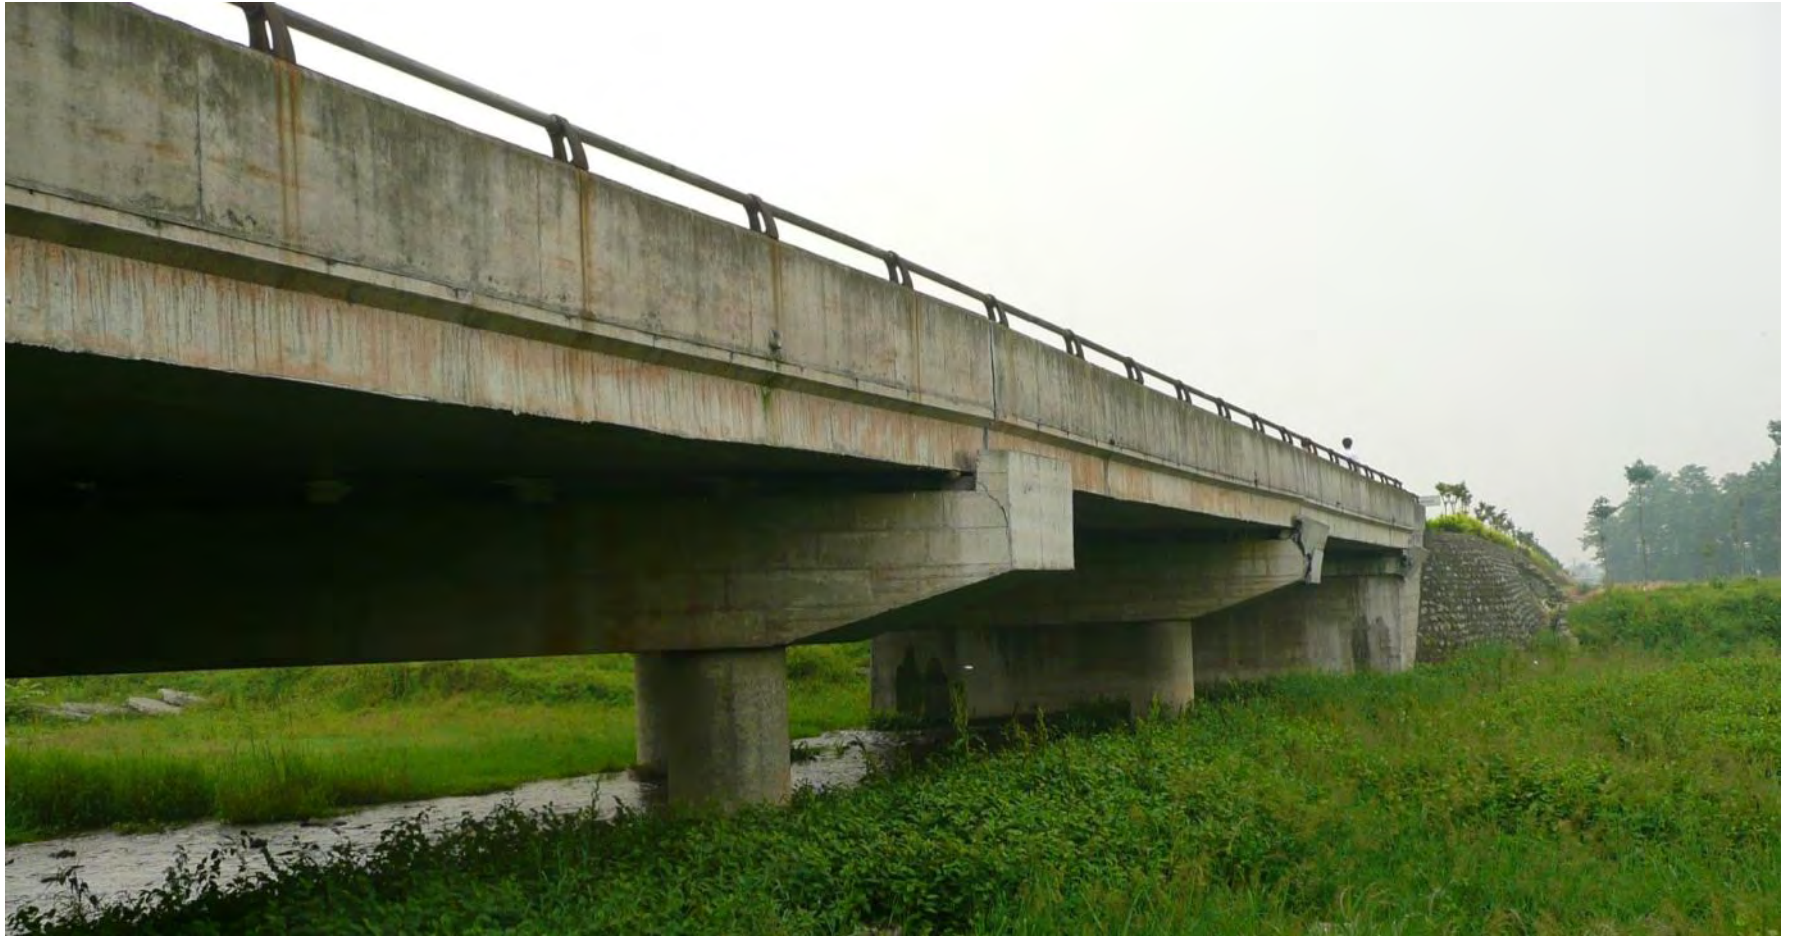
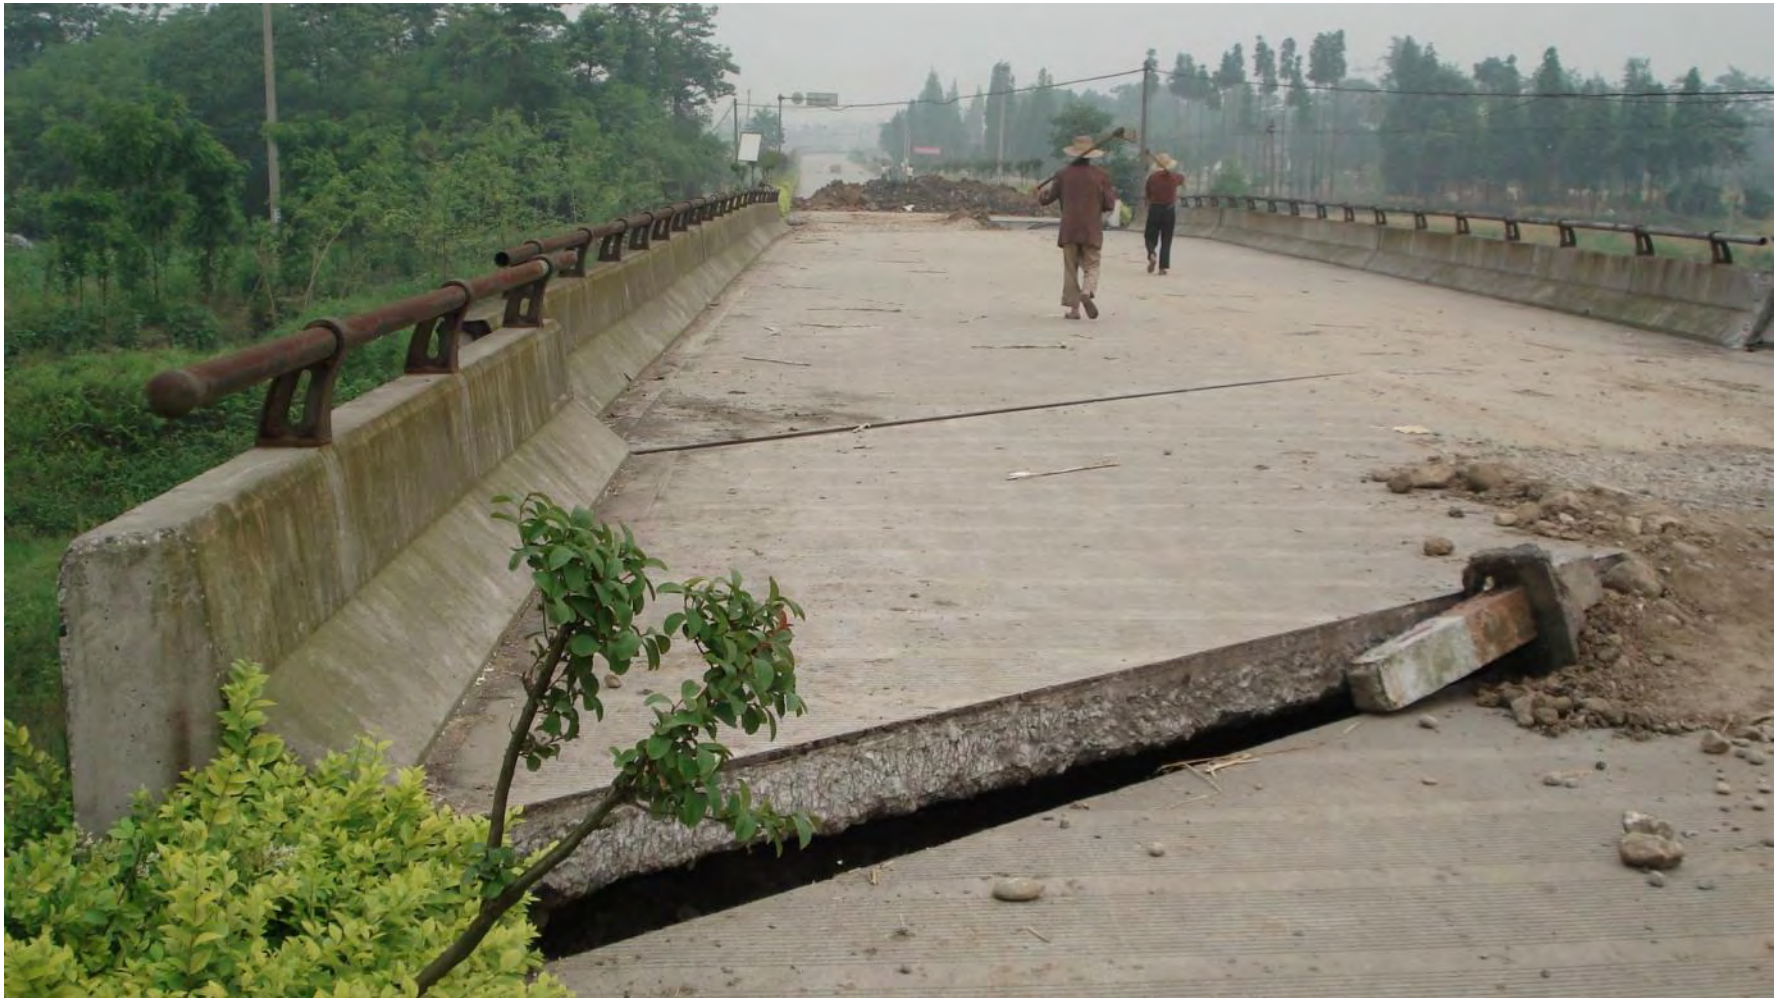
Wudu Mawei River Bridge

This bridge survived the earthquake very well. Damage was concentrated at the abutments, with one abutment having a movement of approximately 450 mm.

Problem with rubber bearing was observed on some of the bridges. It appears that rubber bearings do not offer enough restraint to prevent girders from falling off the bearings during the sudden movements caused by the earthquake.

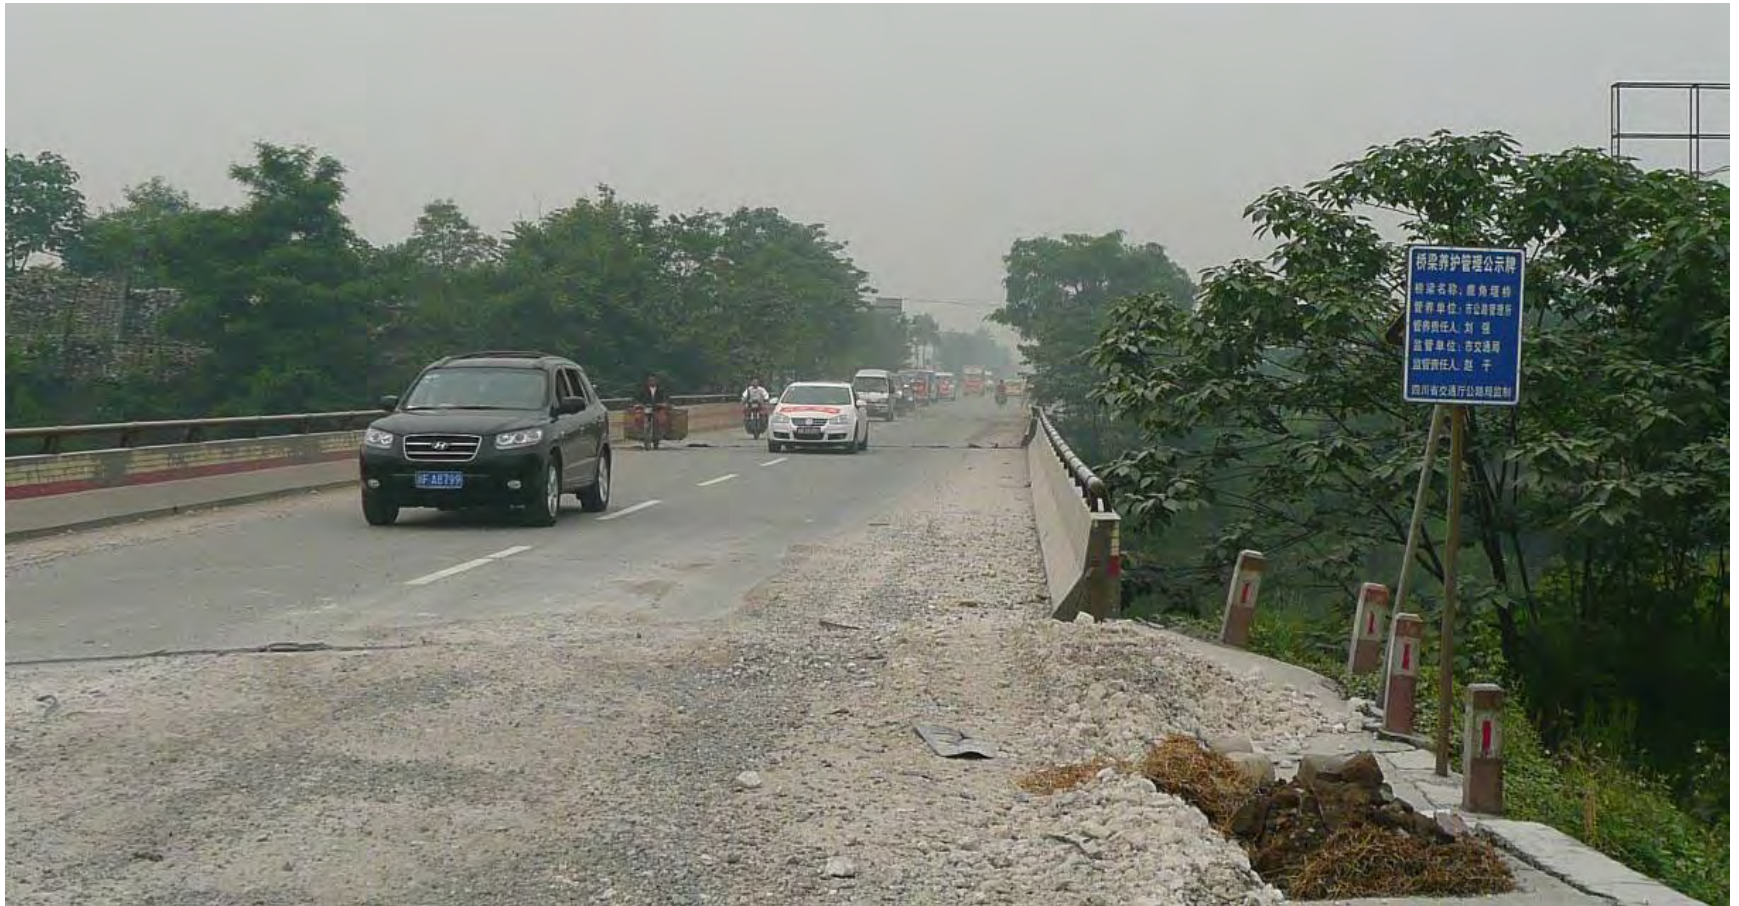
Mianzhu Lujiaoyan Bridge

Another example of damage as a result of sudden movements experienced during earthquakes
